Project: Lee Residence and Shoreline Protection Structure
Applicant: Kyoung-Su Im
Agent: Group 70 International, Inc. (Jeffrey Overton)
Location: 4465 and 4469 Kahala Avenue - Waialae Kahala
Tax Map Key: 3-5-3: 2 and 3
Request: Special Management Area Use Permit (SMP) and
Shoreline Setback Variance (SV)
Proposal: New Residence over 7,500 square-feet and Shoreline Structure within
the 40-foot shoreline setback.

**Subject: Kāhala Residence and Shoreline Structure
Accepted Final Environmental Assessment/FONSI**

Final Draft Environmental Assessment

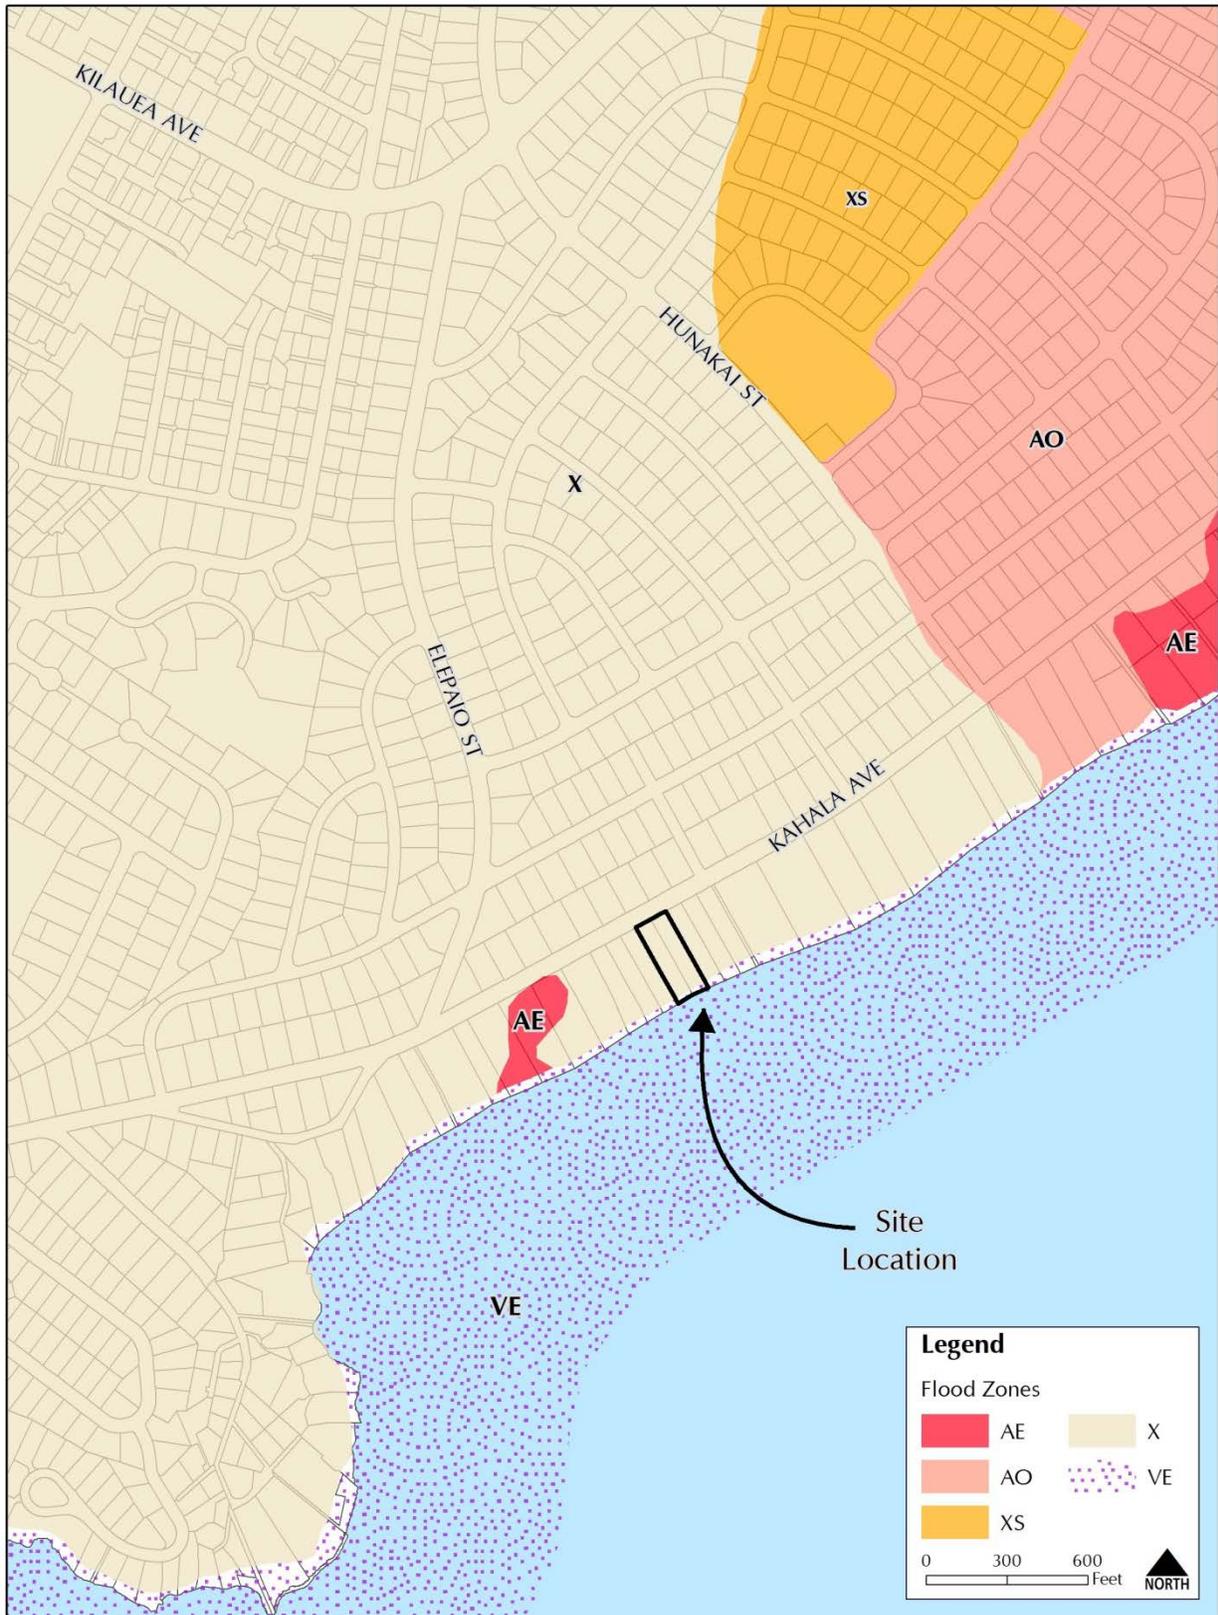
FIGURE 3-2: FEMA FLOOD INSURANCE RATE MAP

Based on the Federal Emergency Management Agency's *Digital Flood Insurance Rate Map, DFIRM data Community Panel No. 15003C0370F*, effective November 30, 2004 2011, the project area is located in "Zone X". As depicted in *Figure 3-2*, the flood Zone X designation indicates the area is outside of the 0.2% annual chance floodplain. The parcels are not located in a Flood Hazard District as defined by LUO Section 21-9.10.

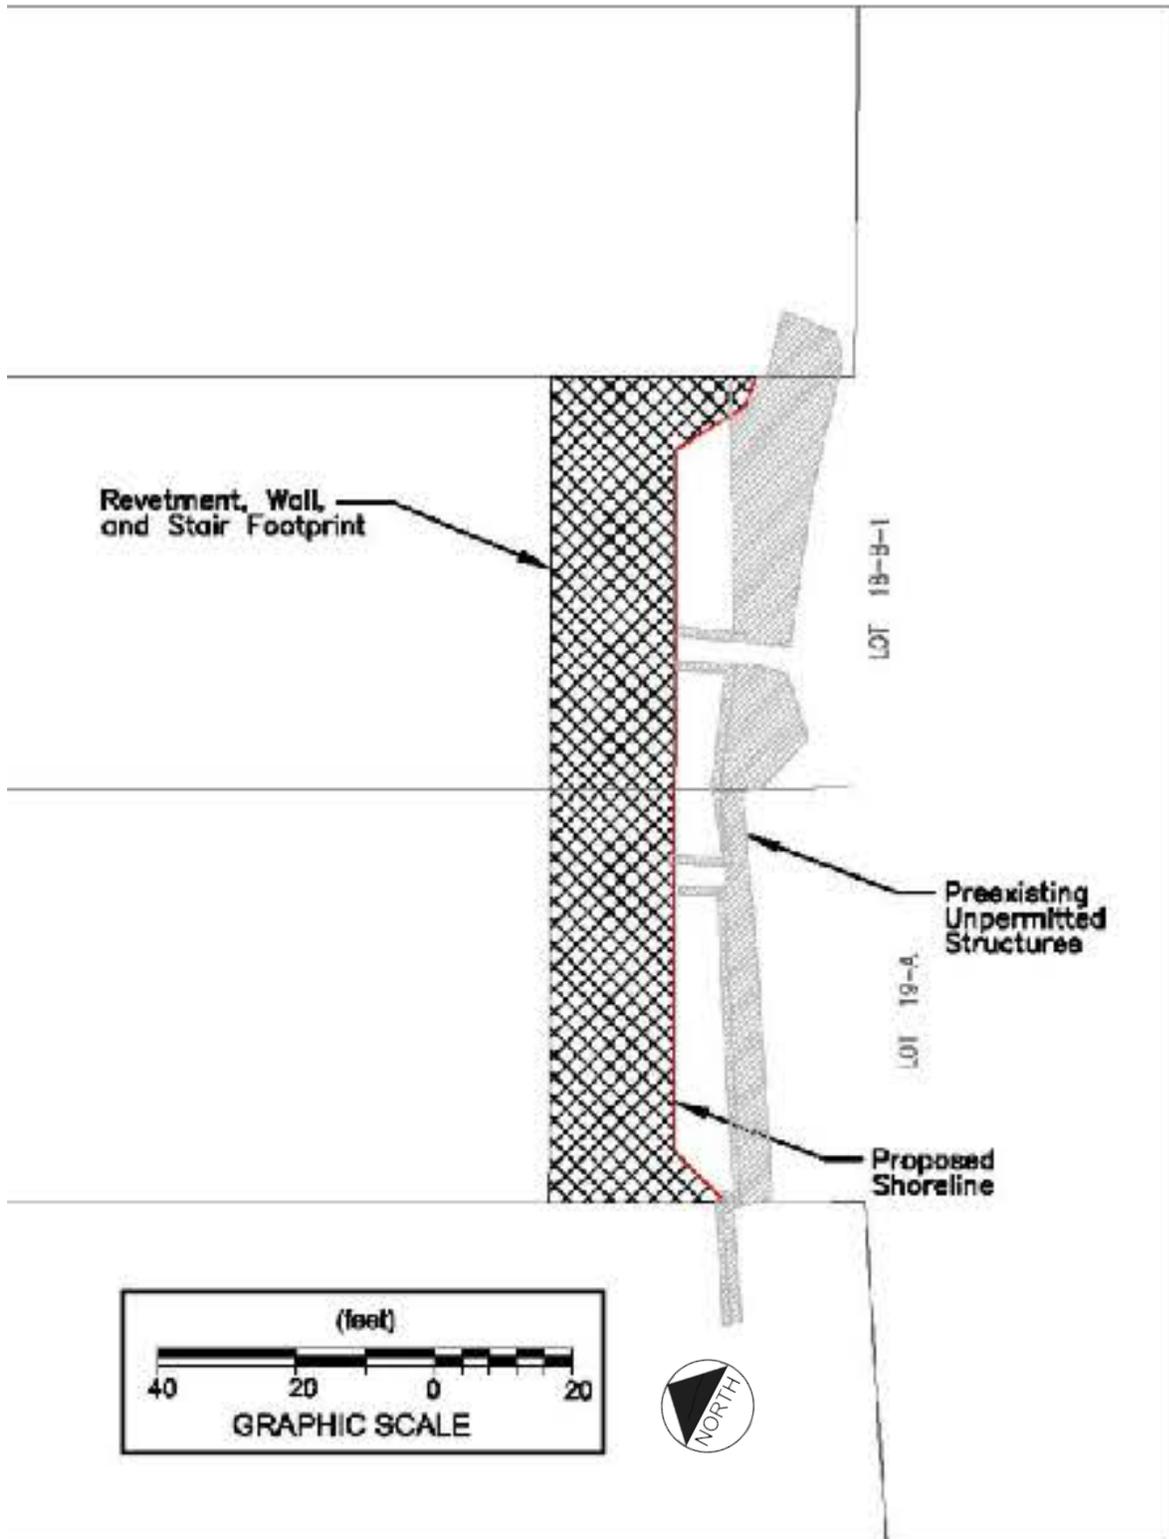
FIGURE 4-1: SITE PLAN PROPOSED REVETMENT FOOTPRINT

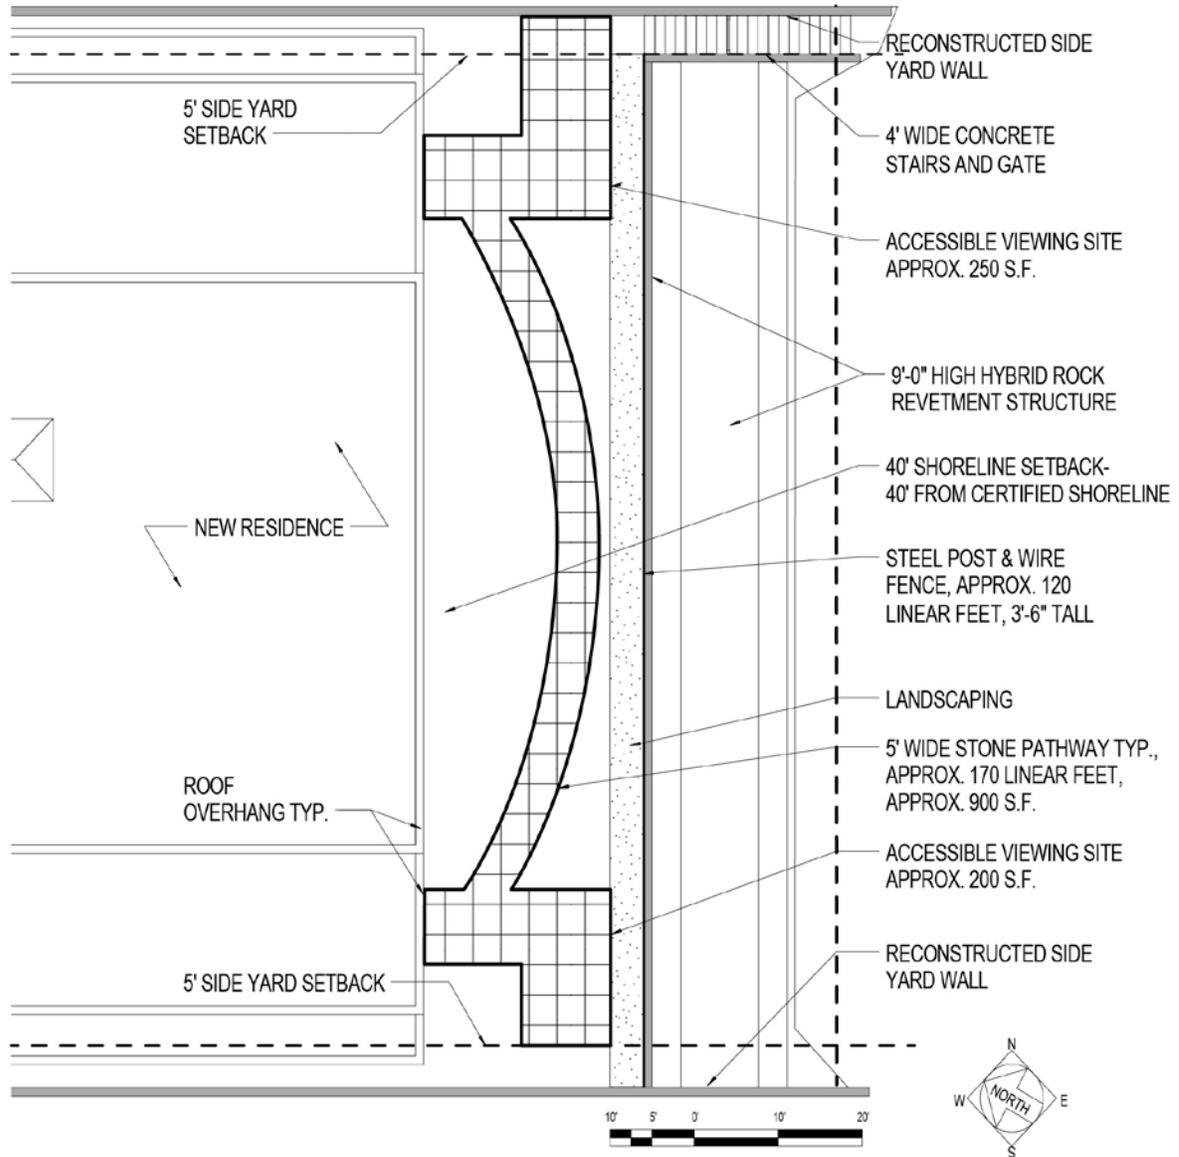
Figure 5-2 Planned Improvements in the Shoreline Setback Area (7/02/14)

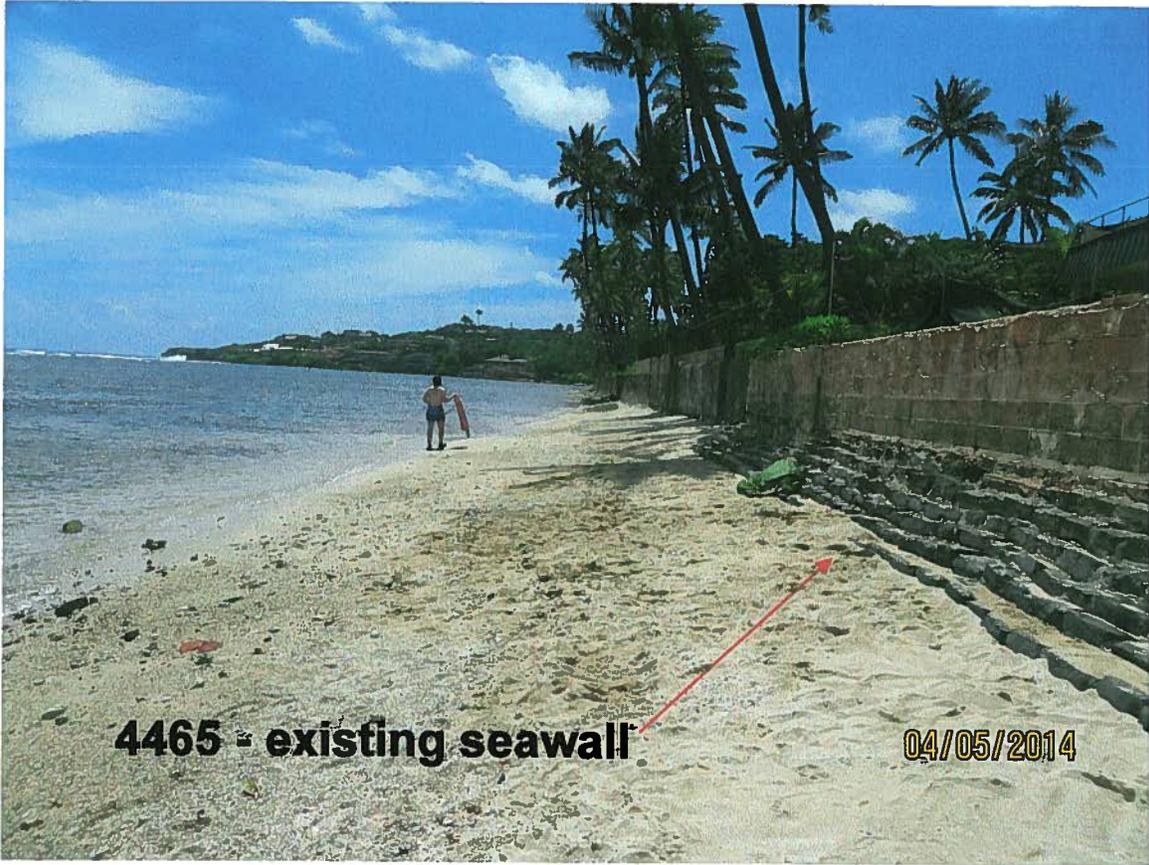
4465 - existing seawall

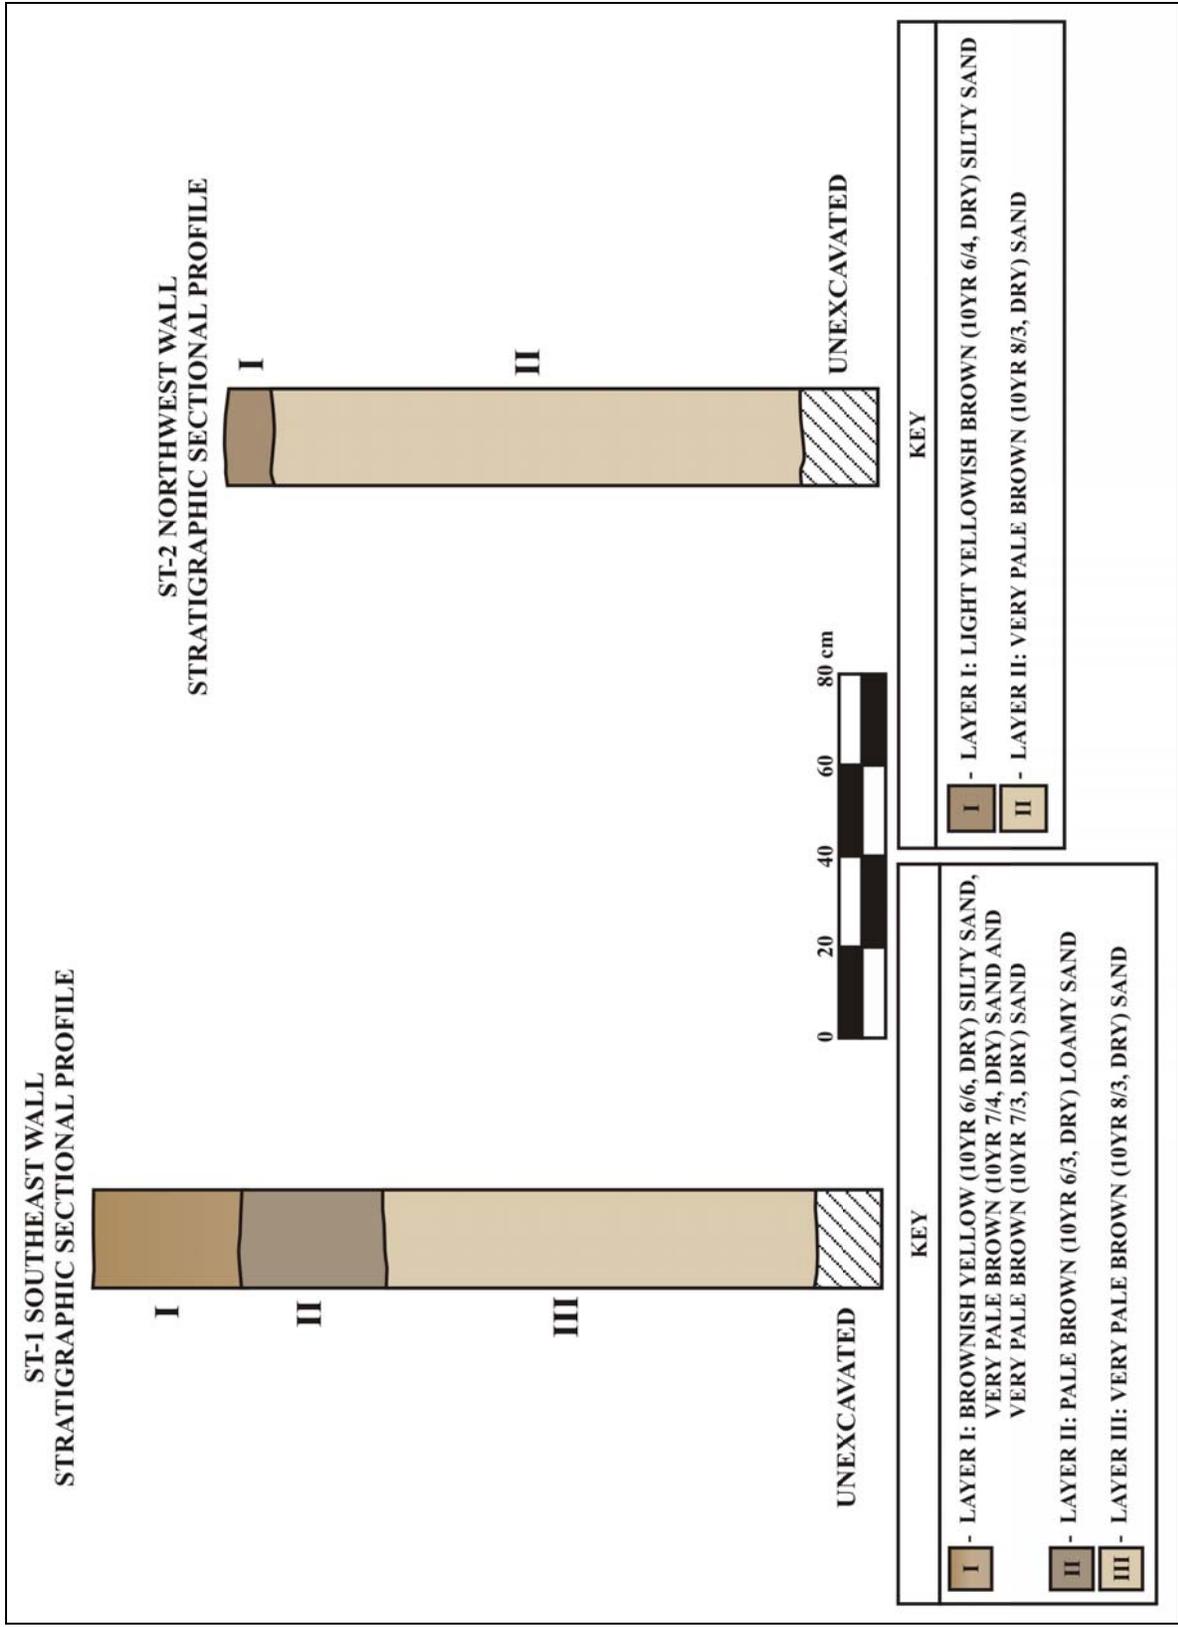
Figure 11: Stratigraphic profiles for Test Trenches ST-1 and ST-2.

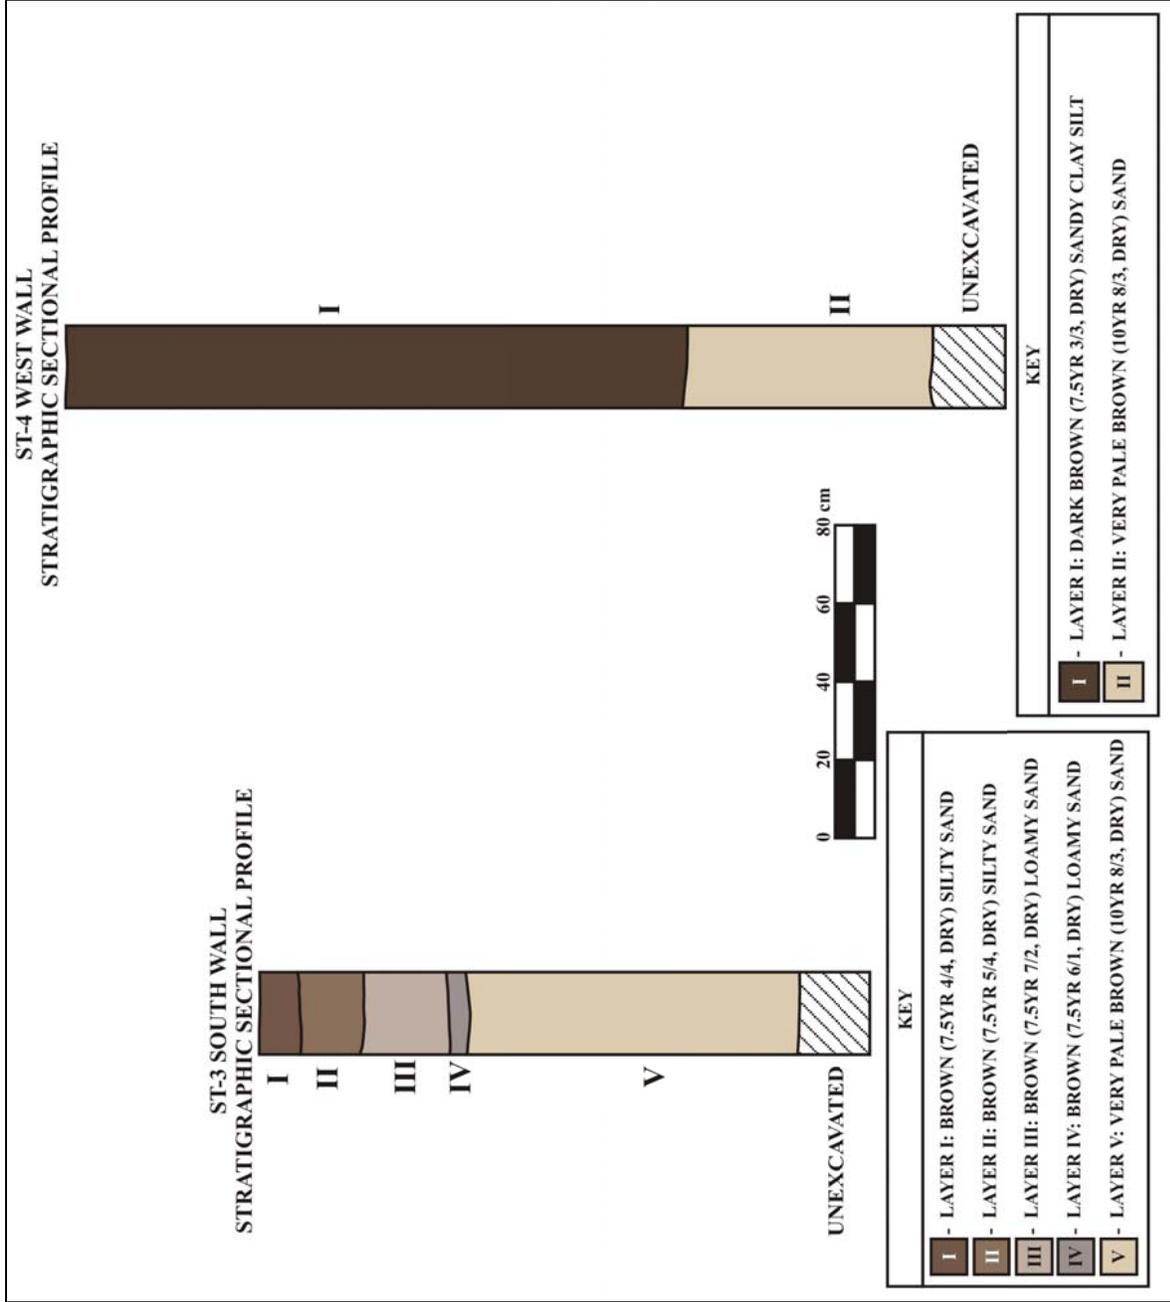
Figure 14: Stratigraphic profiles for Test Trenches ST-3 and ST-4.

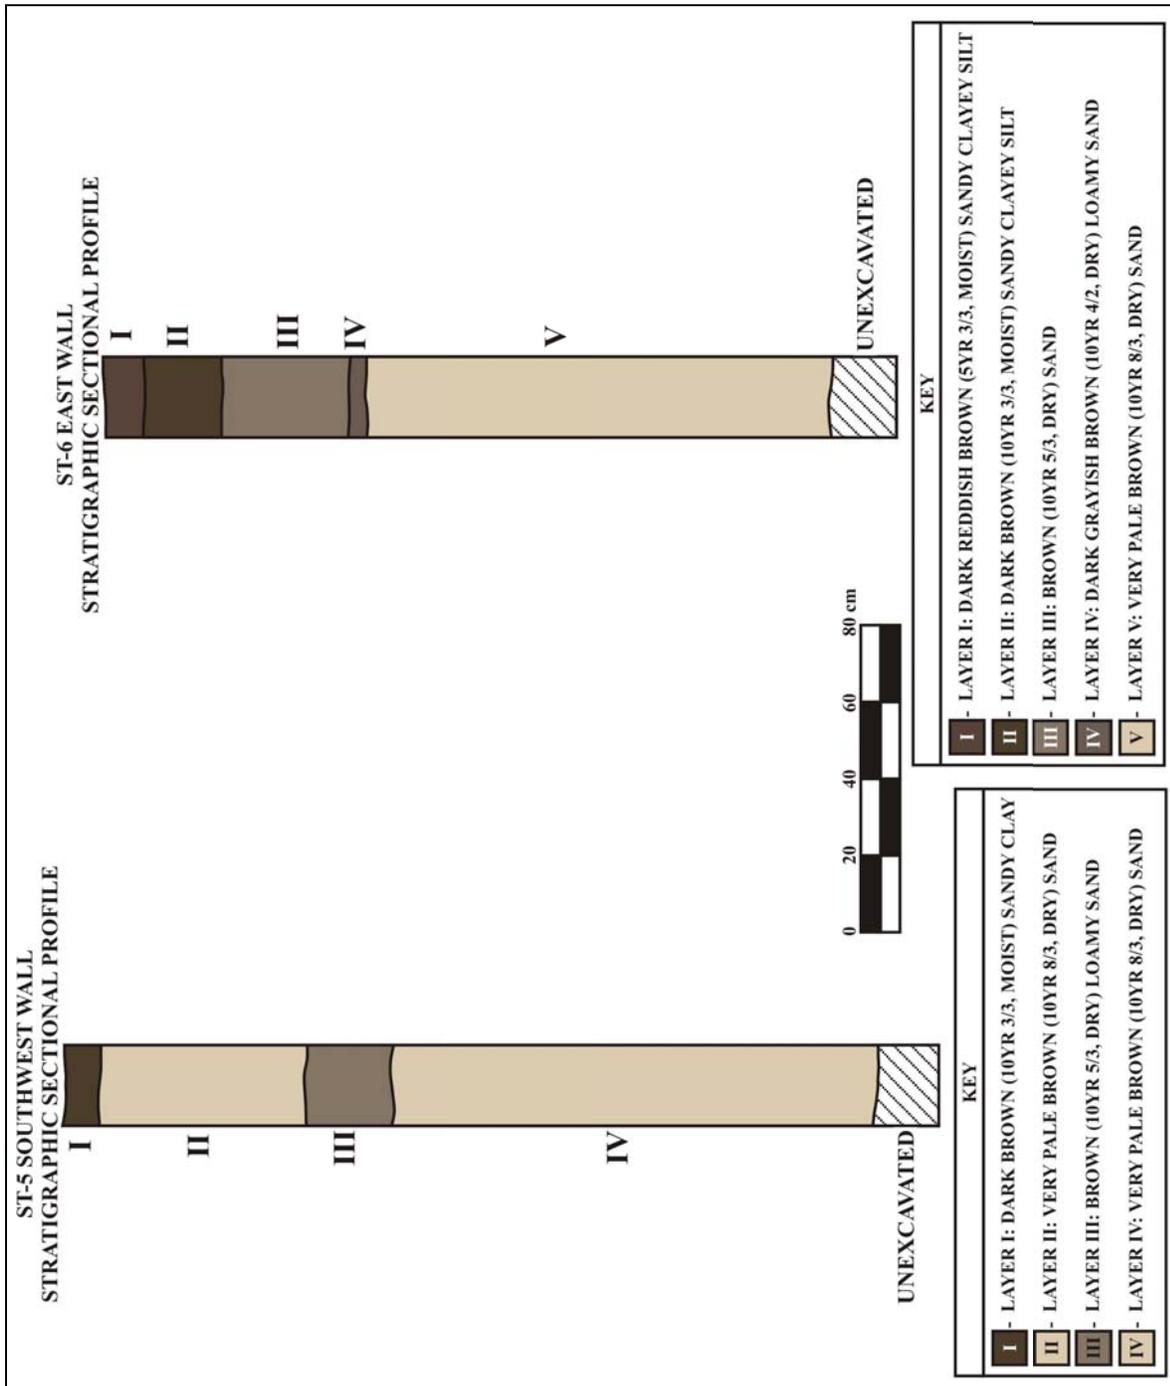
Figure 17: Stratigraphic profiles for Test Trenches ST-5 and ST-6.

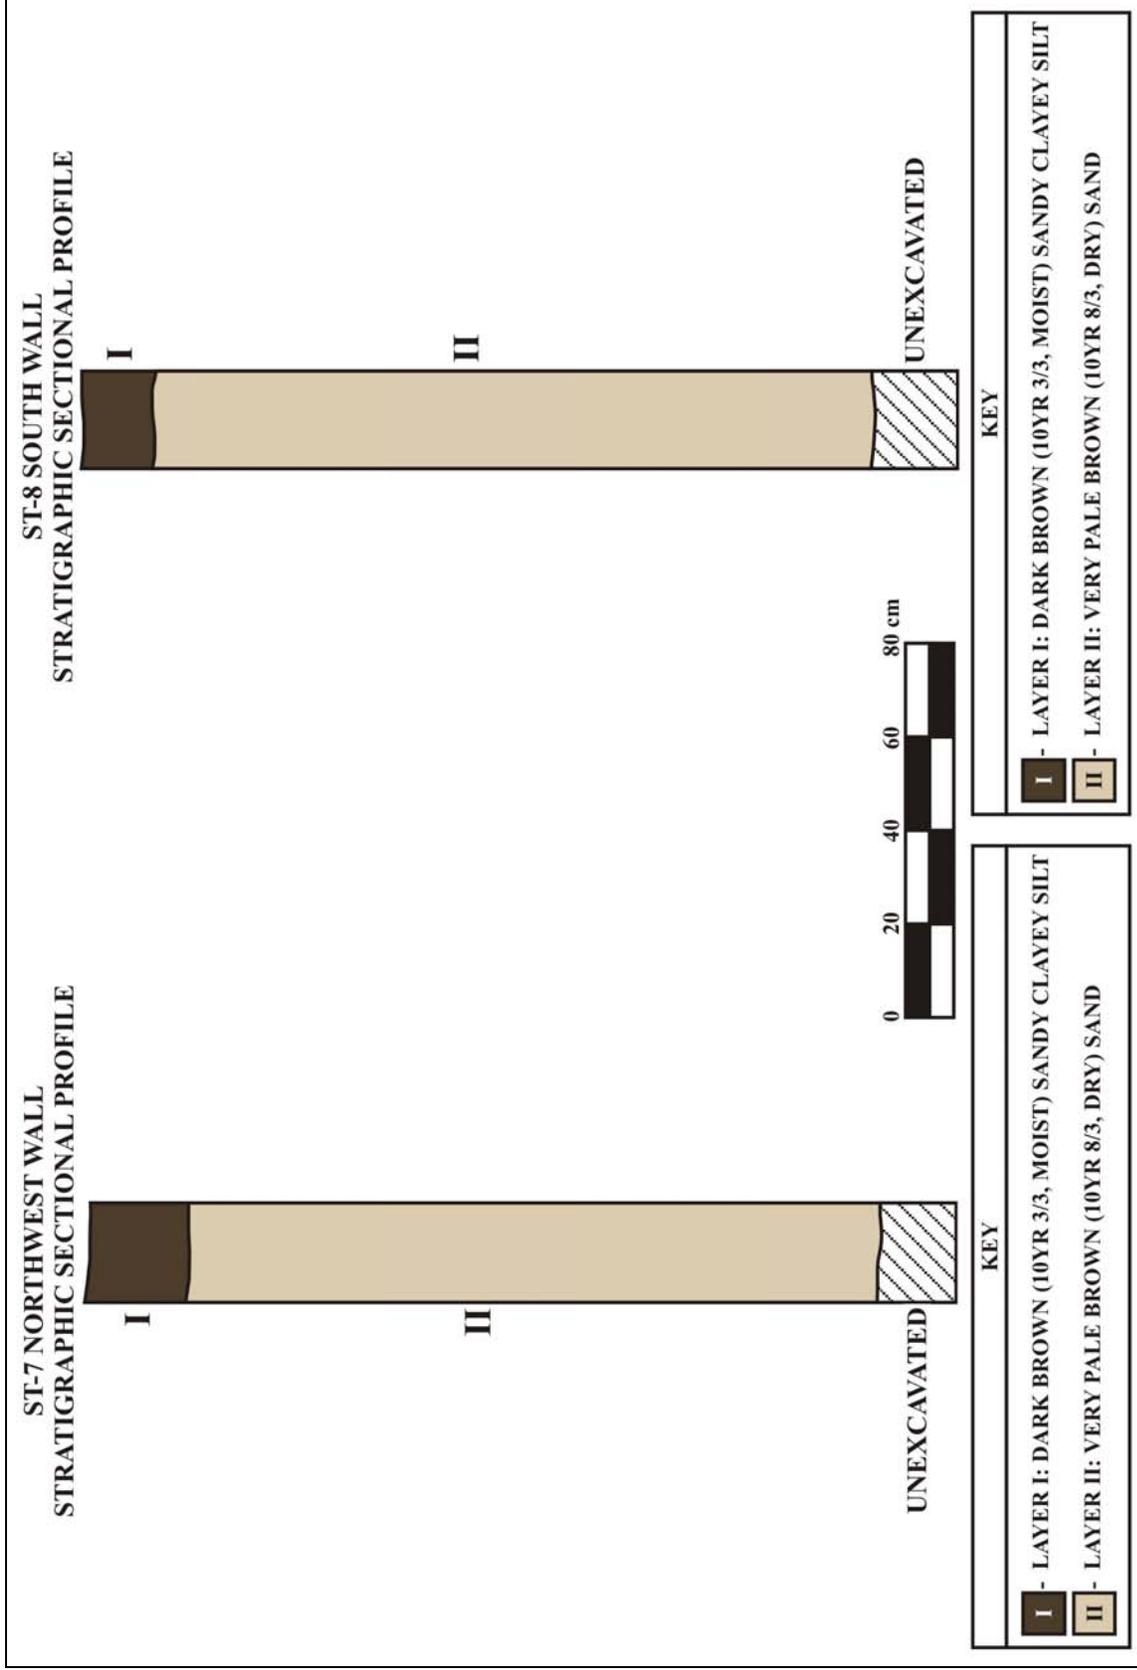
Figure 20: Stratigraphic profiles for Test Trenches ST-7 and ST-8.

Test Trench-8 (ST-8) 6.2 m long by 0.8 m wide and 1.9 m deep) was placed northwest of ST-7, oriented East-West, near the driveway that ran along the northeast edge of the project area (see Figure 10). ST-8 contained two stratigraphic layers which are described below (Figure 20, Figure 22).

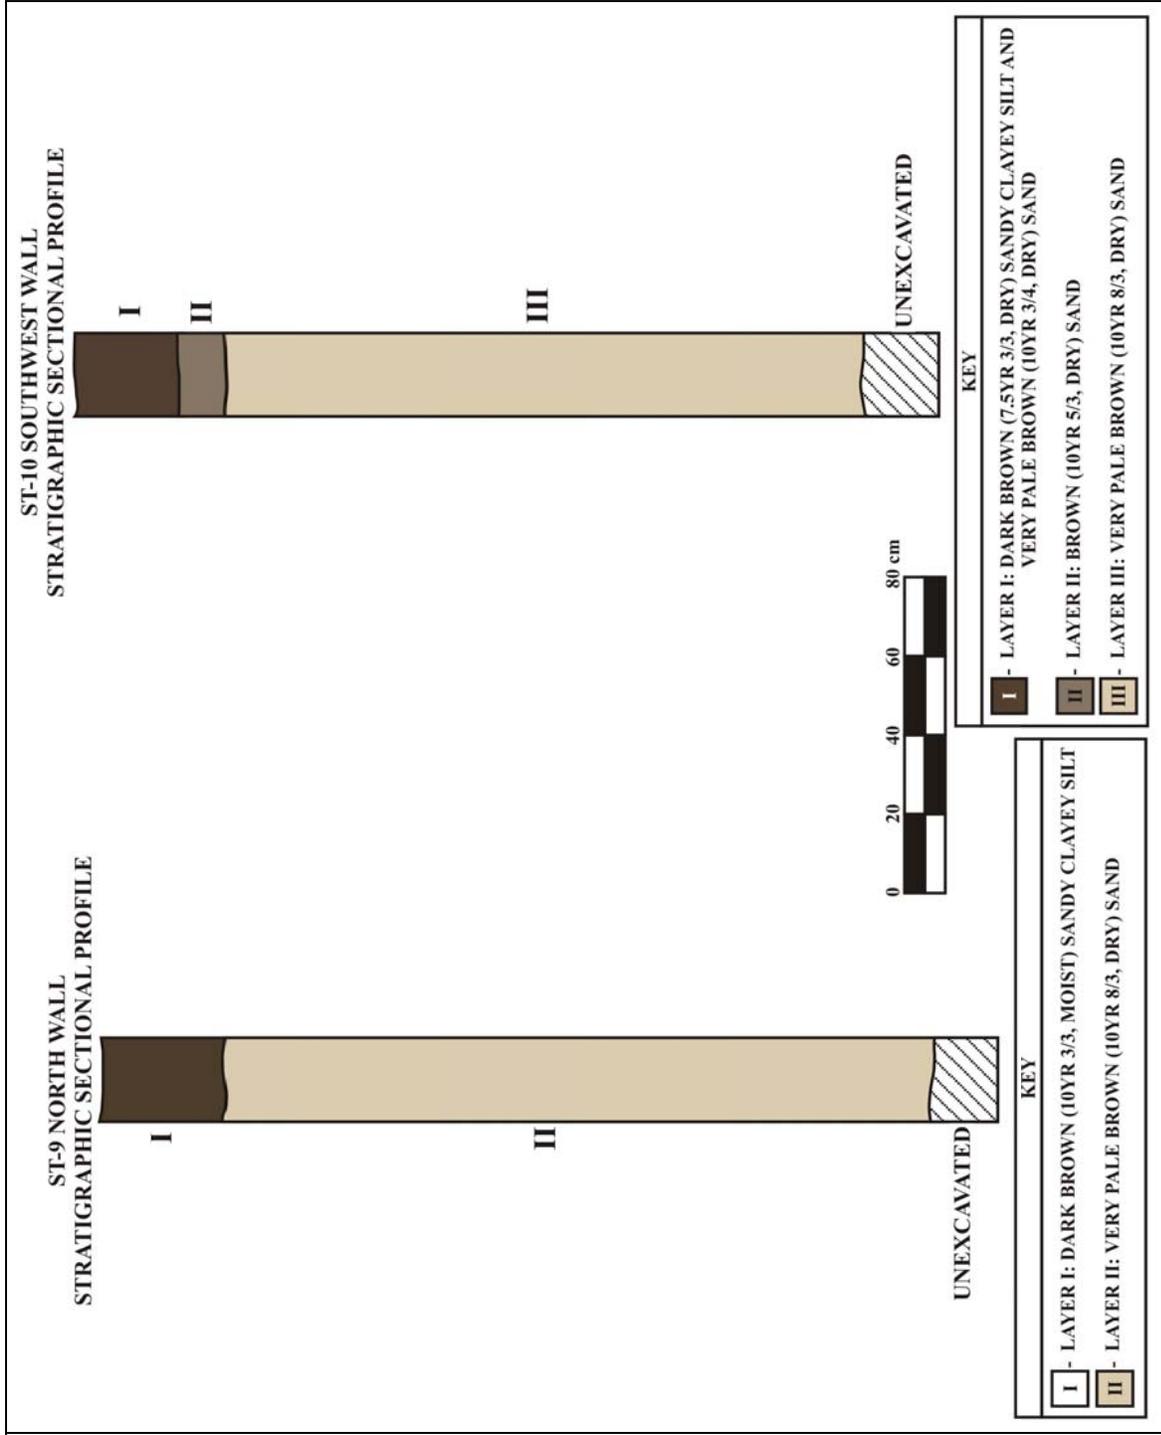
Figure 23: Stratigraphic profiles for Test Trenches ST-9 and ST-10.

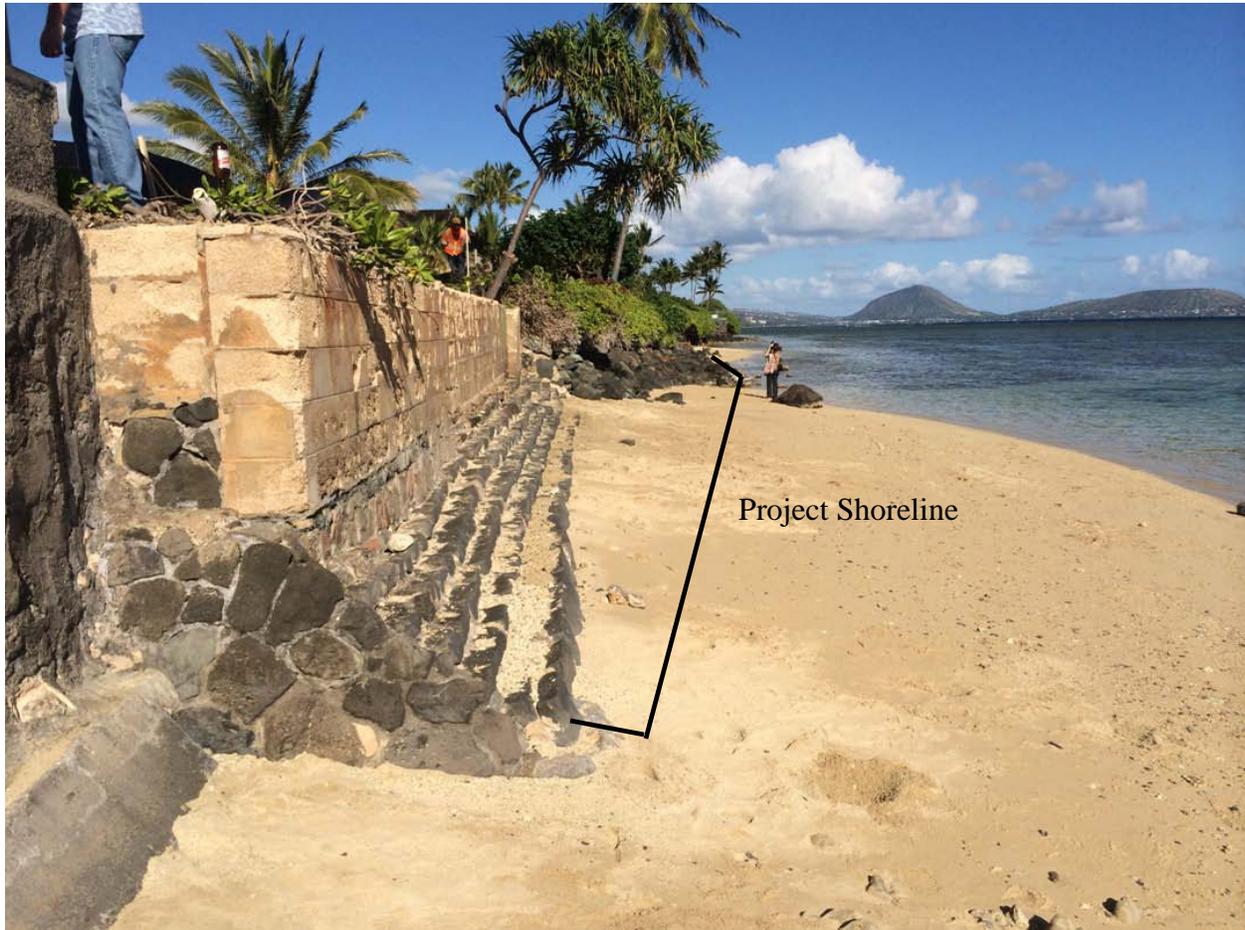
**Figure 1-4 Existing walls and narrow sand patch fronting 4465 and 4469 Kahala Ave. properties
(photograph taken near lower low tide)**

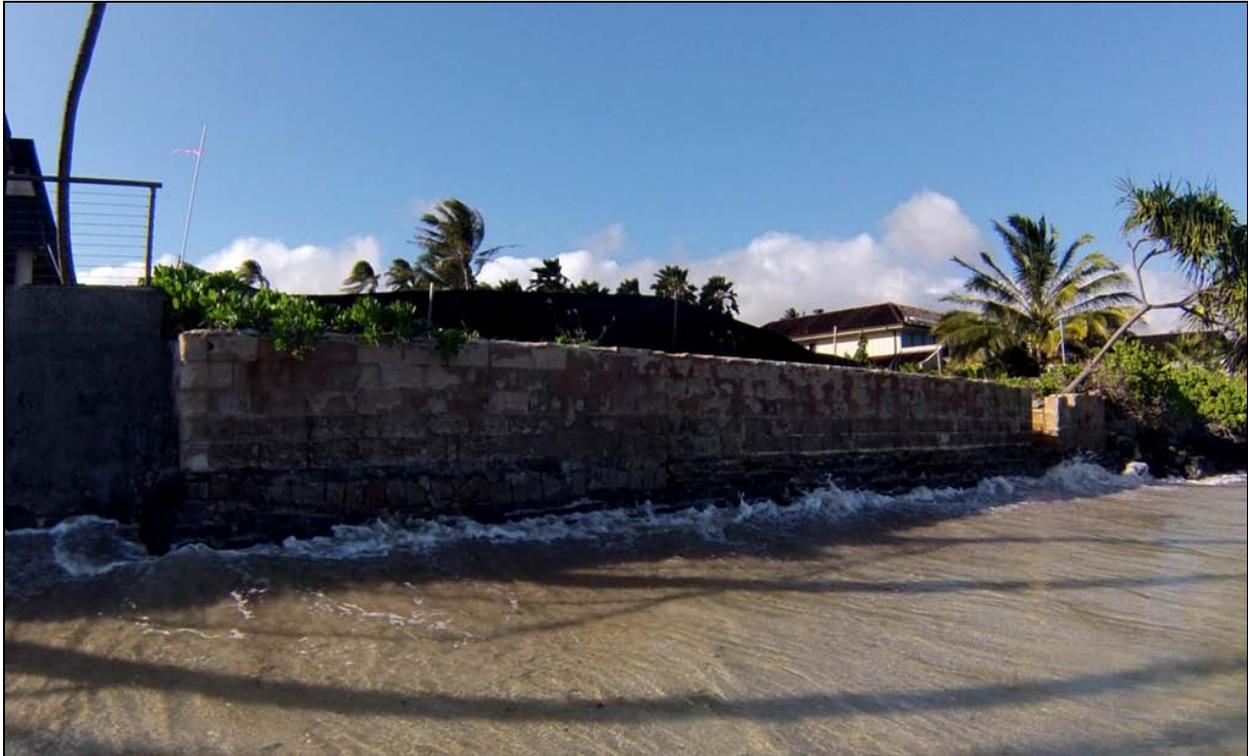
Figure 2-1 Seawall along western lot

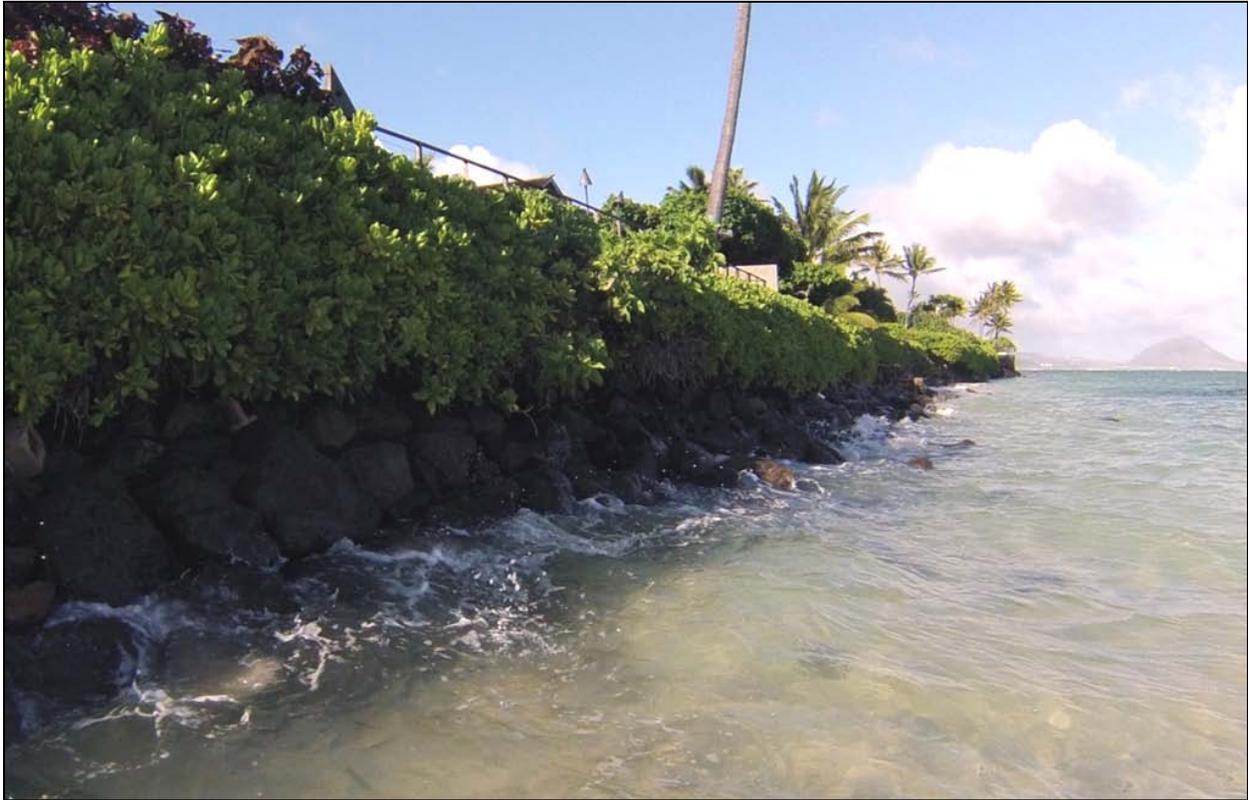
Figure 2-4 Revetment protecting adjoining property to the east

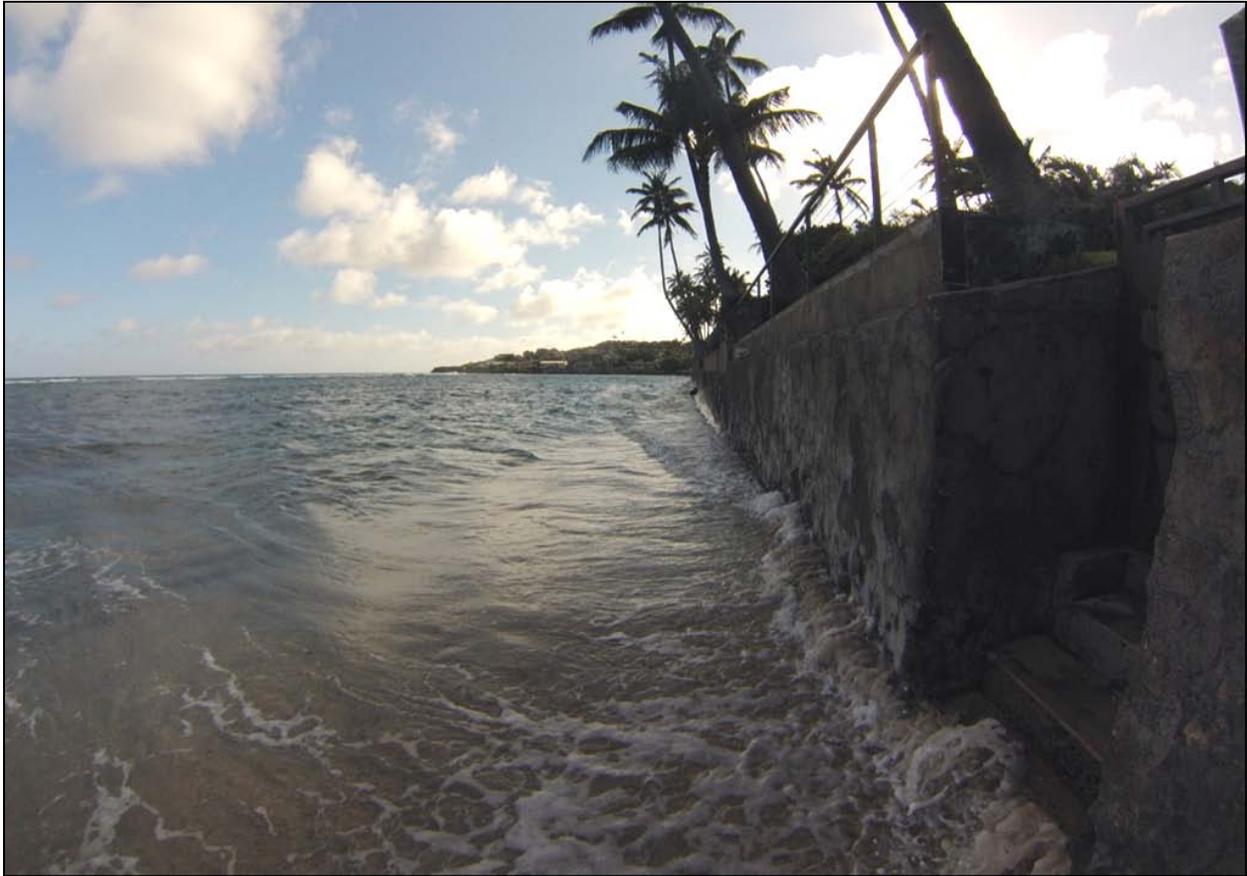
Figure 2-5 Vertical seawall protection property to the west

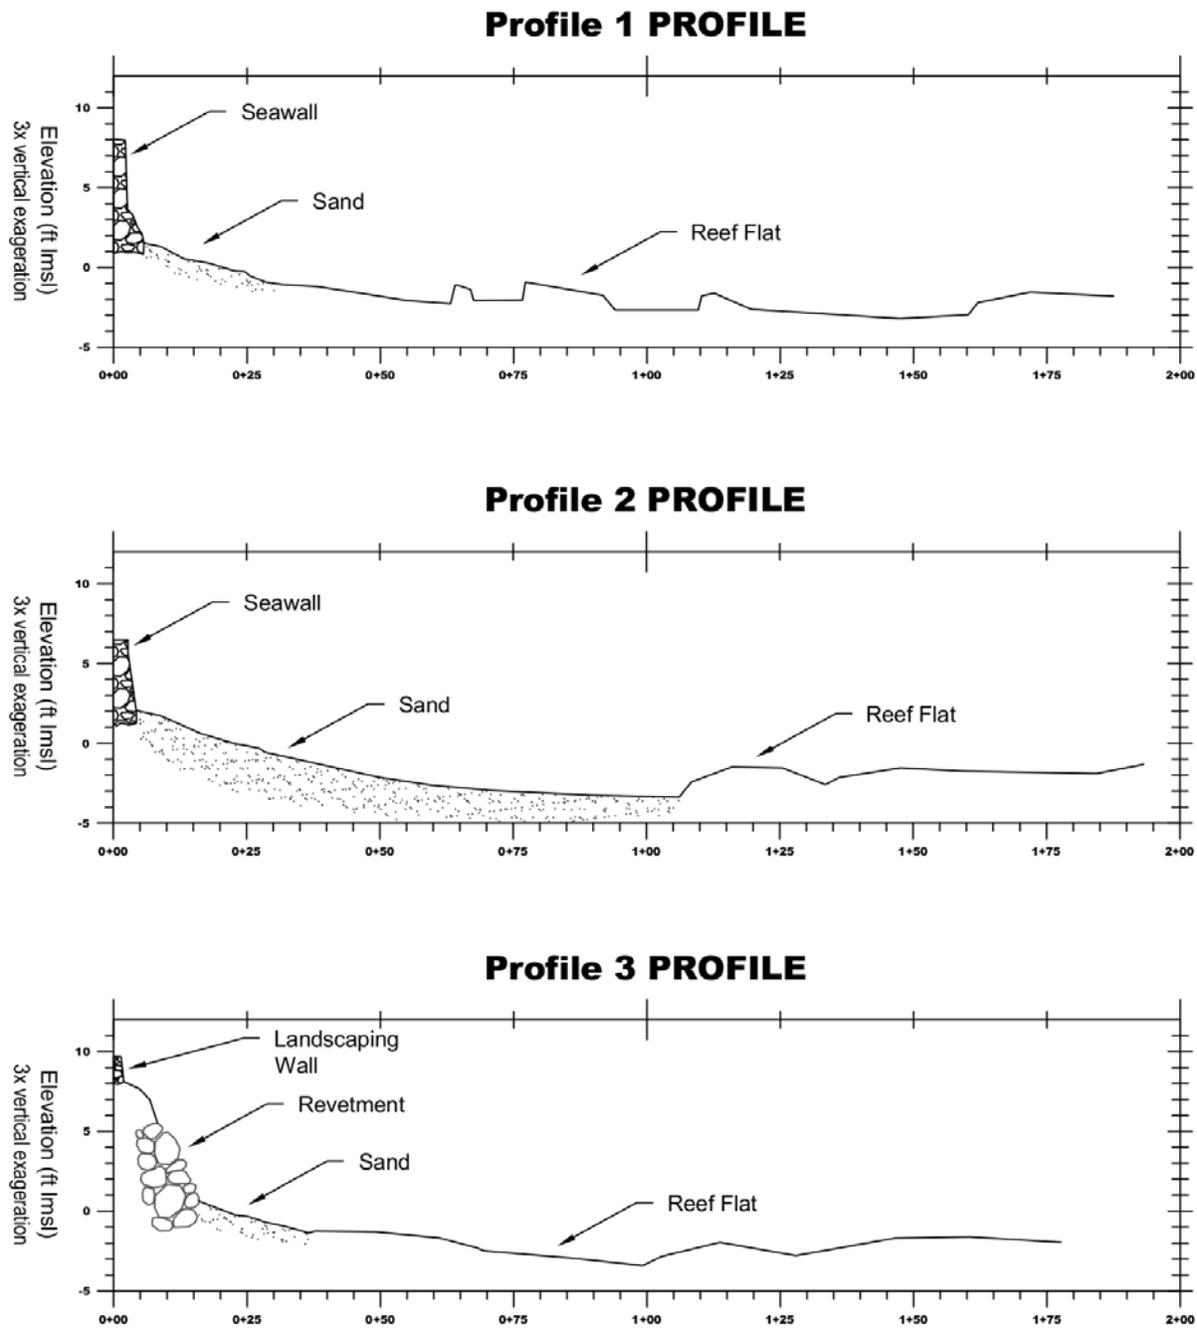
Figure 2-6 Shoreline profiles

Three shoreline profiles were taken at the project site, at either end and at the middle of the property shoreline, extending approximately 175 to 200 feet offshore of the coastal structures. The locations of the profiles are shown in Figure 1-3. The profiles are shown in Figure 2-6. The profiles show the CRM/tile seawall rises to an elevation of 8 feet at the western end of the property and 6 feet for a short segment adjoining the revetment. The revetment rises to an elevation of 5 to 6 feet; the revetment crest is obscured by thick naupaka. Thin sand extends only 20 feet seaward of the structures at Profiles 1 and 3, and approximately 100 feet seaward of Profile 2. The sand is typically a few inches or less in thickness. The limestone reef flat has a typical relief less than 1.0 foot. The reef flat elevation generally ranges from about -2.0 to -3.0 feet msl at 50 feet offshore, and grades to a more consistent -2.0 feet msl by 200 feet offshore.
