Project: Lee Residence and Shoreline Protection Structure
Applicant: Kyoung-Su Im
Agent: Group 70 International, Inc. (Jeffrey Overton)
Location: 4465 and 4469 Kahala Avenue - Waialae Kahala
Tax Map Key: 3-5-3: 2 and 3
Request: Special Management Area Use Permit (SMP) and
Shoreline Setback Variance (SV)
Proposal: New Residence over 7,500 square-feet and Shoreline Structure within
the 40-foot shoreline setback.

**Subject: Kāhala Residence and Shoreline Structure
Accepted Final Environmental Assessment/FONSI**

Final Draft Environmental Assessment

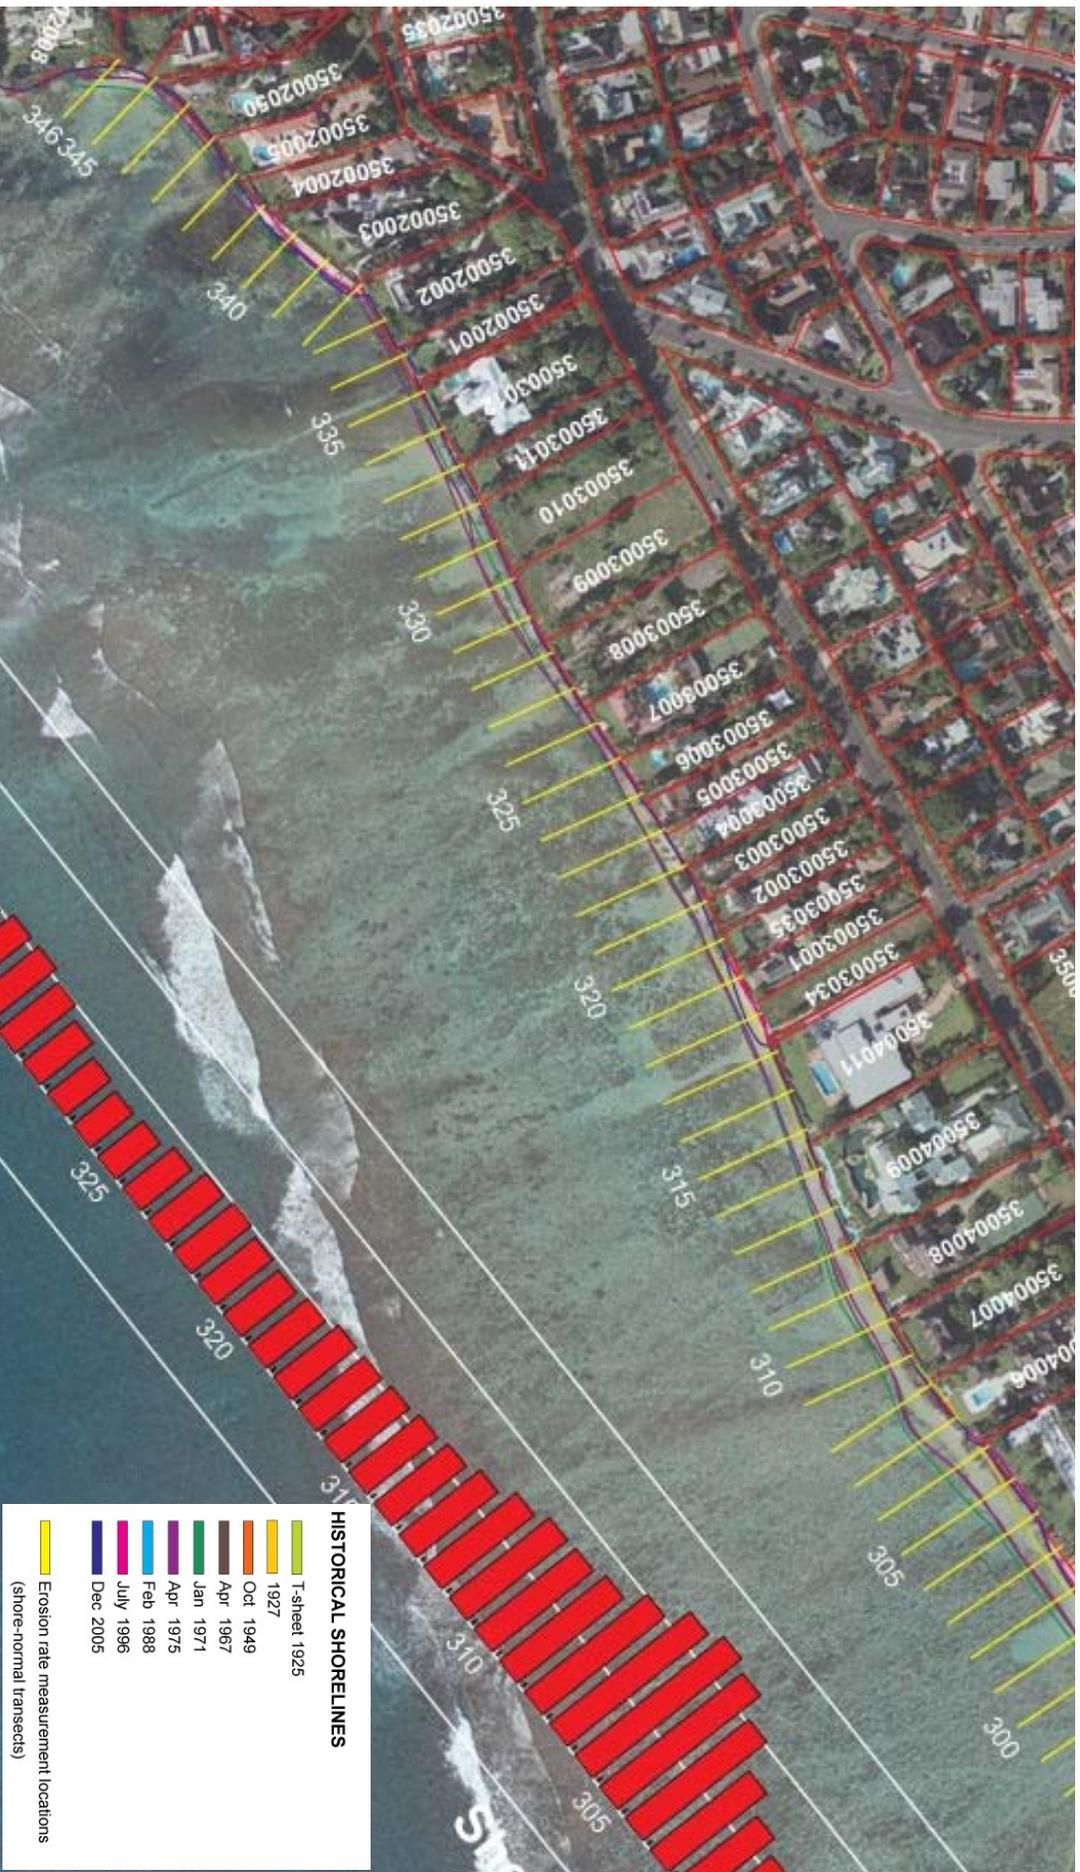
Figure 2-11 Historical shoreline change analysis (UH Coastal Geology Group). Yellow lines indicate transect locations spaced 66 ft apart. Red bar graph indicates annual erosion rate calculated for each transect location. White lines through bar graph represent 1ft/yr erosion rate increments.

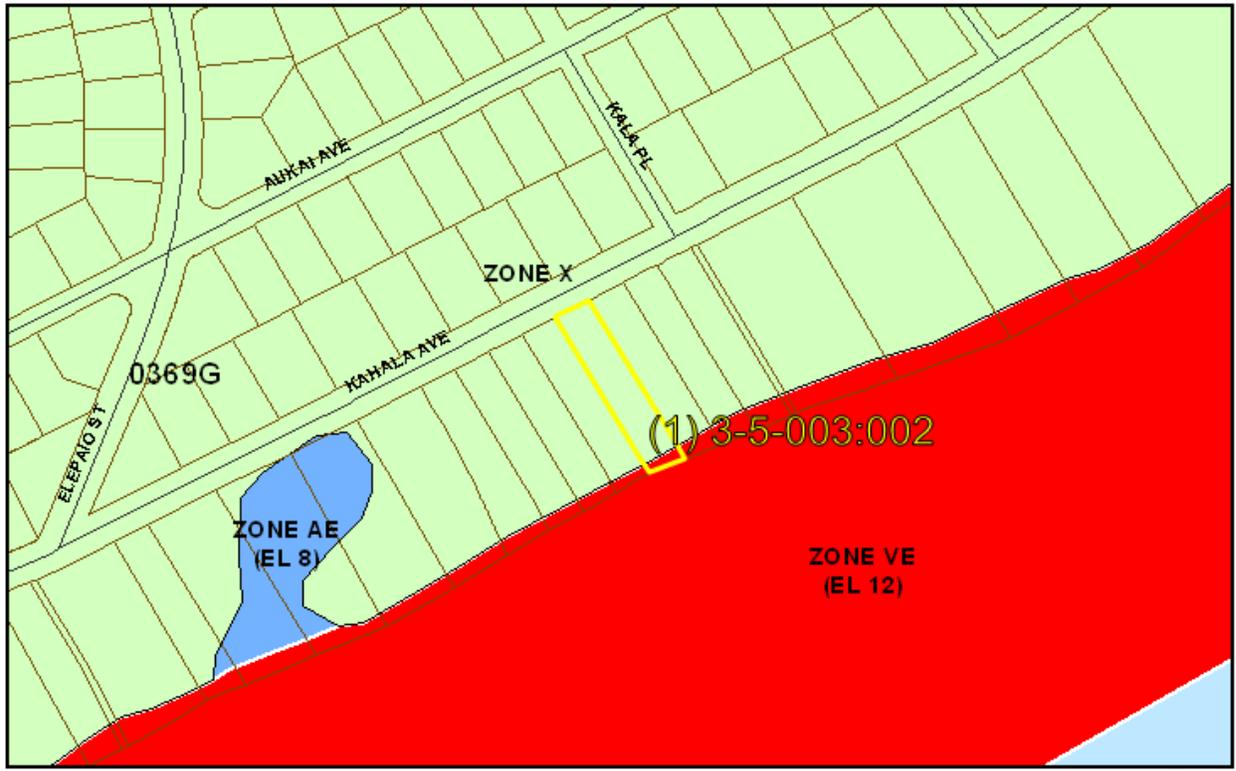
Figure 4-1 Flood hazard designation for the project site

The National Flood Insurance Program, administered by the Federal Emergency Management Agency (FEMA) produces maps identifying flood hazards and risks. Figure 4-1 shows the flood hazard map for the project properties. The map indicates that the properties are rated as Flood Zone X. Zone X is an area determined to be outside of the 0.2% annual chance floodplain. The map indicates that the reef flat offshore is rates as Zone VE (elevation 12). This designates an area along the coast subject to the 1% flood event and velocity wave action. The flood elevation is 12 feet.

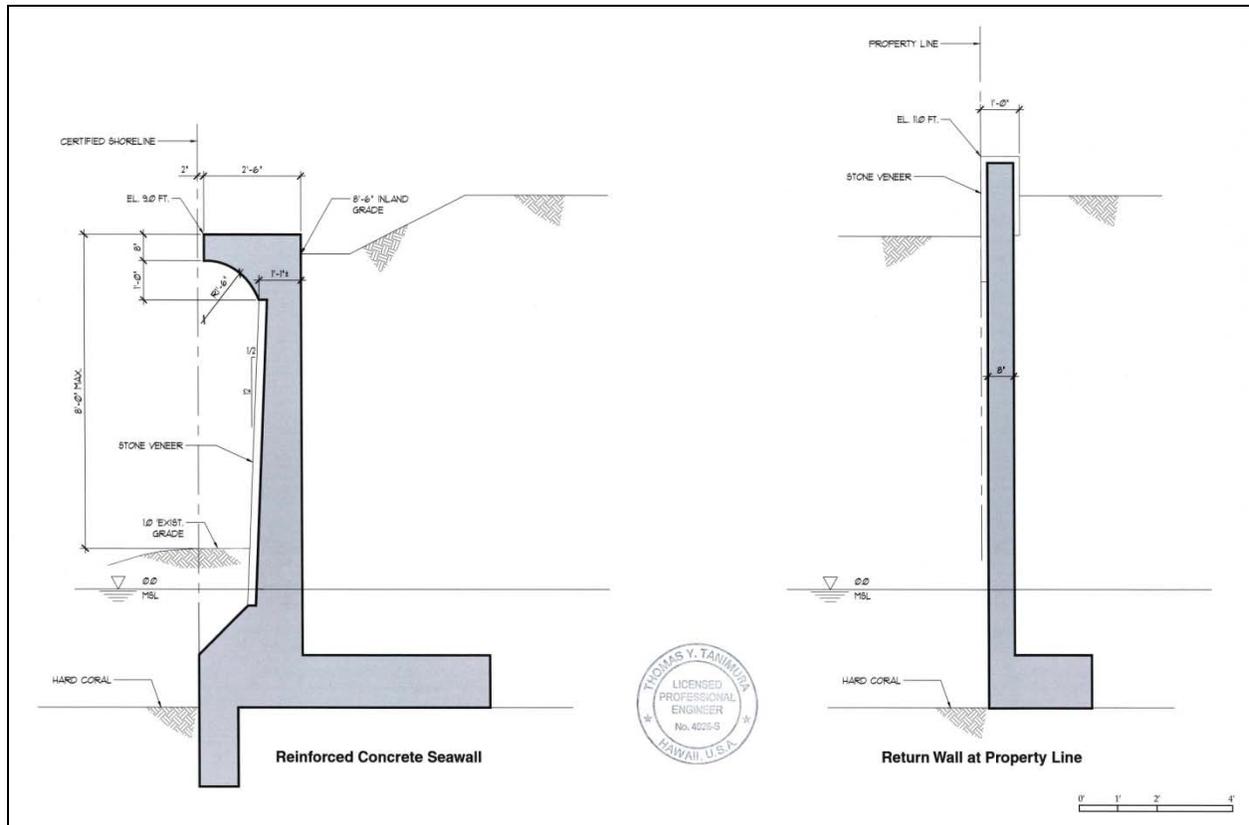
Figure 6-1 Seawall Section Drawings

Although a seawall would save the property owner approximately 15 feet of useable land, it is not the preferred alternative at this site because of the possible wave reflection and sand scour that may result.
