Subject: Central Oahu Ambulance Facility
TMK: 9-4-122: 103
Draft Environmental Assessment
Anticipated Finding of No Significant Impact

Draft Environmental Assessment
Honolulu Medical Services Department
Central Oahu Ambulance Facility

Waipahu, Island of Oahu
Tax Map Keys: 9-4-122: 103

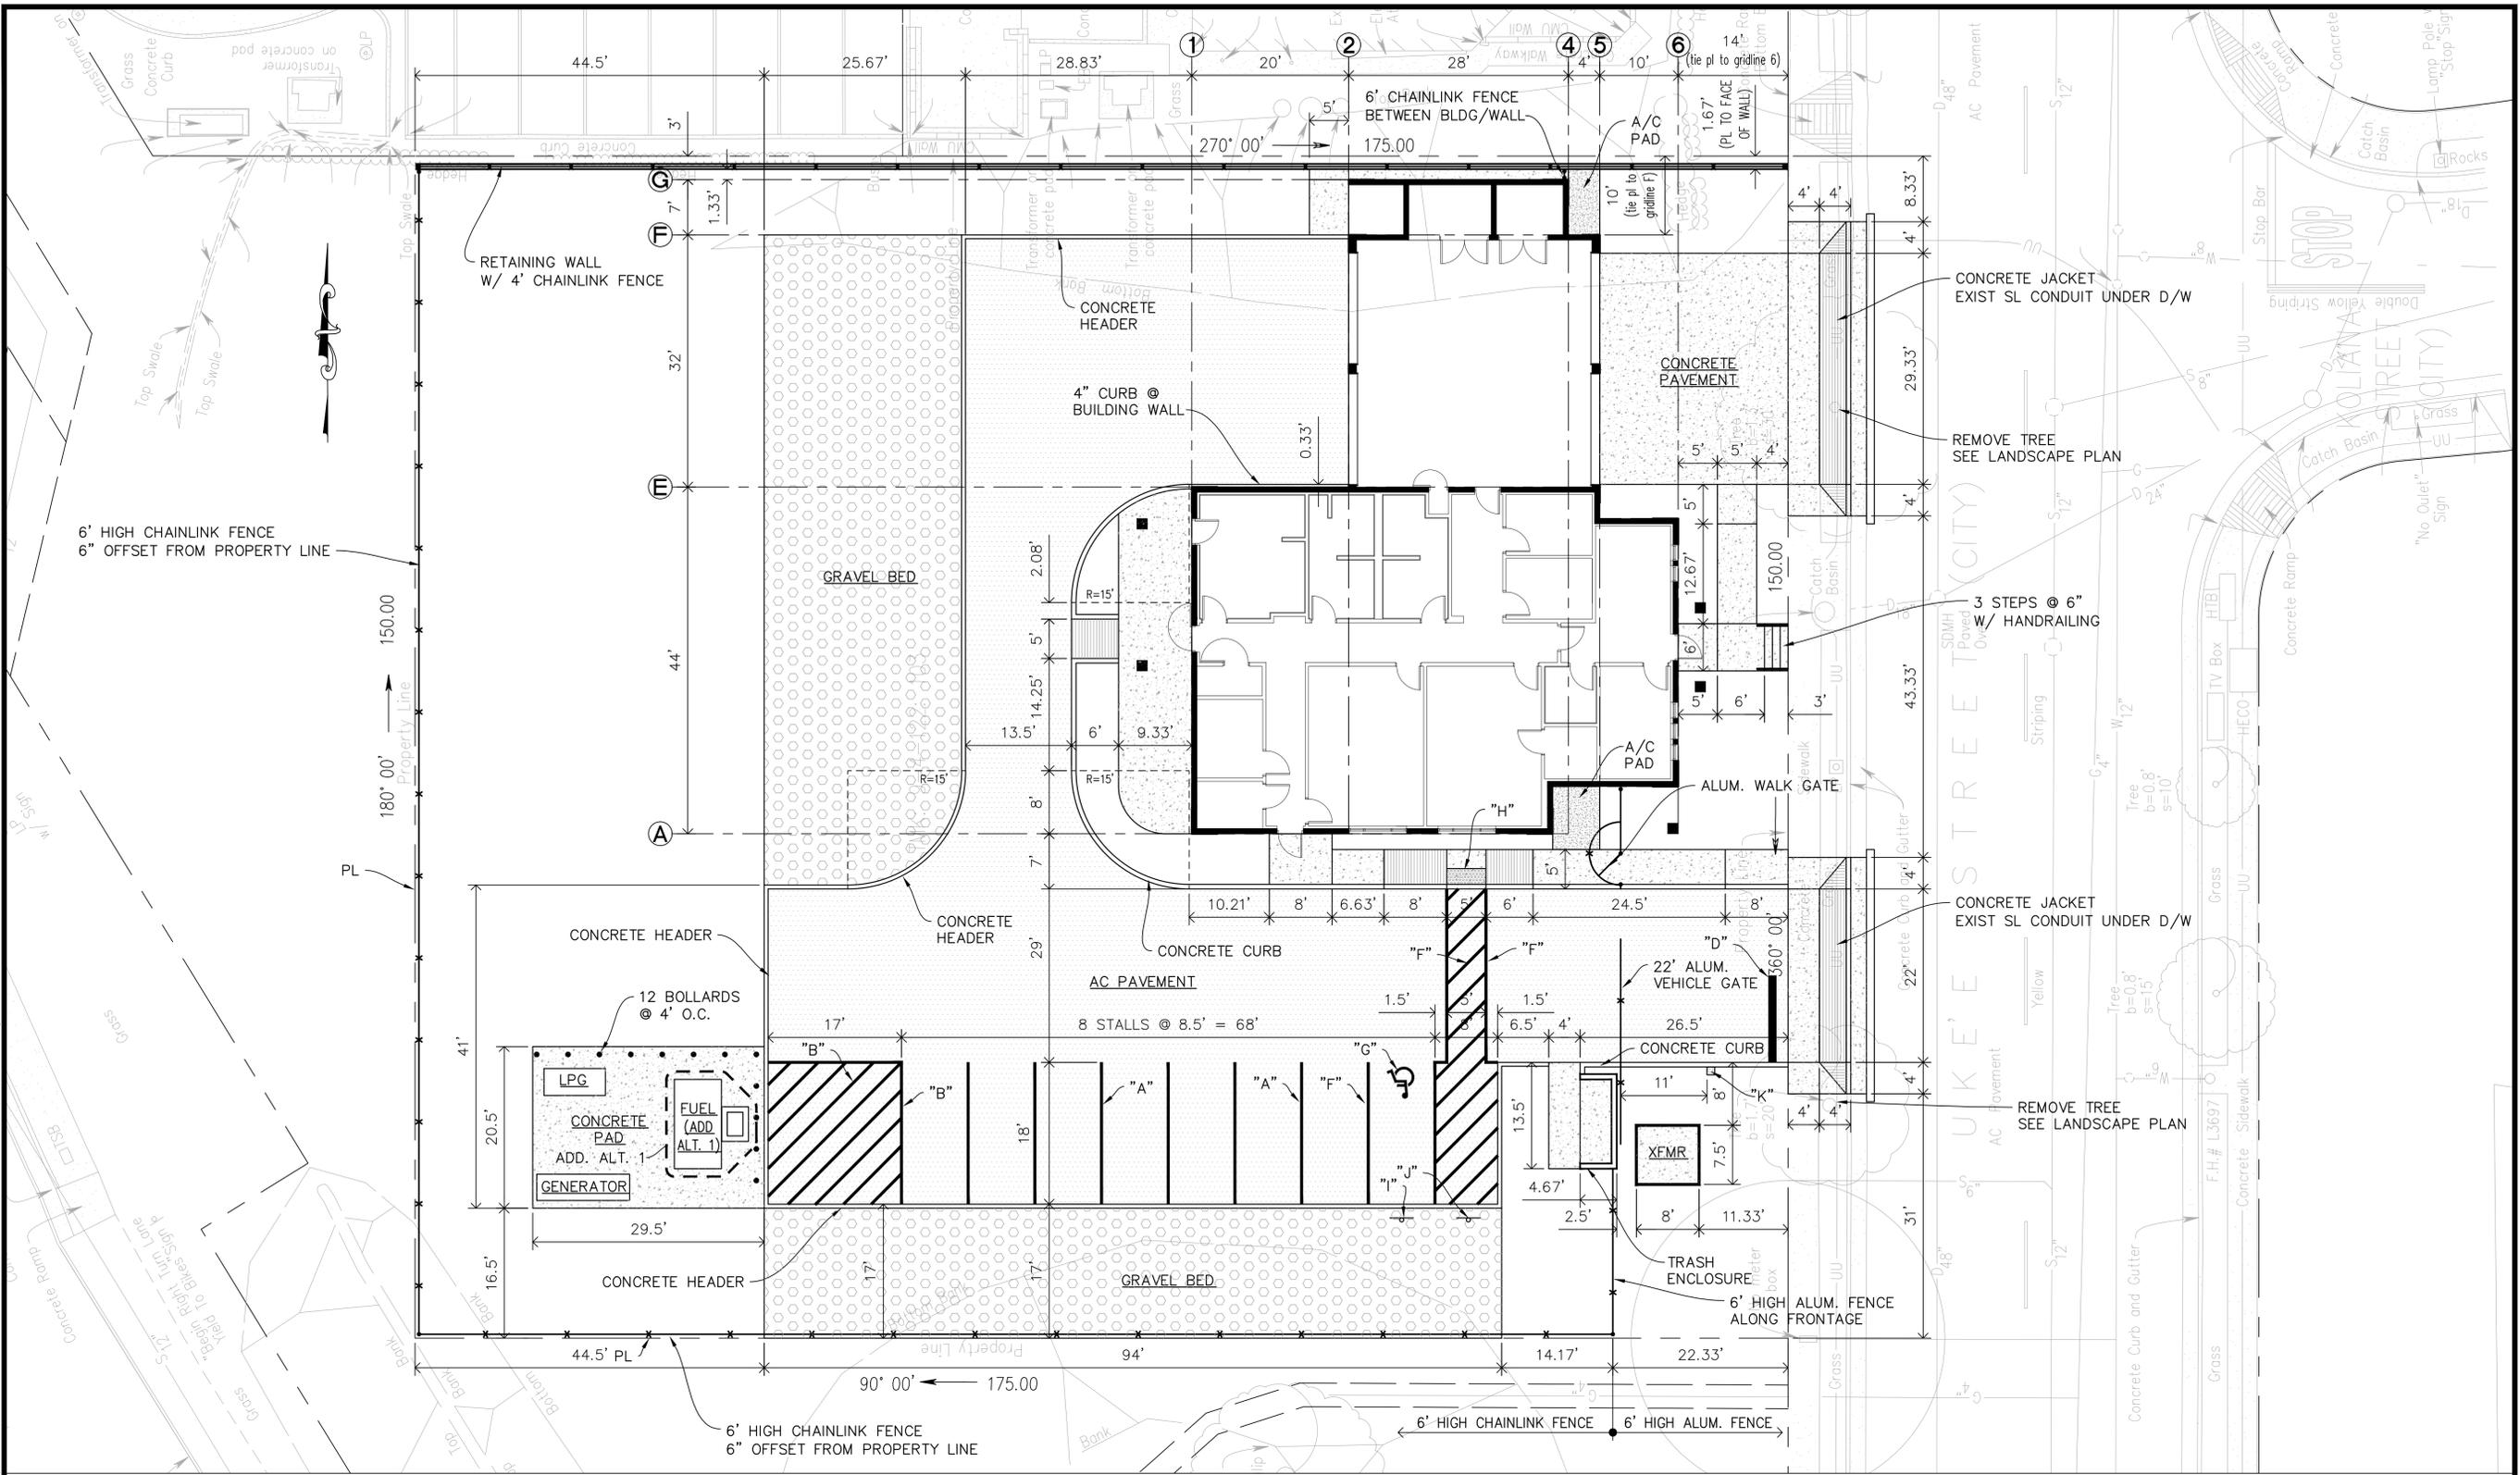
DESIGN BY: CYO
DRAWN BY: CYO/RH
CHECKED BY: HKH
DATE: 2015
PROJECT NO.: XX-XX-XX
DRAWING NO.: C-102
SHEET NO. XX OF XX
FILE DRAW FOLDER

- FOR CONCRETE CURB & GUTTER SEE DPW STD DETAIL R-4A.
- FOR CONCRETE SIDEWALK SEE DPW STD DETAIL R-28.
- FOR CONCRETE DRIVEWAY APRON SEE DPW STD DETAIL R-29A DATED JULY 2009.

- ALUMINUM VEHICLE GATE SHALL BE AMERISTAR TRANSPORT II SLIDING CANTILEVER GATE: MAJESTIC/BRONZE COLOR/22' CLEAR OPENING. WITH AMERISTAR 9150AGS SLIDE GATE OPERATOR: 1HP/115VAC/7A/LOOP DETECTOR/STAINLESS STEEL CHAIN. PROVIDE HARDWARE AND INSTALL PER MANUFACTURE INSTRUCTIONS.

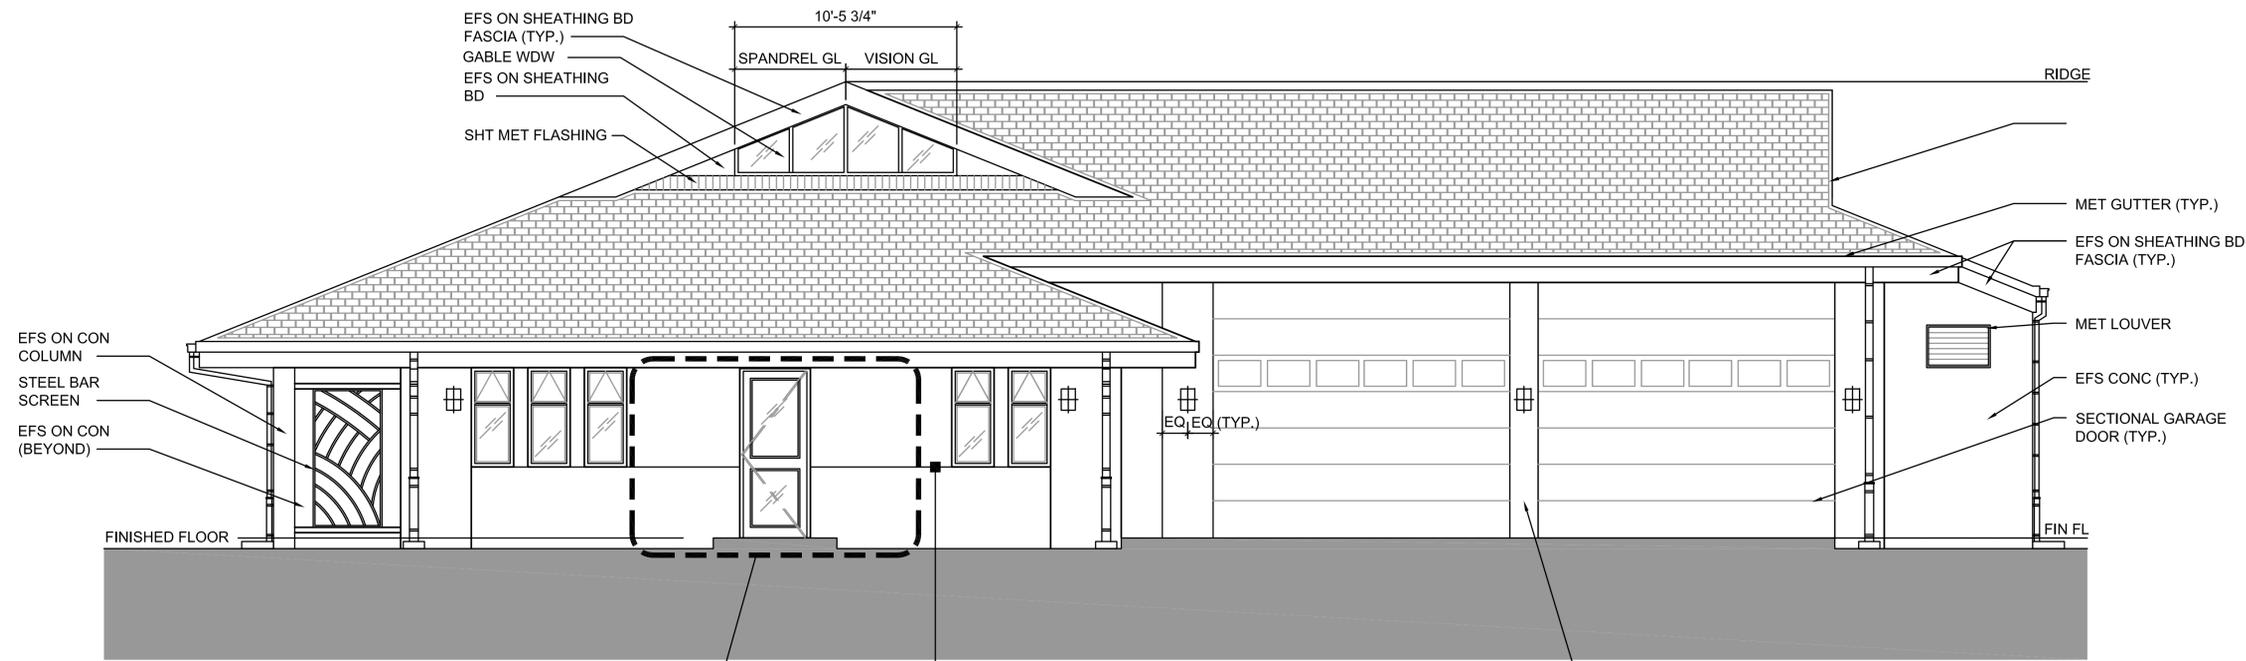
C1
A-201 1/4" = 1'-0"
EAST ELEVATION

TRELLIS & COLUMNS NOT SHOWN FOR CLARITY, SEE TRELLIS DET.

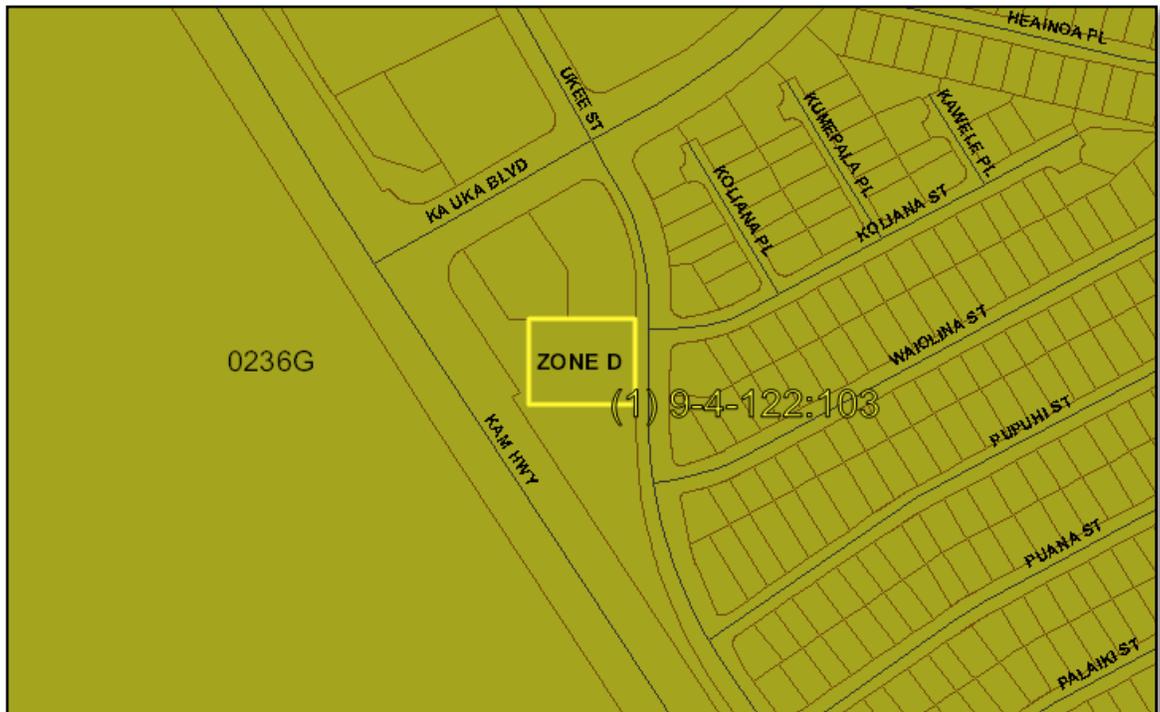
Figure 14: Flood Hazard Map

According to Panel 15003C0236G of the Federal Emergency Management Agency Flood Insurance Rate Map, the entire project area is located in Zone D. This flood zone is classified as unstudied areas where flood hazards are undetermined, but flooding is possible (Figure 12).

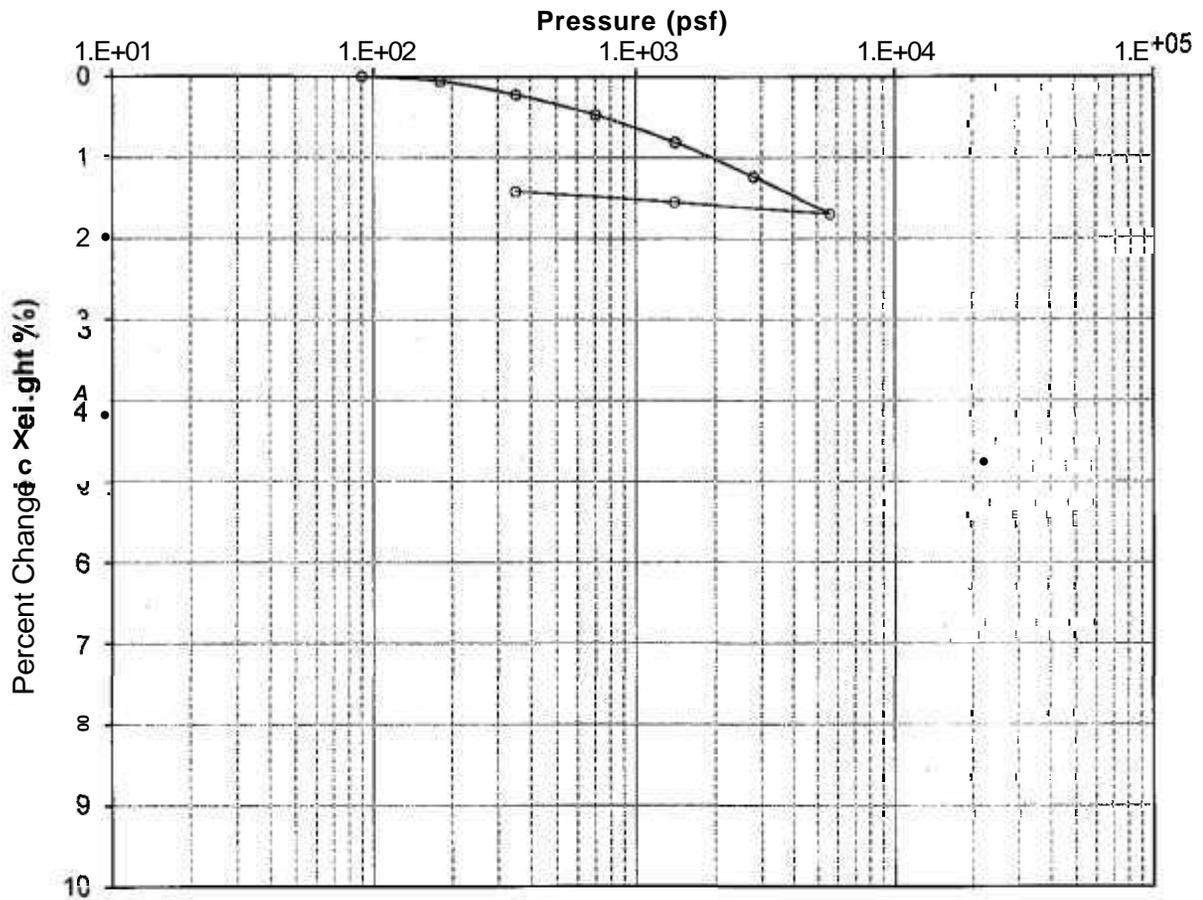
Consolidation Test Results

Boring No.: B2 Depth (ft): 4
 Soil Description: Reddish brown clayey silt

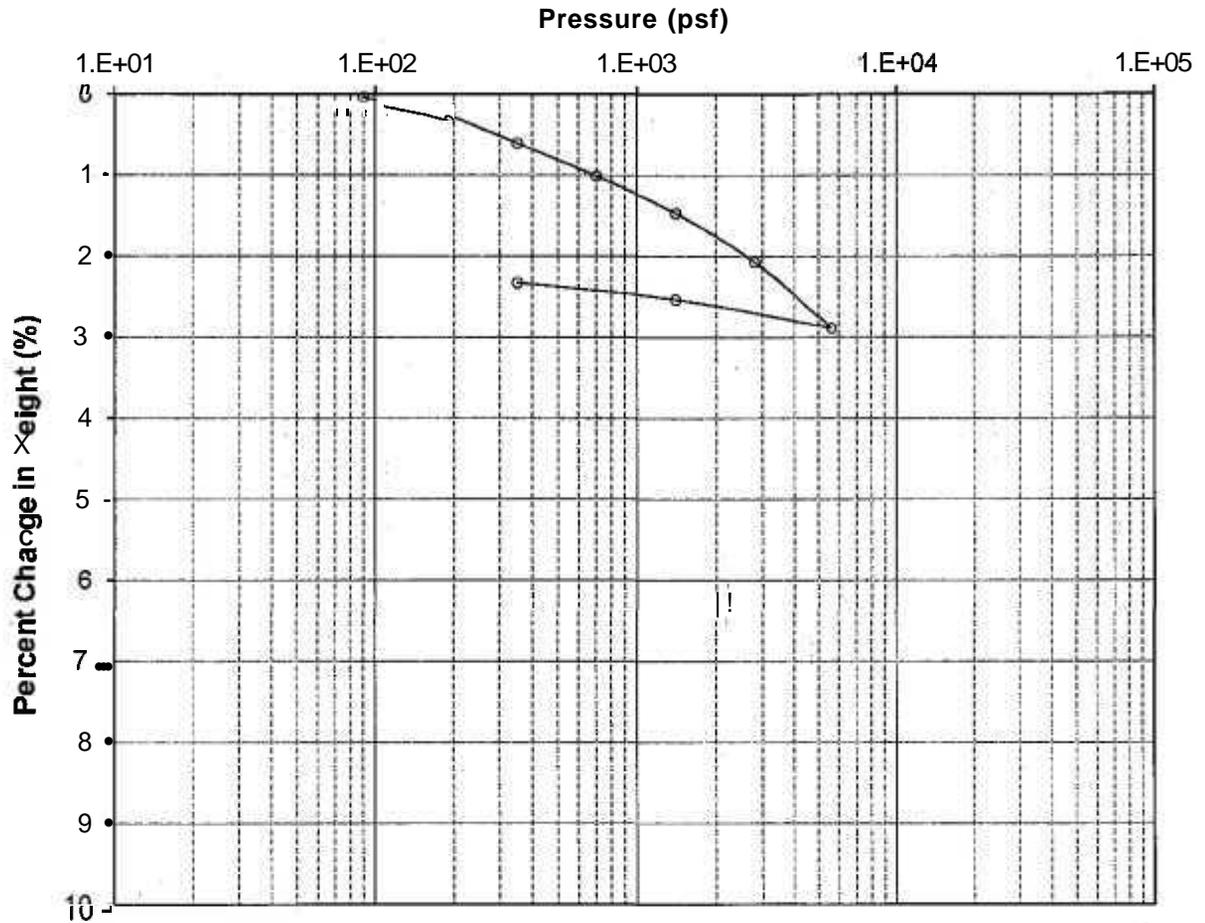
Consolidation Test Results

Boring No.: B6 Depth (ft): 2
 Soil Description: Reddish brown clayey silt

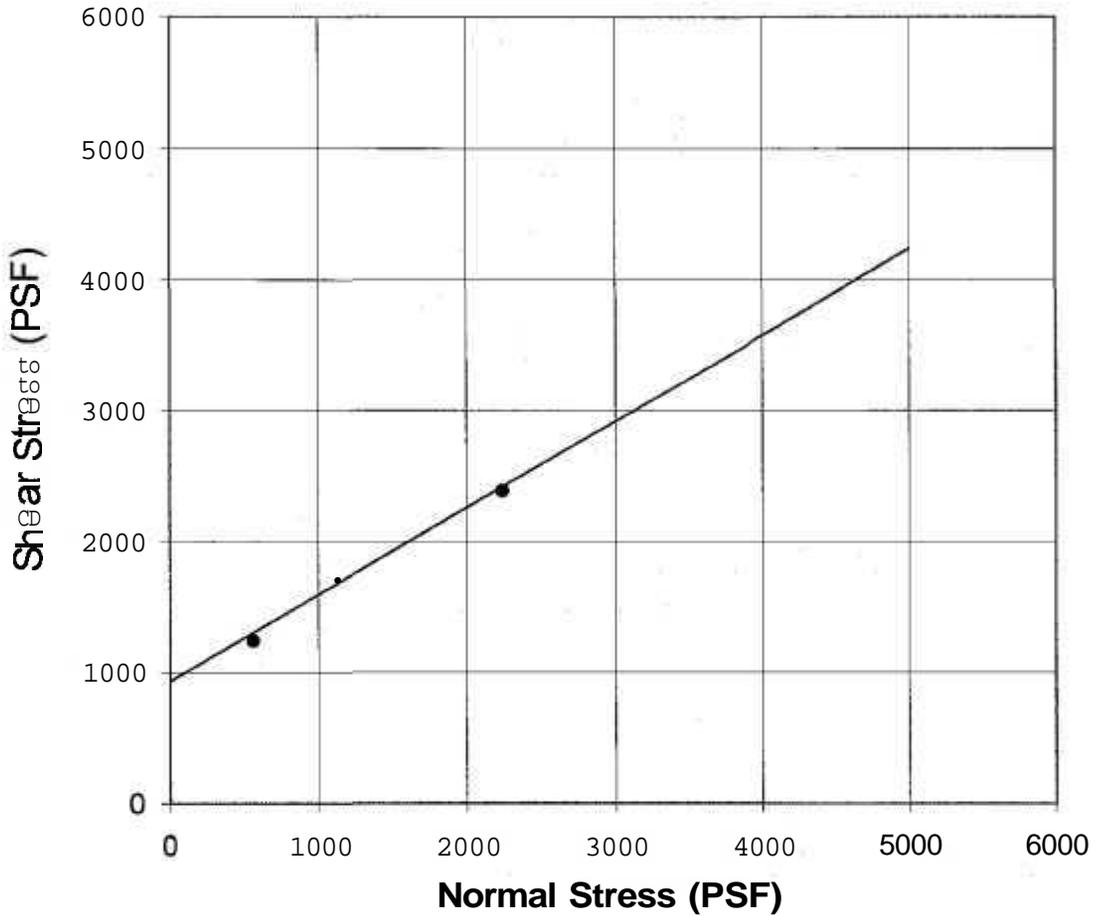
Direct Shear Test Results

Boring No.: B1	Depth (ft): 3
Soil Description: Reddish brown clayey silt	
Strength Intercept (C): 933.4 PSF	(Peak Strength)
Friction Angle (ϕ): 33.5 DEG	(Peak Strength)

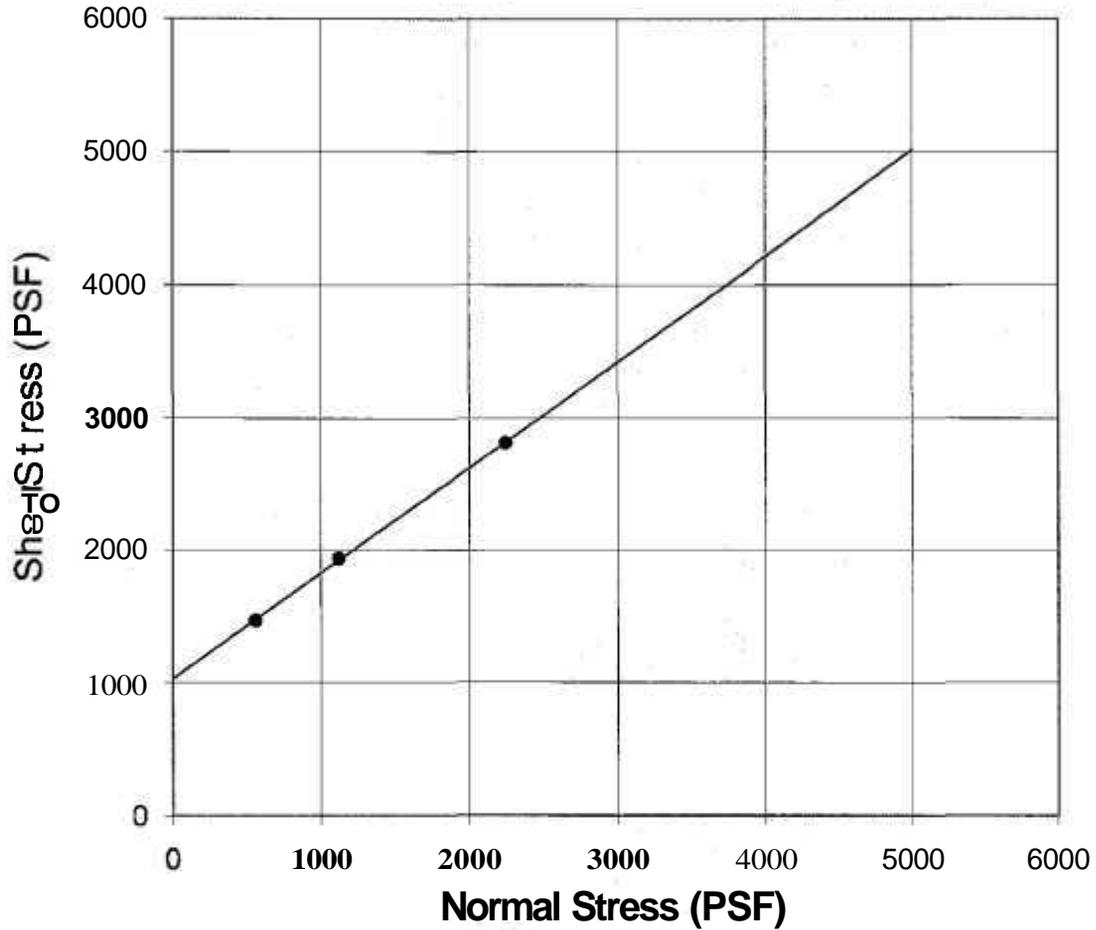
Direct Shear Test Results

Boring No.: B4 **Depth (ft):** 5
Soil Description: Reddish brown clayey silt
Strength Intercept (C): 1033.4 PSF **(Peak Strength)**
Friction Angle (ϕ): 38.5 DEG **(Peak Strength)**

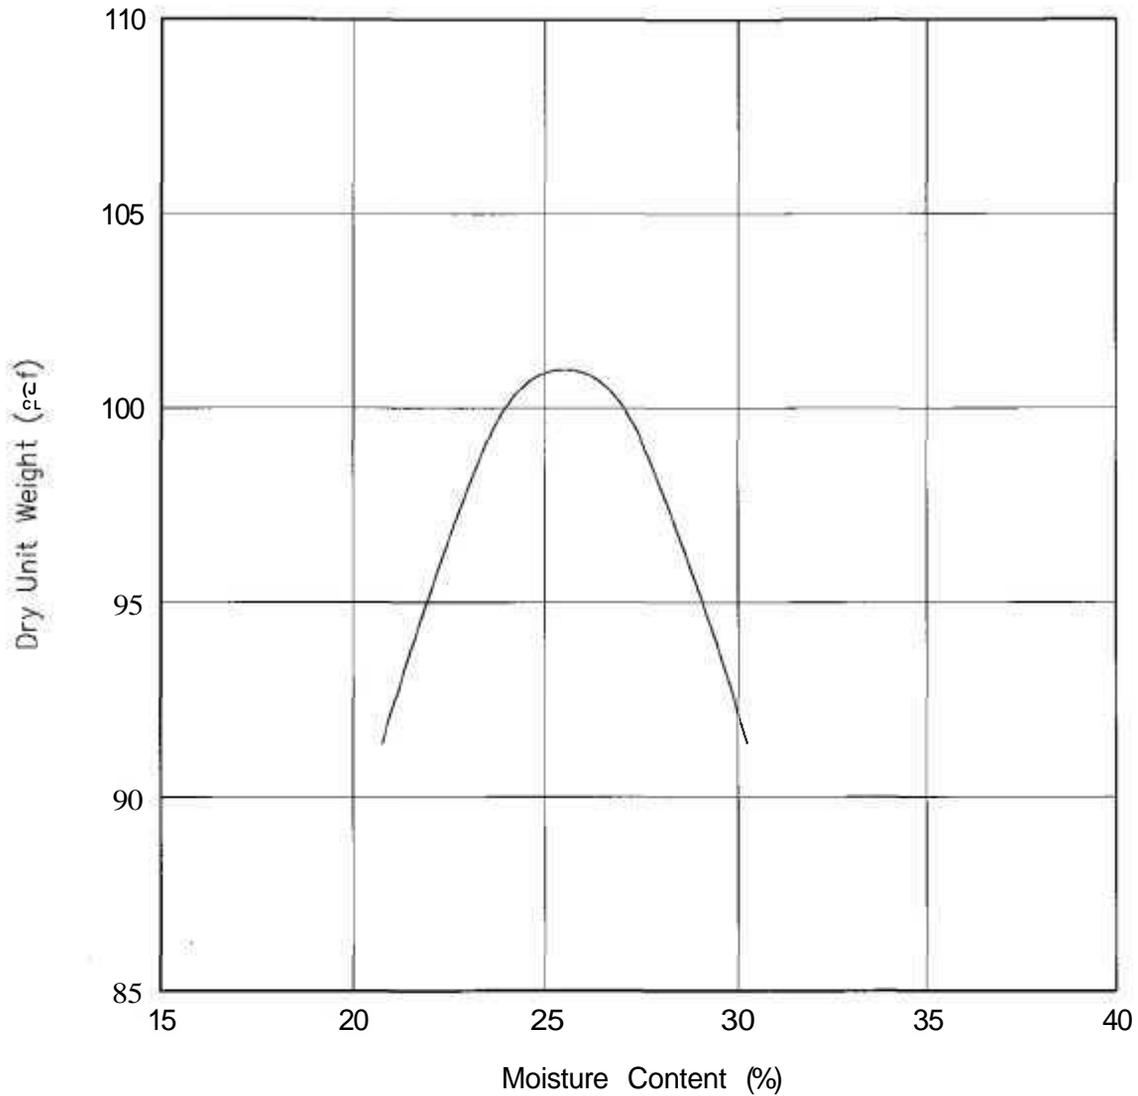
MODIFIED PROCTOR CURVE

Location: Boring B5 at 0.5 feet
