**Subject: Request for Direct Grant of Easement for a Drainage Improvement Project at Lalamilo, South Kohala, Hawaii
Tax Map Key:3rd/6-6-01:por. 01,
Applicants: Mauna Kea Properties, Inc.**

Mauna Kea Resort Drainage Way Improvements Draft Environmental Assessment
Prepared By: Belt Collins Hawaii
August 1994

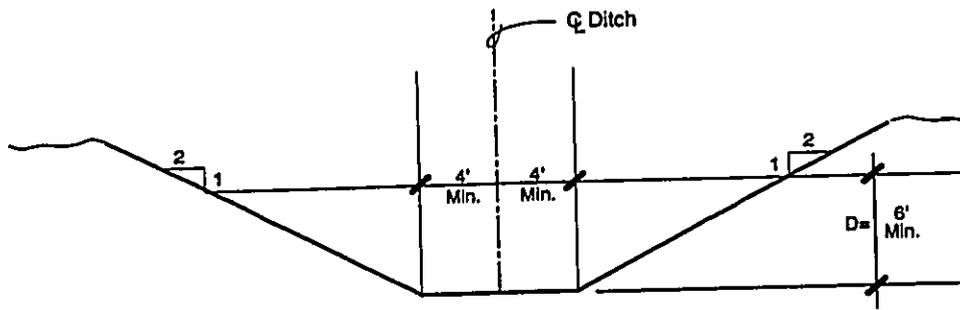
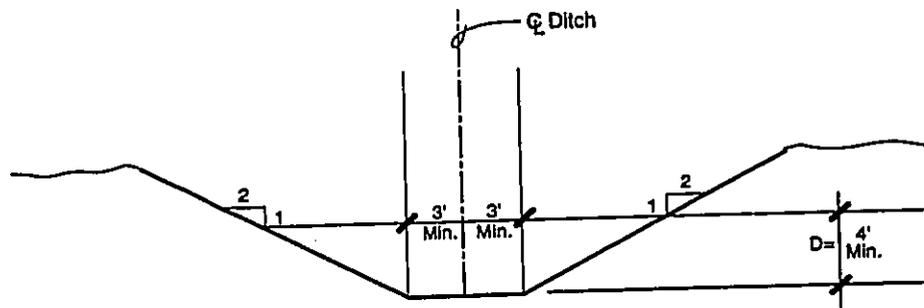
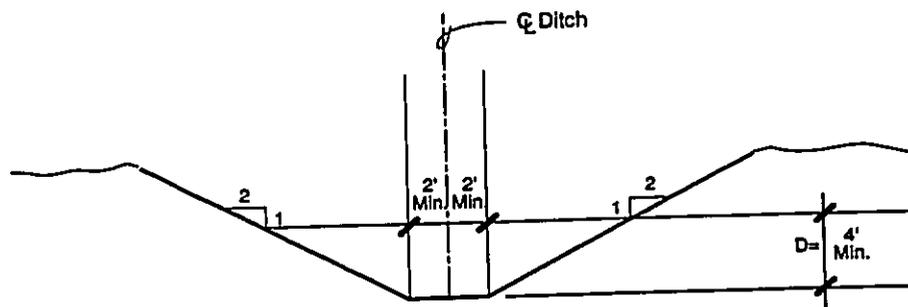
Figure 4
TYPICAL DITCH CROSS SECTIONS

TYPICAL DITCH SECTION NO. 1

TYPICAL DITCH SECTION NO. 2

TYPICAL DITCH SECTION NO. 3

Component 1: Construction of three diversion ditches. The first diversion ditch will be approximately 520 feet in length, extending from an elevation of about 410 feet above mean sea level (MSL) to an elevation of about 455 feet MSL (Ditch No. 1). It will include a desilting basin at its makai end, sized to retain a 2-year, 24-hour storm. The second ditch will be approximately 780 feet in length, extending from an elevation of about 495 feet above mean sea level (MSL) to an elevation of about 530 feet MSL (Ditch No. 2). The third ditch will be approximately 1,180 feet in length, extending from an elevation of about 560 feet above mean sea level (MSL) to an elevation of about 600 feet MSL (Ditch No. 3). Typical cross-sections of the three ditches are presented in Figure 4.

The specific alignment of Ditch No. 1 is presented in Figure 5. The 520-foot long ditch will be designed to have a base width of 8 feet, side slopes of 2:1, and a minimum depth of 6 feet. The width of the requested easement needed to accommodate the ditch will be 60 feet and the overall easement area will be 3.85 acres, which includes a 2.89 acre desilting basin and a 25-foot wide access easement extending approximately 100 feet into state-owned land from the applicant's property boundary. Ditch No. 1 is the lowest elevation and widest of the three proposed diversion ditches.

The alignment of Ditch No. 3 is presented in Figure 7. The 1,180-foot long ditch will be designed to have a base width of 4 feet, side slopes of 2:1, and a minimum depth of 4 feet. The width of the requested easement needed to accommodate the ditch will be 40 feet and the overall easement area will be 1.11 acres. No additional access roadway easement is required for this diversion ditch because the proposed easement abuts the applicant's property boundary. Ditch No. 3 is the highest elevation and the narrowest of the three proposed diversion ditches.

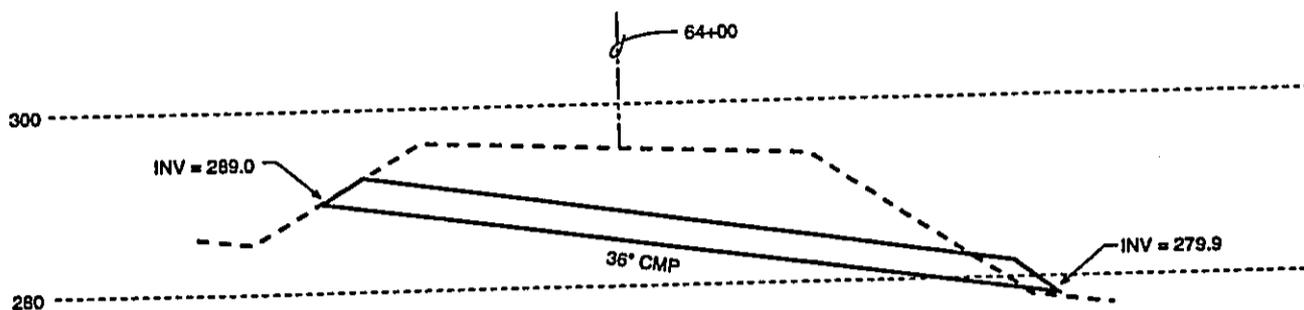
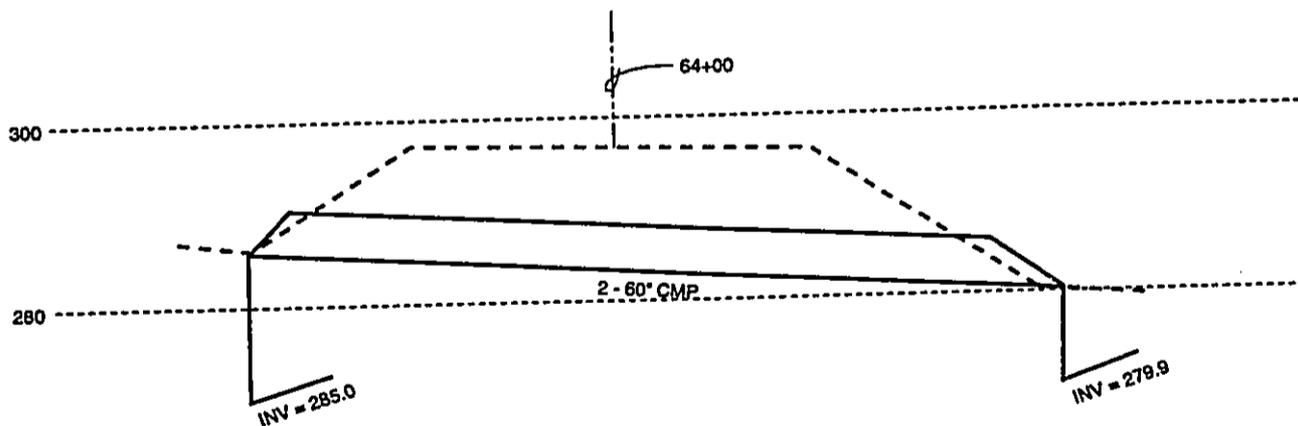
SECTION @ 64+00—EXISTING 36" CMP CULVERT

SECTION @ 64+00—PROPOSED 2 - 60" CMP CULVERTS

Replacement of the existing corrugated metal pipe culverts passing beneath Queen Kaahumanu Highway with larger concrete masonry culverts will require a 17-foot wide trench excavated perpendicular to the highway's right-of-way at each of the two roadway stations. Within the highway's paved area, the trench will be repaved to match the existing pavement of the highway and will conform to Department of Transportation specifications. Figures 8 and 9 present section views of the existing culverts and their proposed replacements.

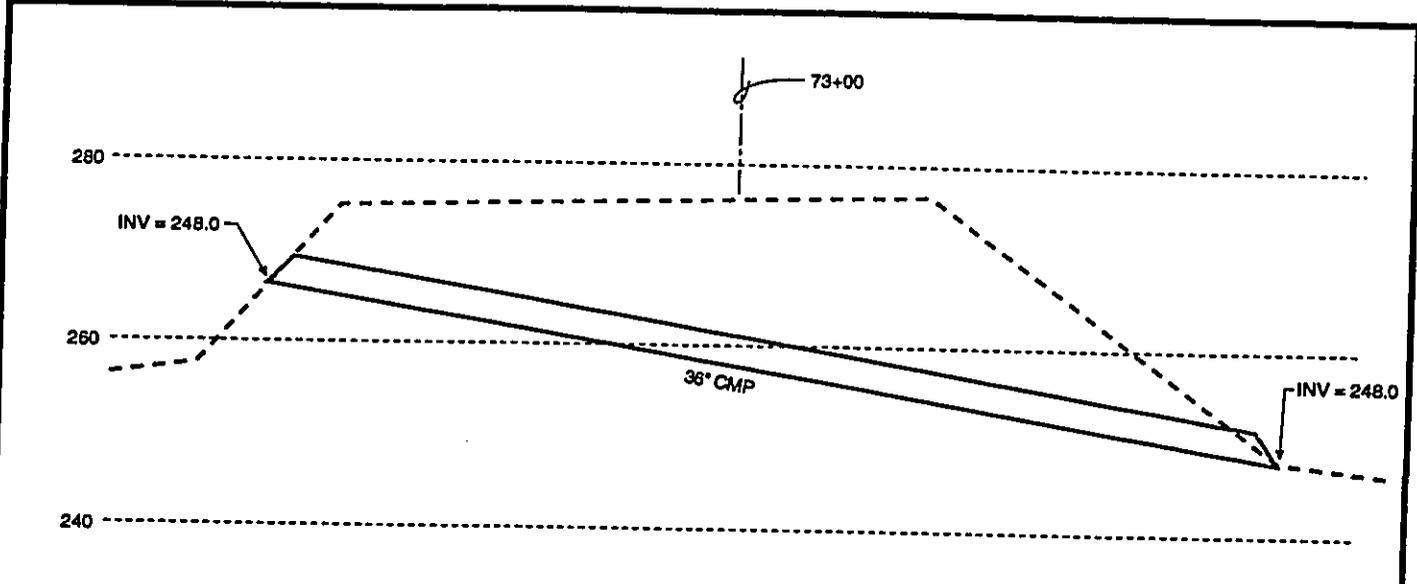
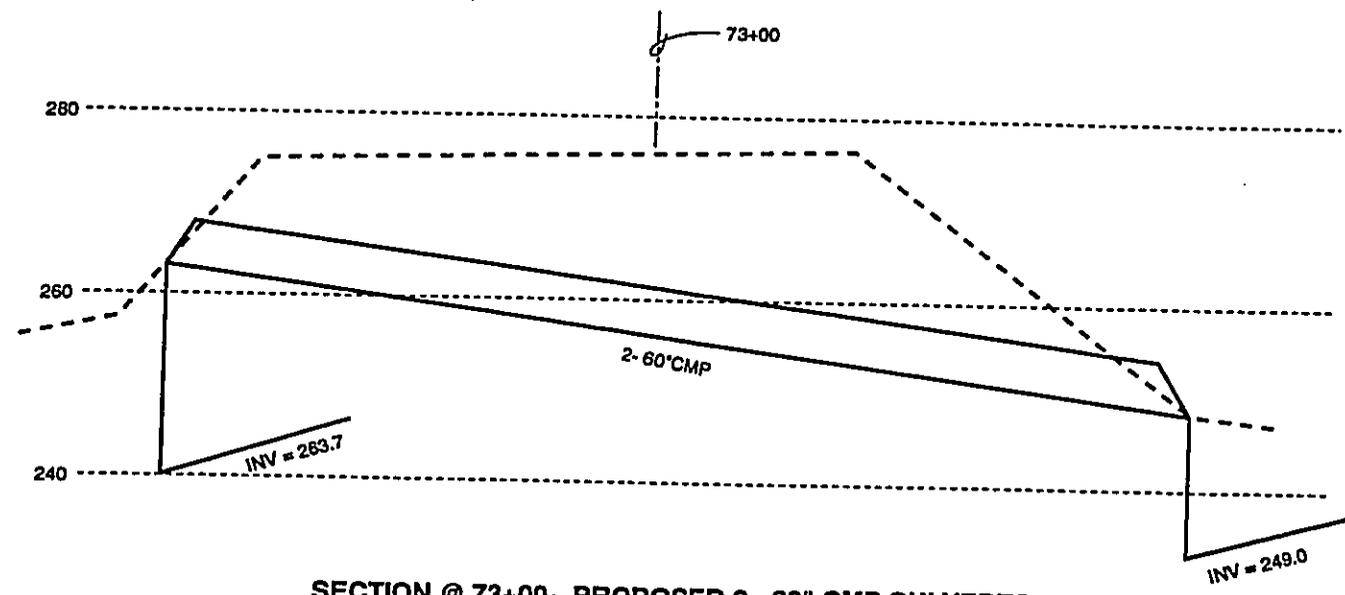
SECTION @ 73+00—EXISTING 36" CMP CULVERT

SECTION @ 73+00—PROPOSED 2 - 60" CMP CULVERTS

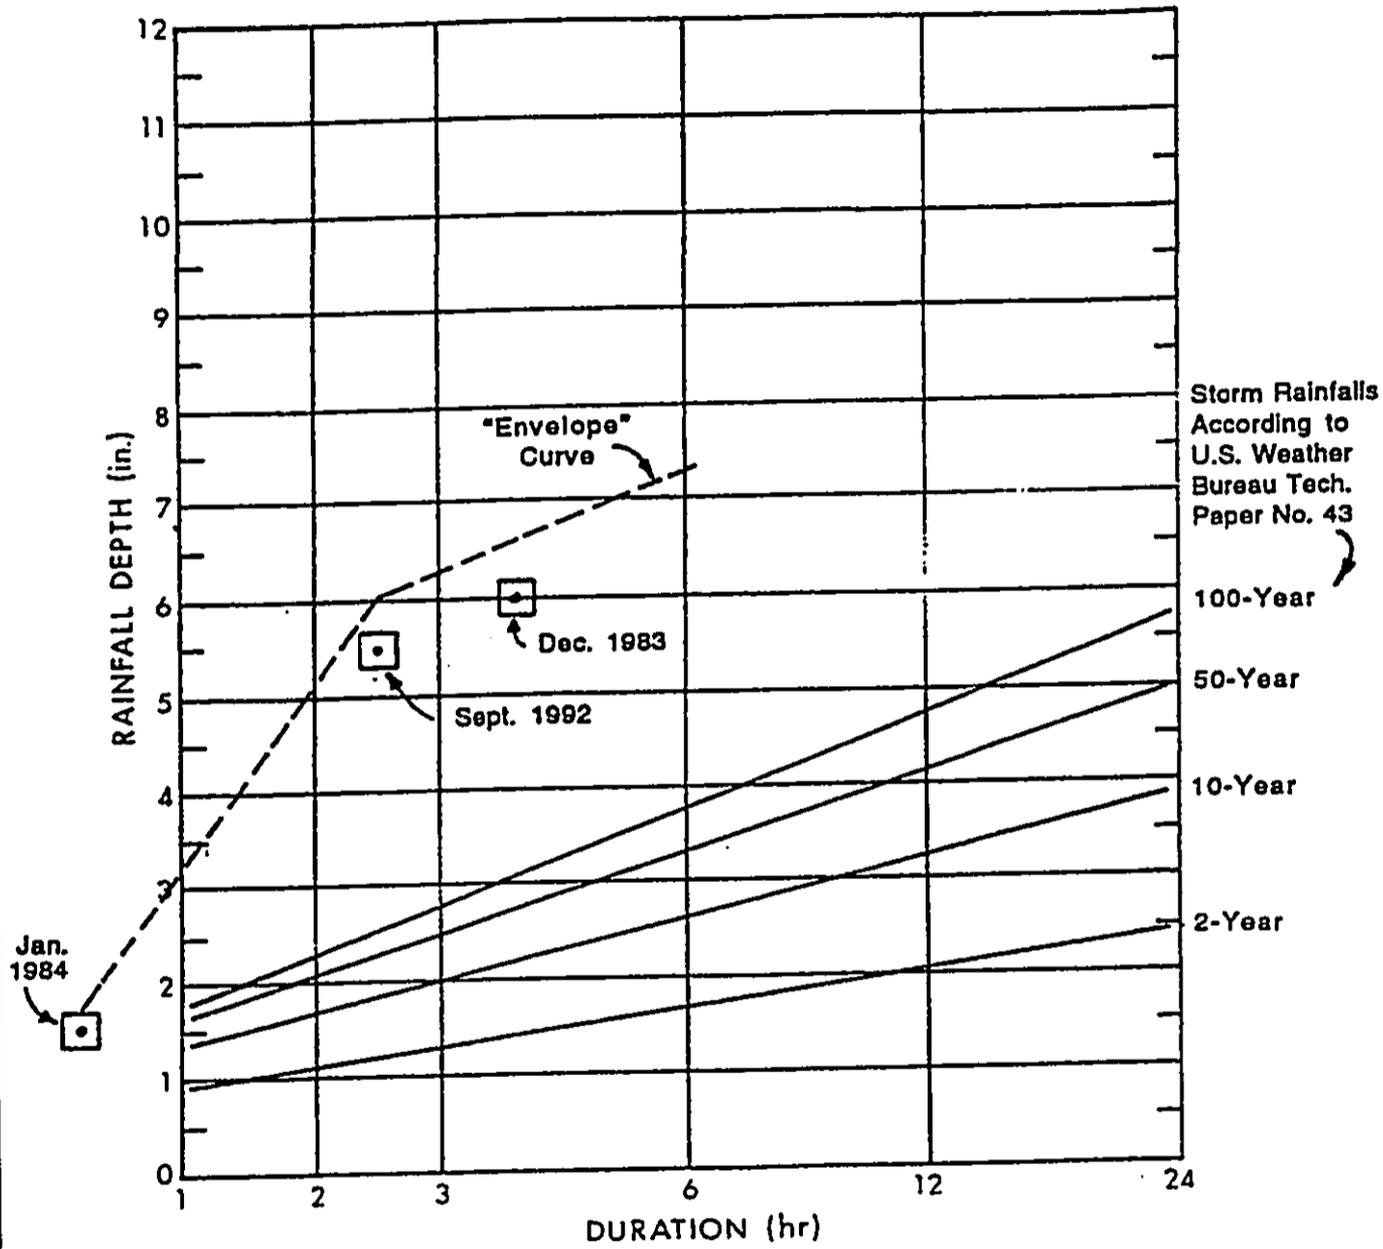
Figure 12
RAINFALL AMOUNTS AS A FUNCTION OF STORM DURATION
Mauna Kea Resort Drainage Way Improvements Draft Environmental Assessment
Prepared By: Belt Collins Hawaii
August 1994

The following information concerning drainage summarizes a report prepared by Tom Nance Water Resource Engineering in March 1993 (see Appendix A). According to Nance, establishing appropriate storm rainfall amounts is the heart of the problem for any drainage design in the area. The only published rainfall frequencies are in the outdated "Rainfall Frequency Atlas of the Hawaiian Islands" (U.S. Weather Bureau Technical Paper No. 43). No storm rainfall data in this part of South Kohala was available for the preparation of Technical Paper No. 43. The frequencies that were included were based on comparisons with other areas of similar average annual rainfall. Unfortunately, this does not satisfactorily represent actual storm rainfall probabilities. Figure 12 compares these published rainfall frequencies with actual rainfalls as reported by the applicant's staff for three storm events: 12/26/83 (6 inches in 4-5 hours); 1/16 to 1/17/84 (1.59 inches in two short duration rainfalls, one for 5 minutes and the other for 20-25 minutes); and 9/14 to 9/15/92 (5.5 inches in two and a half hours). Two of these three storm events are approximately two times greater than the published 100-year rainfall amounts for the same durations. Because the fraction of rainfall resulting in runoff increases in greater rainfall events, the difference in resulting runoff is even greater than the difference in rainfall.

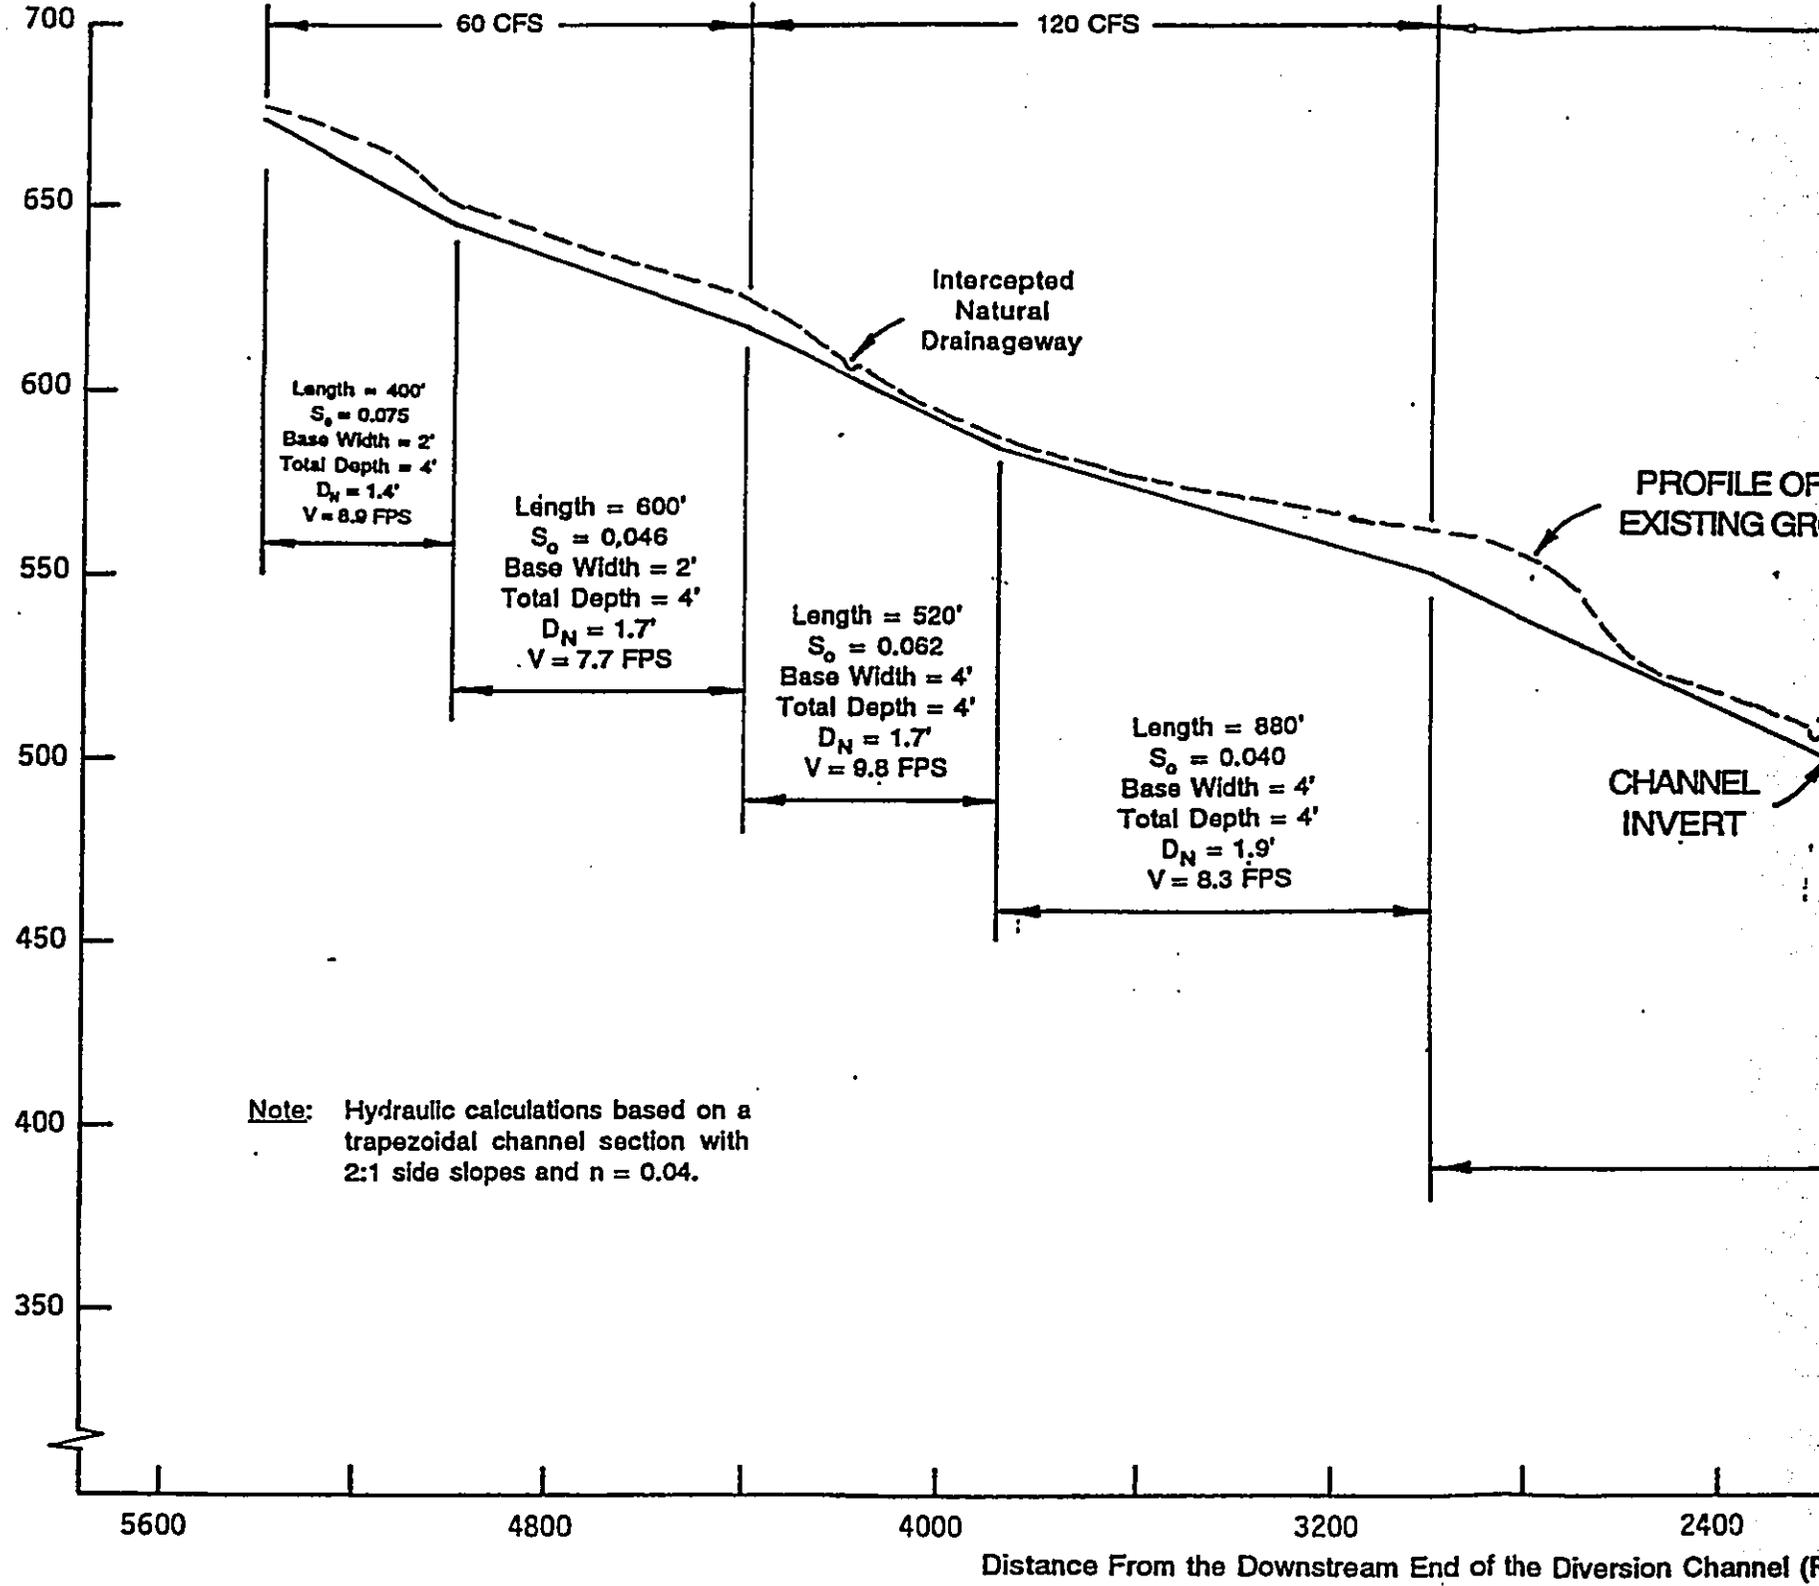
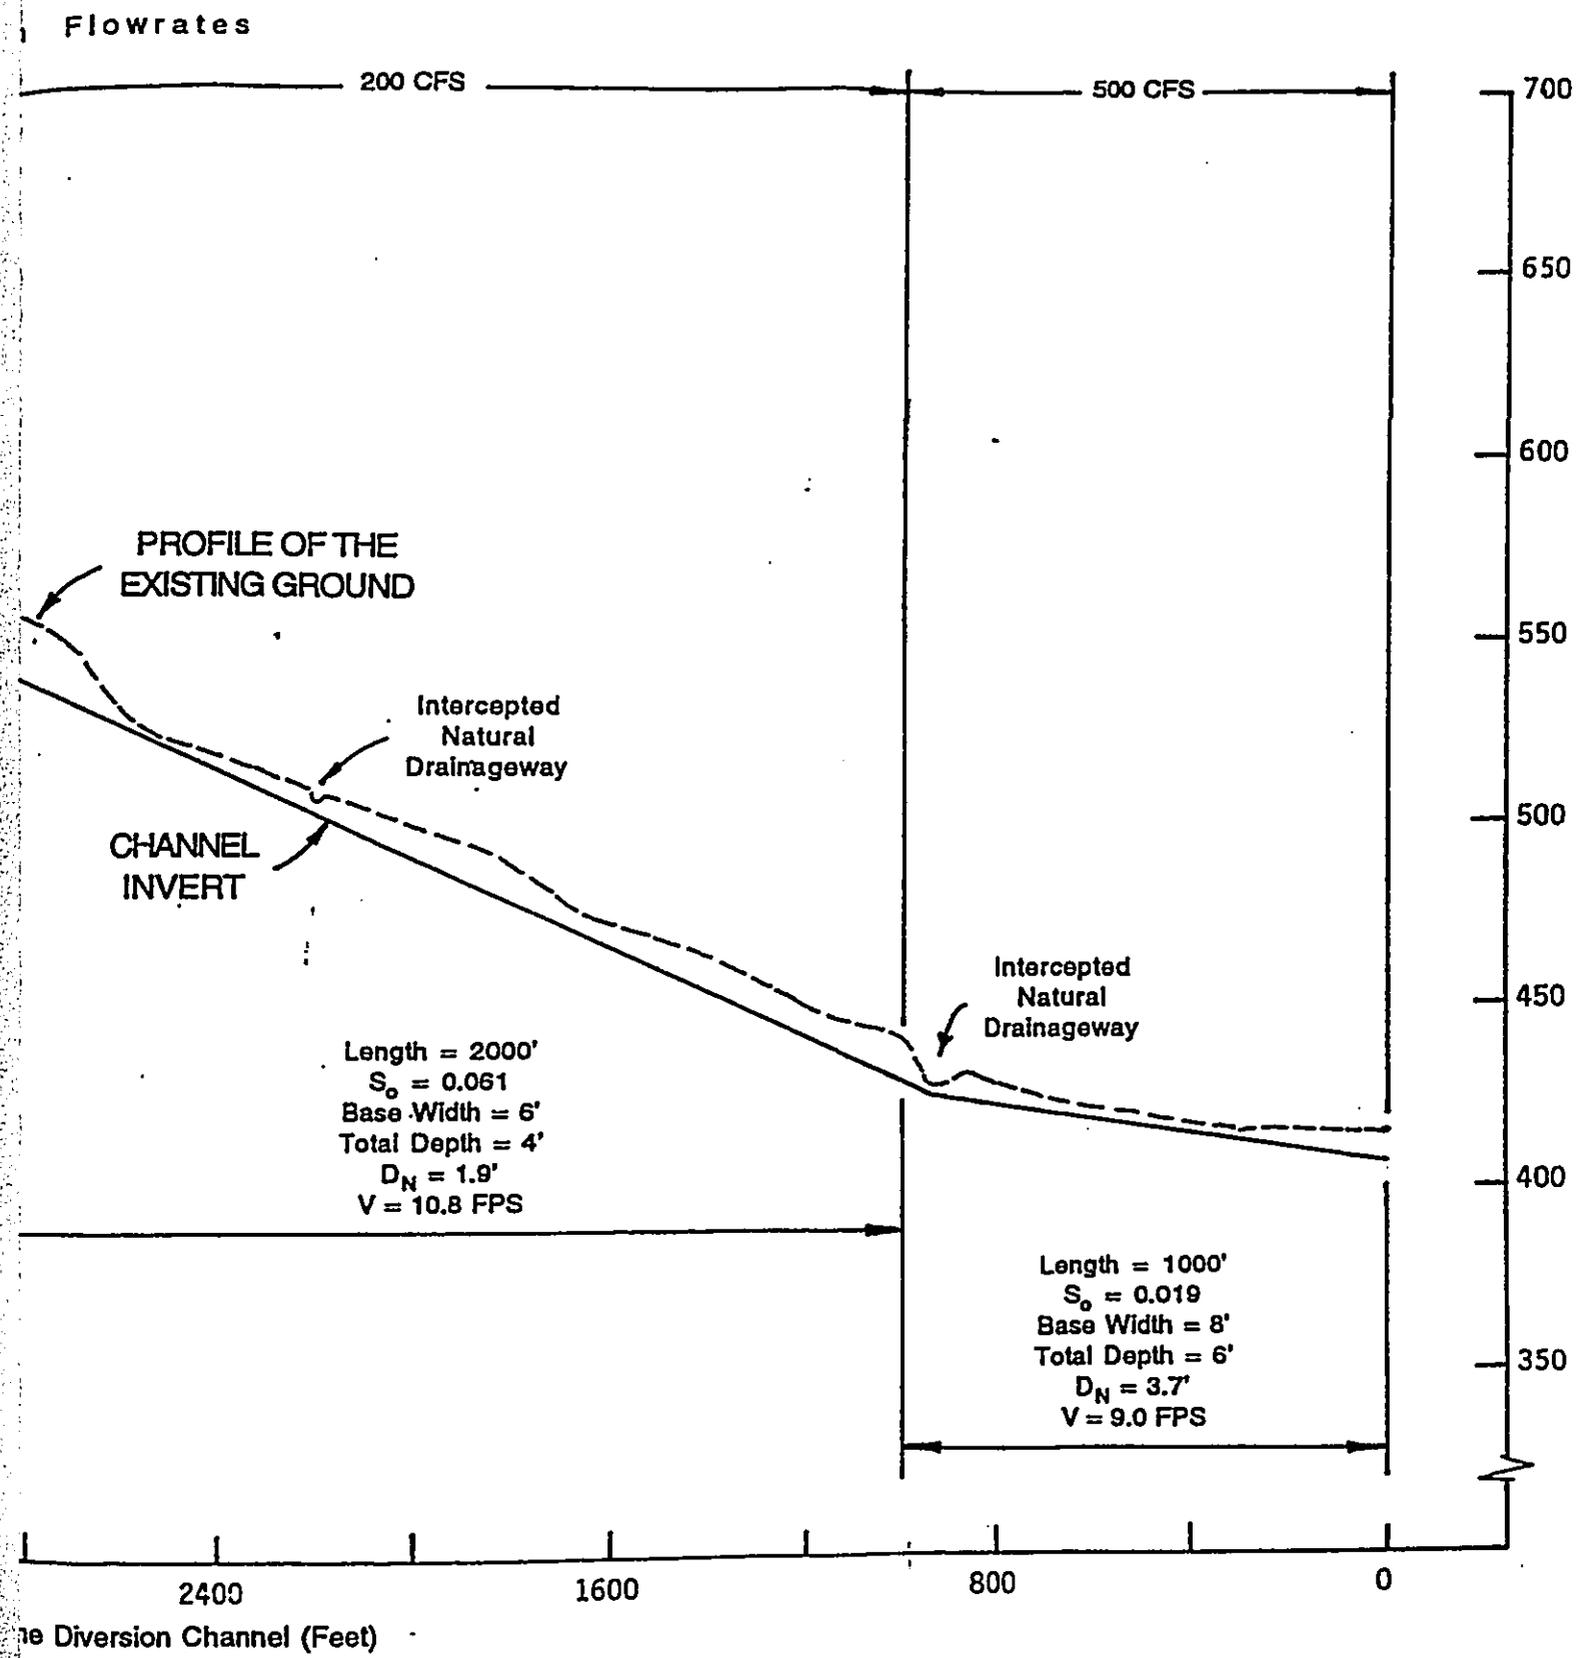
Figure 4
Profile of the Proposed Diversion Channel

Elevation
(Ft. msl)

Recommended Design Flowrates
