SUBJECT: DRAFT ENVIRONMENTAL ASSESSMENT FOR KUKUIOLONO 0.5 MG TANK, KALĀHEO, KAUA'I, HAWAII. TMK: (4) 2-3-05: Por. 02, 06, and 25

The Kauai County Department of Water (DOW) hereby transmits the draft environmental assessment and anticipated finding of no significant impact (DEA-AFONSI) for the Kukuiolono 0.5 MG Tank situated at (4) 2-3-05: Por. 02, 06, and 25, in the Kalāheo District on the island of Kaua'i for publication in the next available edition of the Environmental Notice.

KUKUIOLONO 0.50 MG, 866' TANK
 JOB NO. 11-09, K-05A
 Kalāheo, Kaua'i, Hawai'i

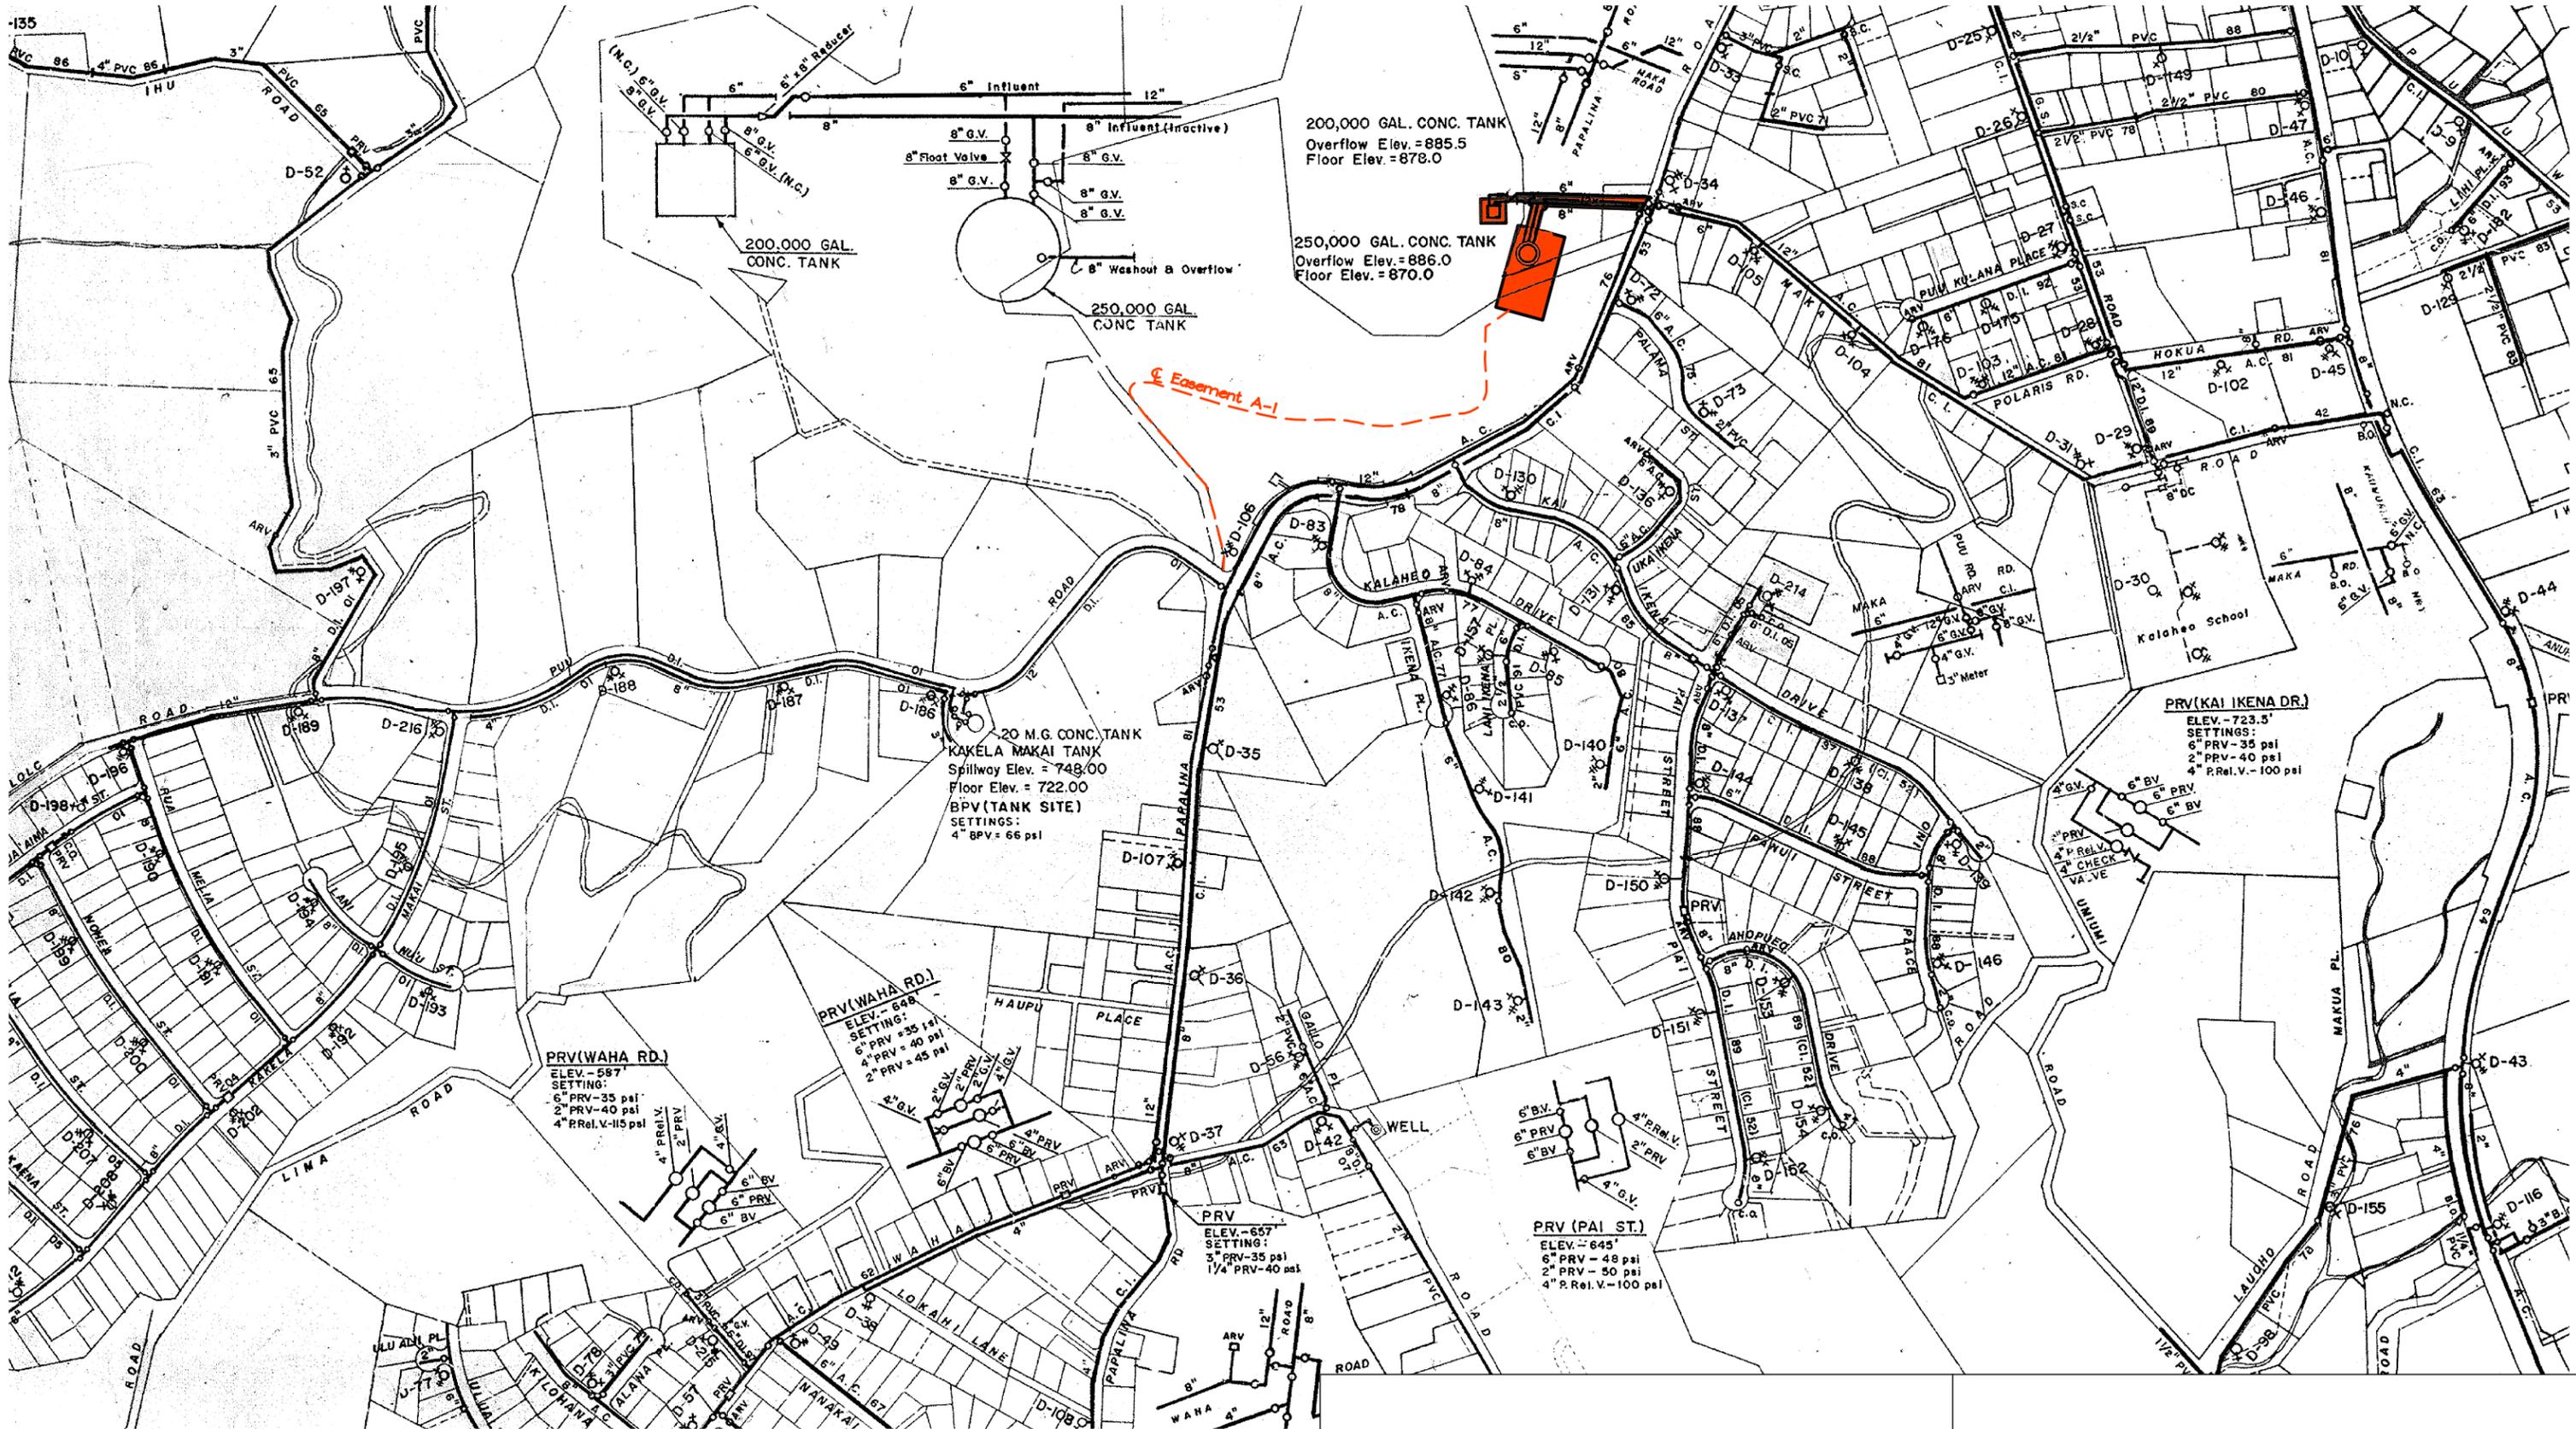
FIGURE 5
WATER FACILITY MAP
 KUKUIOLONO 0.50 MG, 866' TANK
 JOB NO. 11-09, K-05A
 Kalaheo, Kaua'i, Hawai'i

KALAHEO WATER SYSTEM
KALAHEO
 DEPARTMENT OF WATER
 COUNTY OF KAUAI
 LATEST REVISION: JUNE 2008

As shown in Figure 5 there are two existing water tanks, one located on Parcel 6 (0.2 MG tank) and one on Parcel 25 (0.25 MG tank). As part of this project, the existing water tank on Parcel 6 will be demolished and a 0.5 MG replacement tank will be constructed on Parcel 25. The new storage tank will occupy approximately 4,738 Sq. Ft., it will be constructed of concrete and measure approximately 78 Ft. in diameter and 15.2 Ft. high (floor elevation to spillway elevation). A recent field investigation by the Department of Water of the existing tank facilities uncovered the presence of an underground storage tank located on Parcel 6, prior to the 0.2 MG tank demolition, an independent study of the underground storage tank will be done, the appropriate course of action for the underground storage tank will depend on the findings of the investigation.

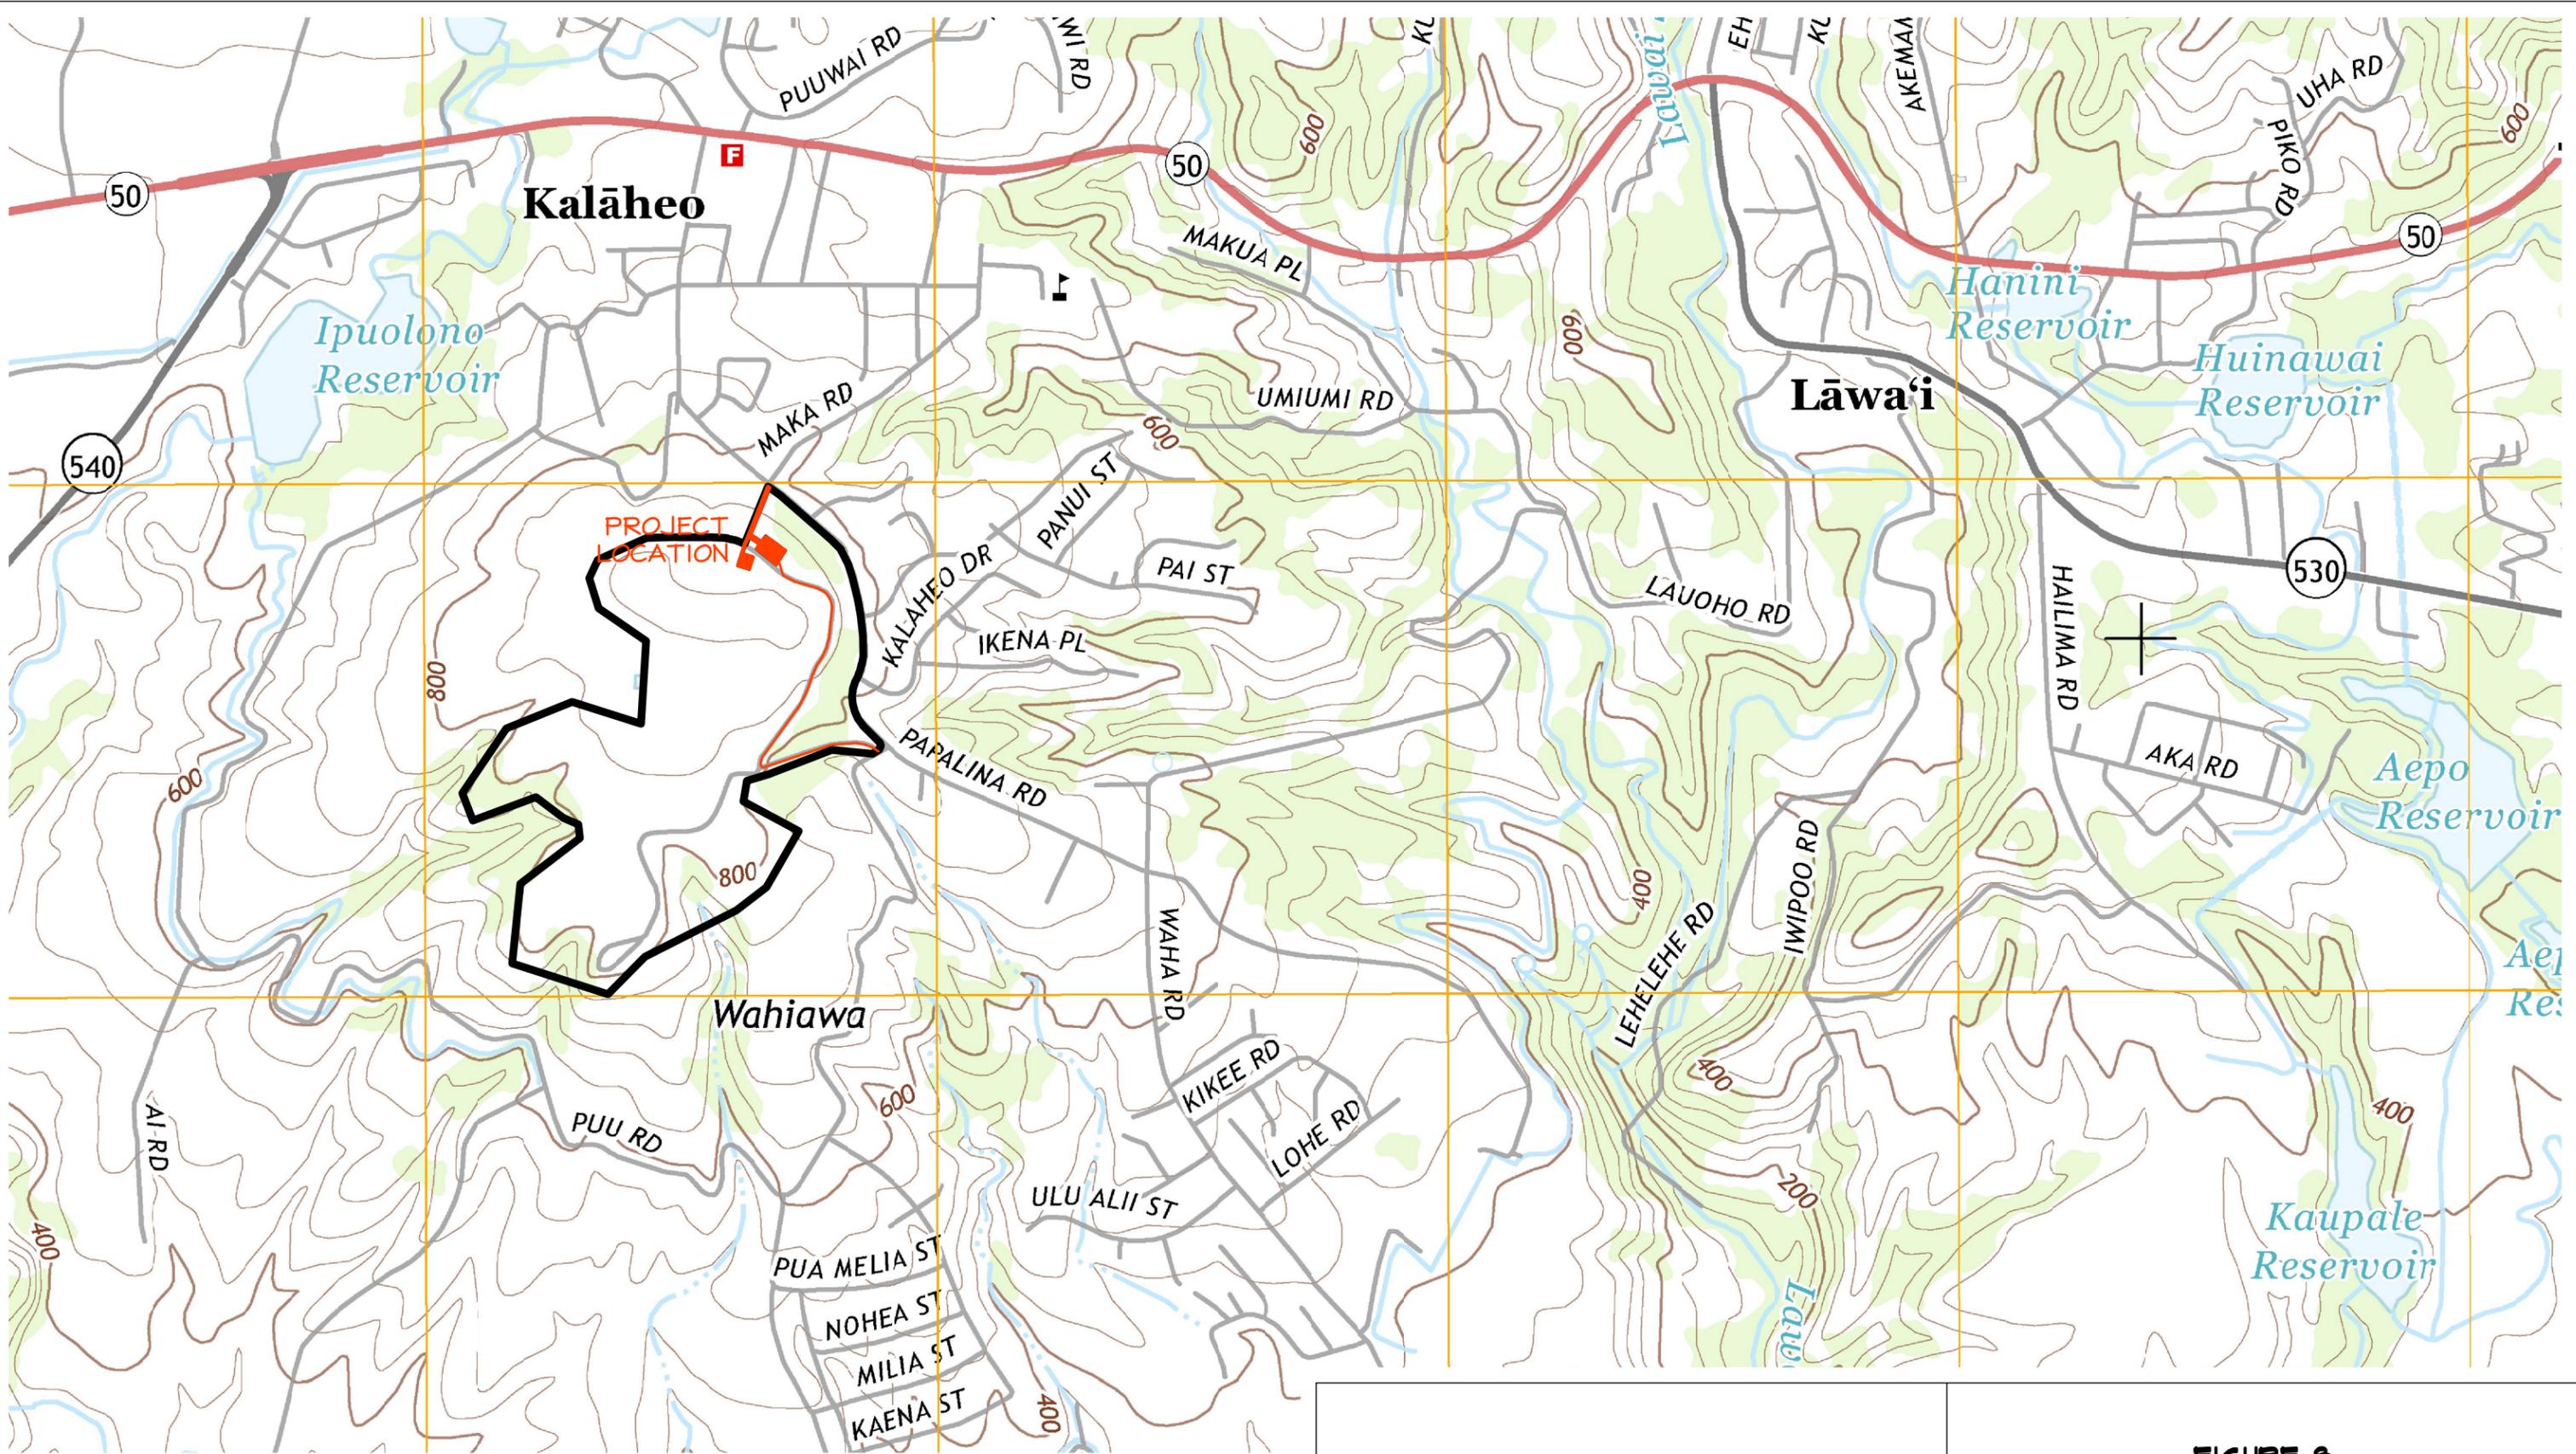
FIGURE 8
USGS MAP
KUKUIOLONO 0.50 MG, 866' TANK
JOB NO. 11-09, K-05A
Kalāheo, Kaua'i, Hawai'i

KOLOA QUADRANGLE
HAWAII-KAUAI CO.
7.5-MINUTE SERIES

Ground elevation within the project area ranges from a high of 880 feet to a low of 861 feet for the tank location. Cross slope is minimal. See Figure 8 for USGS Map. The soils of Kauai have developed primarily from volcanic materials and have concentrated iron and aluminum in the profiles. The quantities of silica and bases are low, particularly in the high rainfall areas, due to leaching of these materials. According to the U.S. Department of Agriculture (USDA), Natural Resources Conservation Service, the soils in the region are Puhi silty clay loam (PnB, PnC) and Ioleau silty clay loam (IoD2). See Figure 9 for Soils Map.

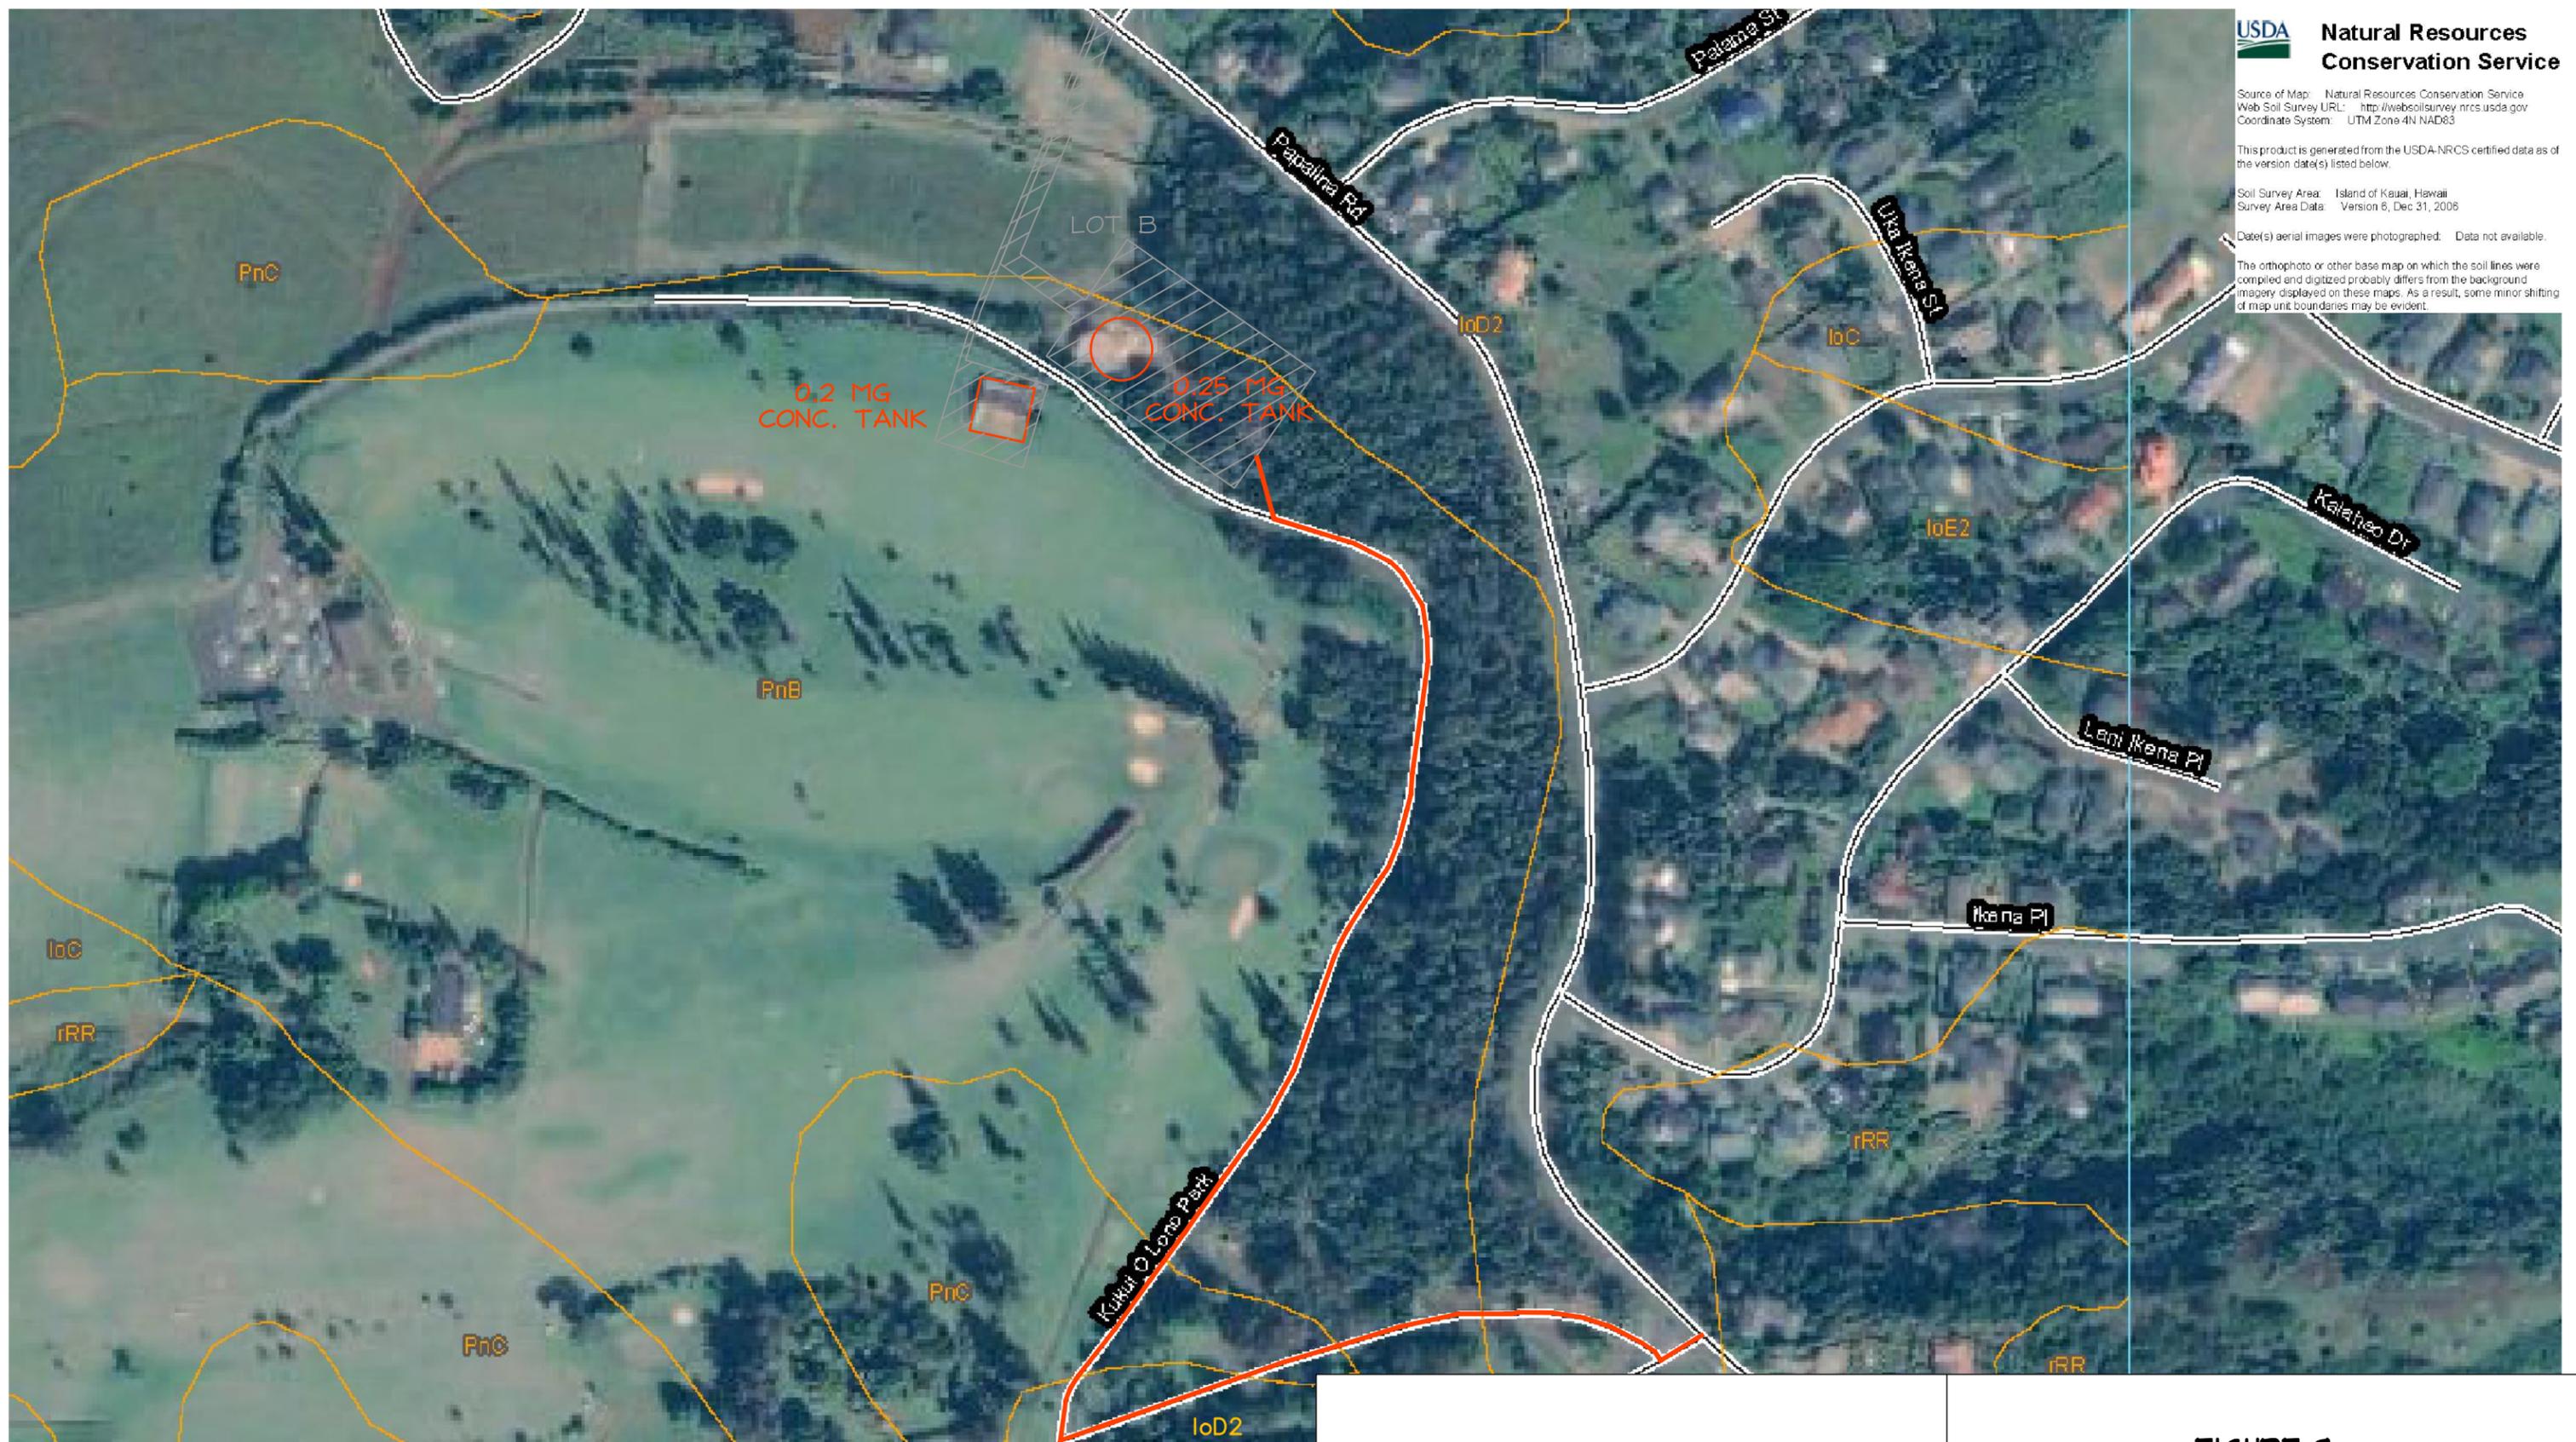
**FIGURE 9
 SOILS MAP**

SYMBOL	DESCRIPTION
loC	loleau silty clay loam (6% to 12% slopes)
loD2	loleau silty clay loam (12% to 20% slopes)
loE2	loleau silty clay loam (20% to 30% slopes)
PnB	Puhi silty clay loam (3% to 8% slopes)
PnC	Puhi silty clay loam (8% to 15% slopes)
rRR	Rough broken land

The Puhi series consists of deep, well drained soils that formed in material weathered from basic igneous rock. Puhi soils have very slow to rapid runoff, depending upon slope, and moderately rapid permeability; the soils are on uplands and have slopes of 3 to 40 percent, with dominant slopes from 3 to 15 percent.

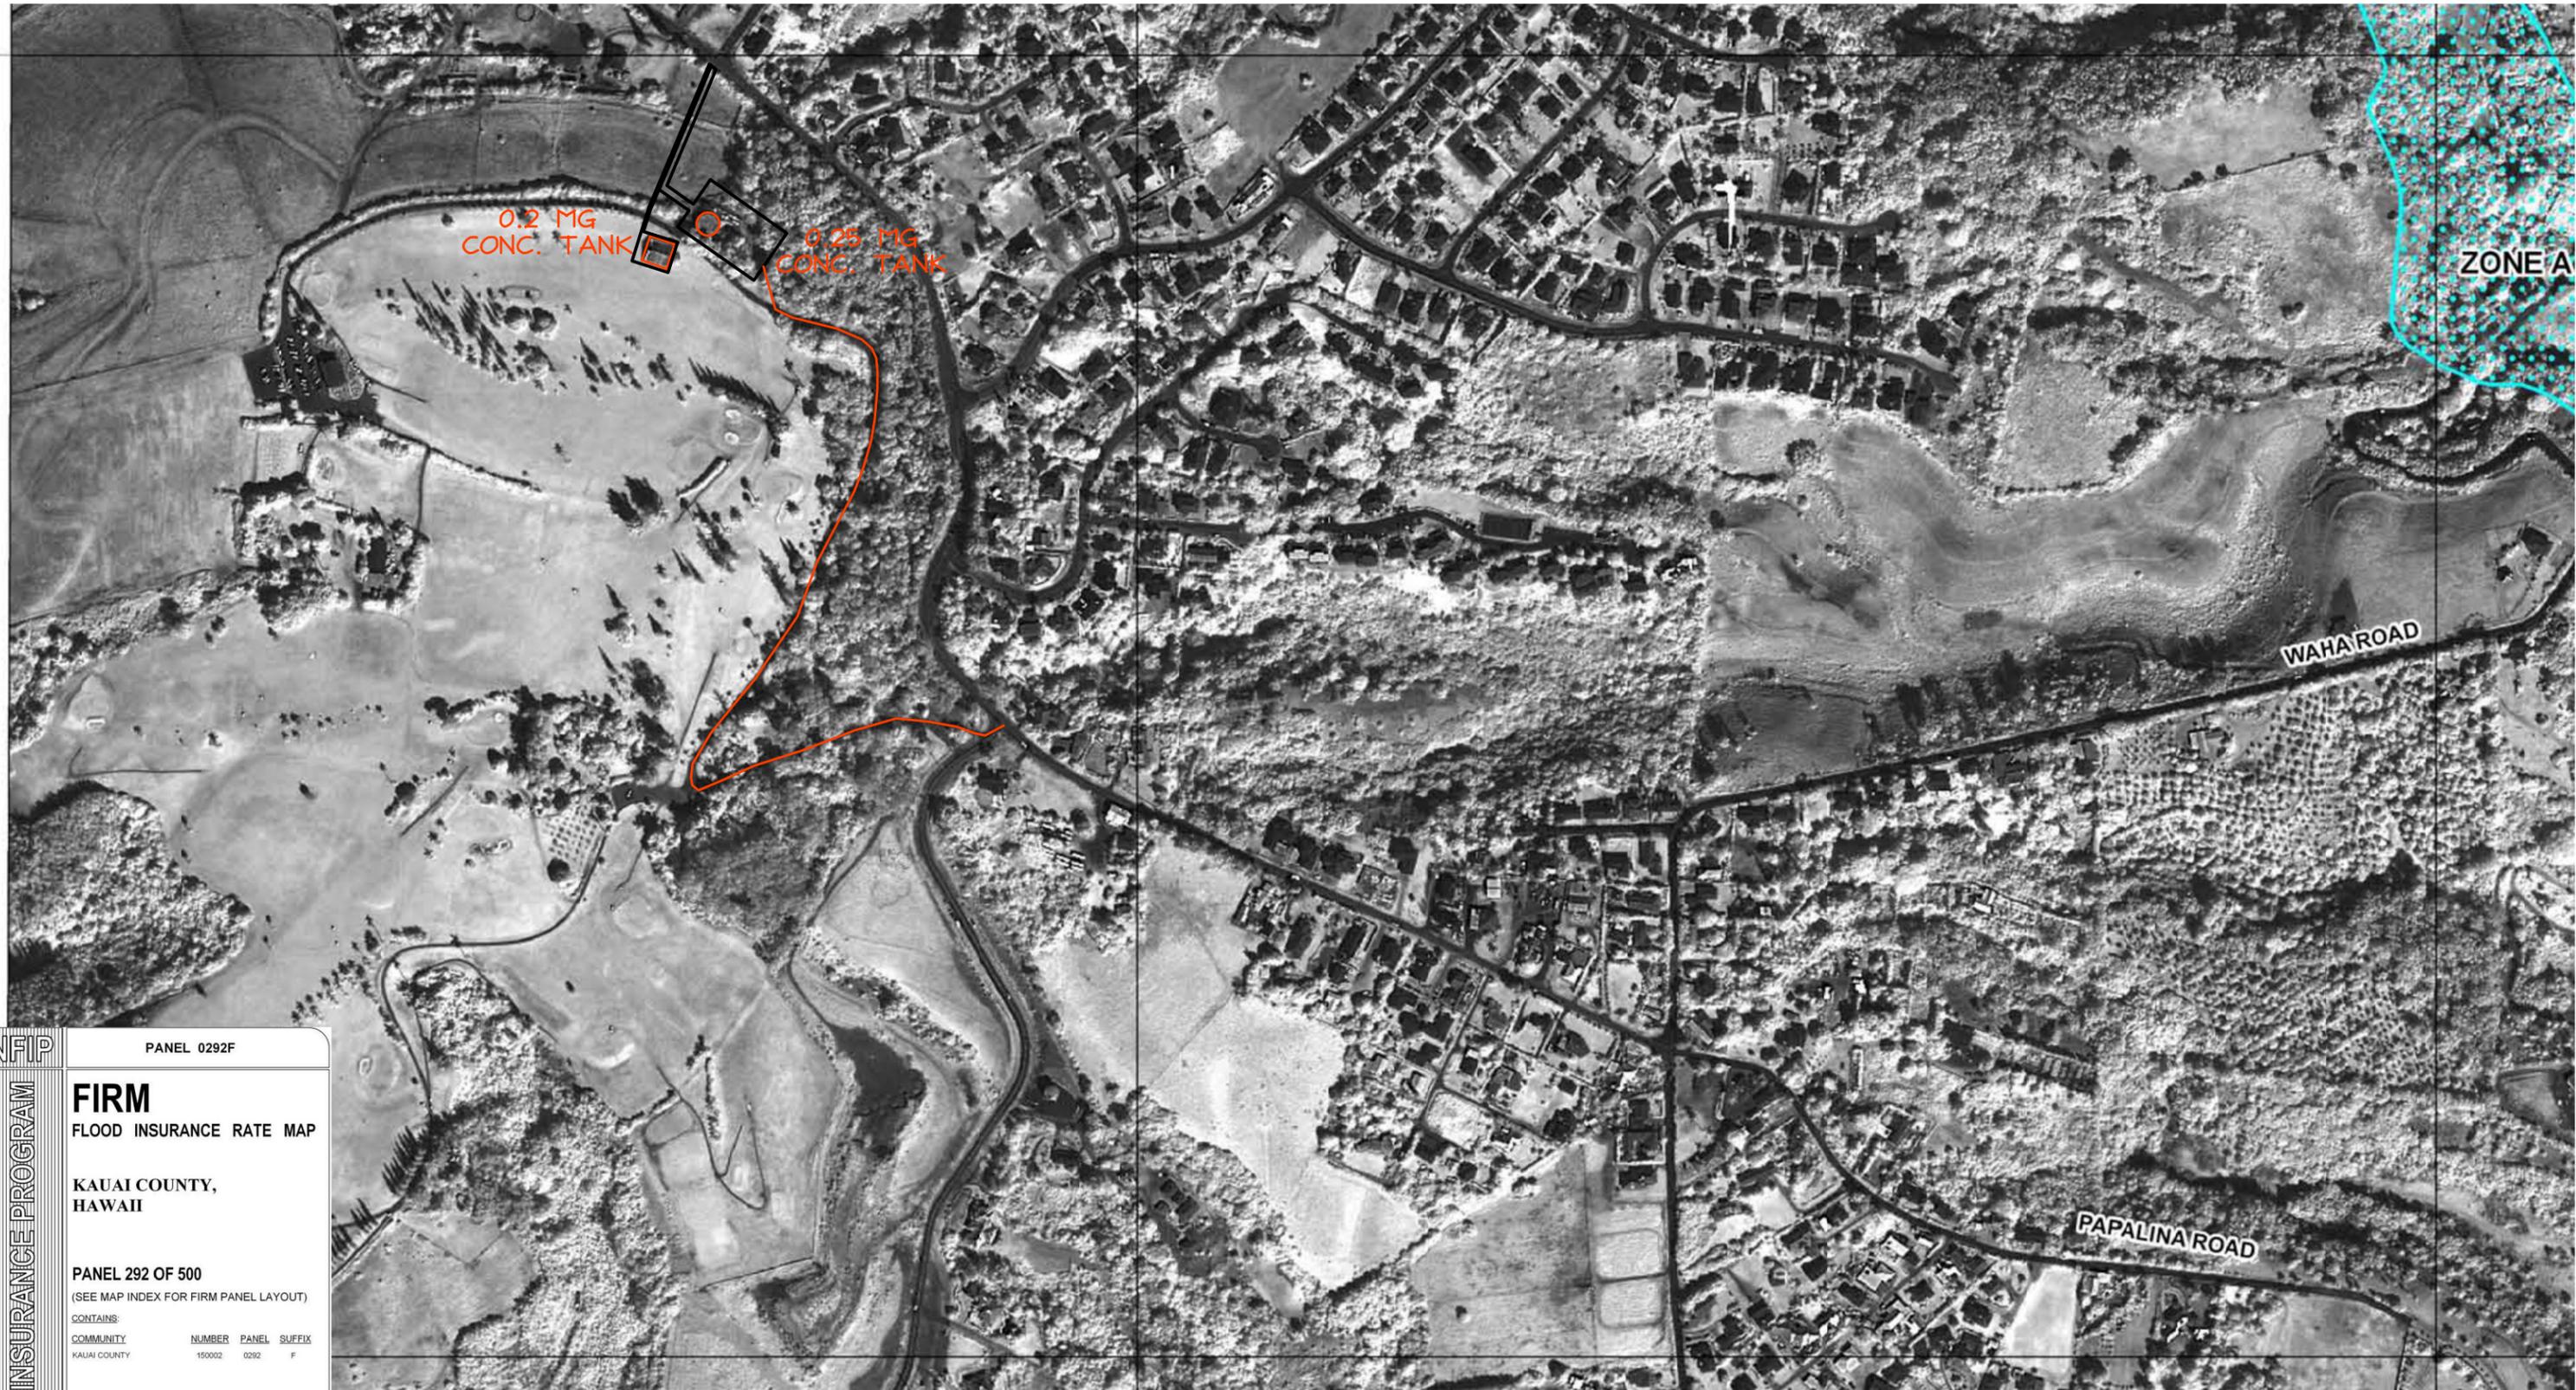
FIGURE 12
FLOOD INSURANCE RATE MAP
 KUKUIOLONO 0.50 MG, 866' TANK
 JOB NO. 11-09, K-05A
 Kalāheo, Kaua'i, Hawai'i

NFIP
NATIONAL FLOOD INSURANCE PROGRAM

PANEL 0292F

Existing Conditions: The project area is not in an identified flood area and is designated as "Zone X" on Kaua'i County's Flood Insurance Rate Map dated November 26, 2010. Zone X is defined as "Areas determined to be outside the 0.2% annual chance flood plain". See Figure 12 for Flood Insurance Rate Map.

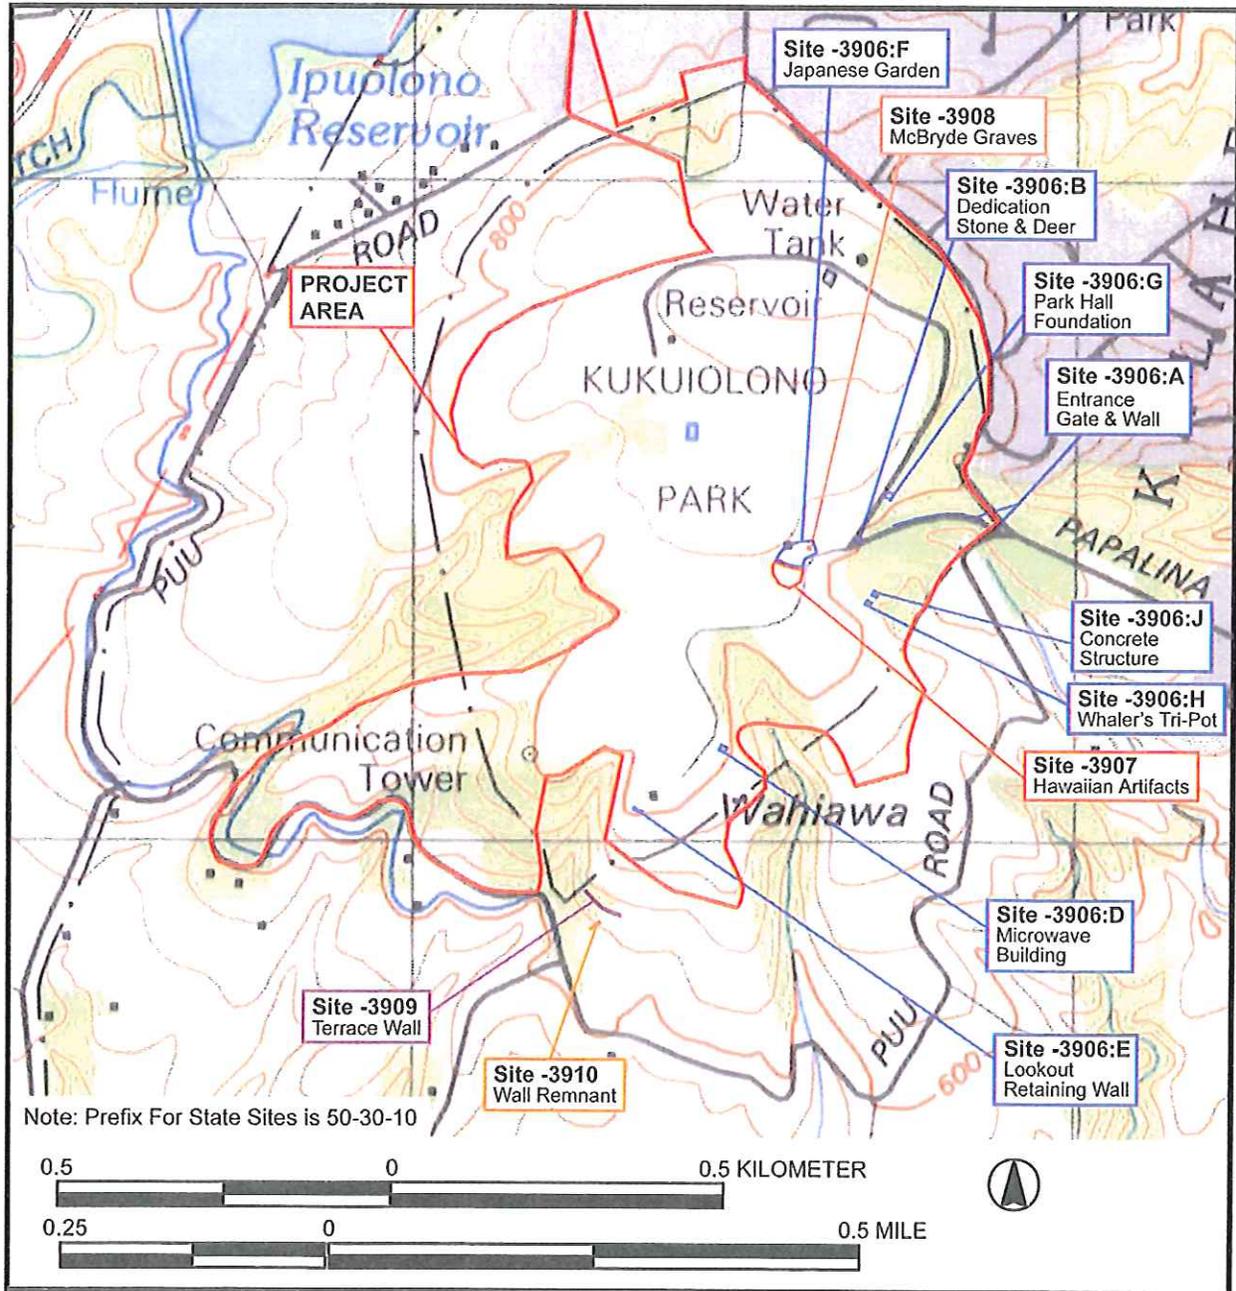
Figure 19. U.S. Geological Survey Topographic Map, showing the location of identified historic properties within the project area

The entrance to Kukuilono Park is from the east via Papalina Road (Figures 19 & 20). At the entrance is a gate consisting of a combination of four stone and mortar pillars with iron fencing between the pillars (Figure 20). A cement arch with lanterns atop spans the entrance road. The entrance gate is approximately 14 ft. (4.3 m) in height. The Kukuilono entrance gate was constructed by Walter D. McBryde in 1927, in memory of his mother (Sandison 1956).

The Dedication Stone is located at the junction in the park access road, where the road splits to go north to the golf course clubhouse or south to the Japanese Garden (Figure 19). The Dedication Stone is a large, flat basalt boulder with a circular metal plaque inset (Figure 21). The plaque reads 'To Commemorate Walter D. McBryde's Magnificent Gift of Kukui-o-Lono Park to the Island of Kaua'i January 24 A.D. 1919'. The Dedication stone is set on a mortared basalt boulder and cobble foundation. It is said that the stone was brought from McBryde's beach

Located in the southern portion of Kukuioolono Park, on the outskirts of the golf course, is a commercial microwave communications antenna and associated building (see Figure 19). The communications station is modern, however the associated building appears to be of historic construction, later adapted and reused by the communications station (Figure 24). The building is rectangular, measuring approximately 5.5 m by 9.4 m. The walls of the building are of basalt boulder and mortar construction measuring 8 ft. (2.4 m) in height. There are four bands of stonework separated by layers of cement.

Located near the park pavilion, in the southern portion of Kukuioolono Park, is a historic retaining wall (see Figure 19). The area is used as a lookout point, associated with the park pavilion. It is believed that it is at this location that signal torches were kept lit for navigation purposes in traditional times (see Section II: Historical Background). The mortared basalt boulder and cobble wall is constructed along the top edge of a relatively steep slope (Figure 25). The wall measures approximately 15.5 m long, 80 cm high, 40 cm wide, and curves along the contour of the hill. At the time of the field inspection (January and March 2004) the south end of the retaining wall was being undercut by erosion, causing the wall to crack. Stabilization measures had addressed this problem satisfactorily by September 2005. (Figure 26).

The Hawaiian artifacts collection is located between the Japanese garden parking lot and the Kukuioolono golf course, in the eastern portion of Kukuioolono Park (see Figure 19). The collection is accessed by an unpaved footpath. The collection is broken up into two groups of

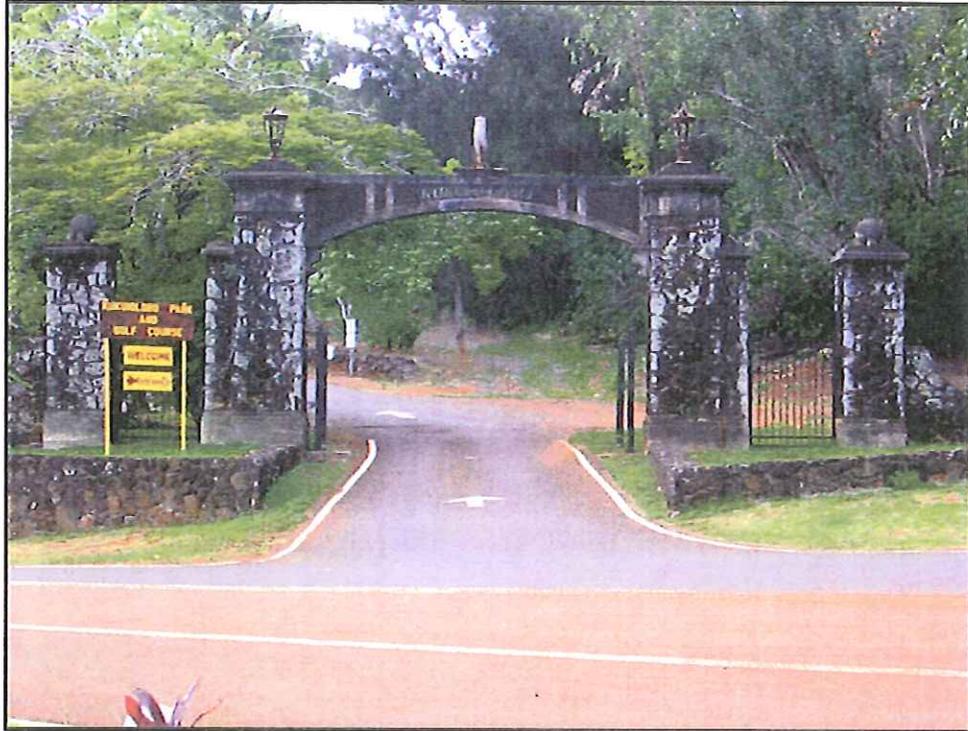
Figure 20. Site -3906 Feature A: Kukuilono entrance gate, view to northwest

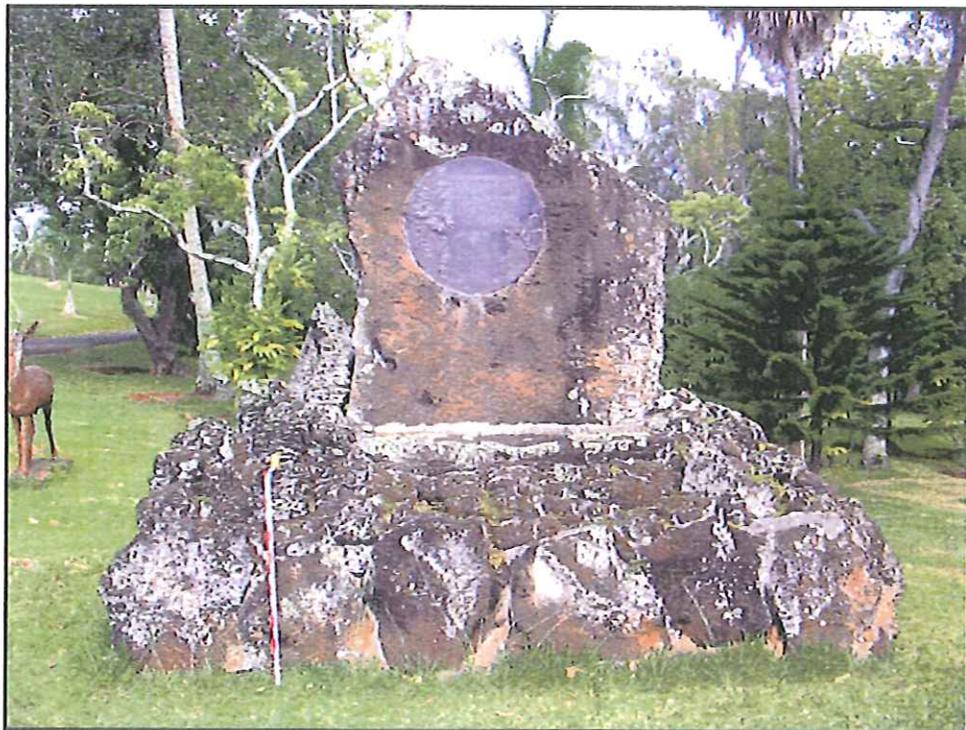
Figure 21. Site -3906 Feature B: dedication stone, view to north (Note iron deer at left)

home in Nomilo, where he used the stone as a breakfast table (Sandison 1956). Adjacent to the Dedication Stone is an iron deer statue (Figure 21). The deer is said to have been manufactured in England by order of Queen Victoria as part of a memorial to the Prince Consort. The sculpture was brought to Hawai'i by John T. Waterhouse (Sandison 1956).

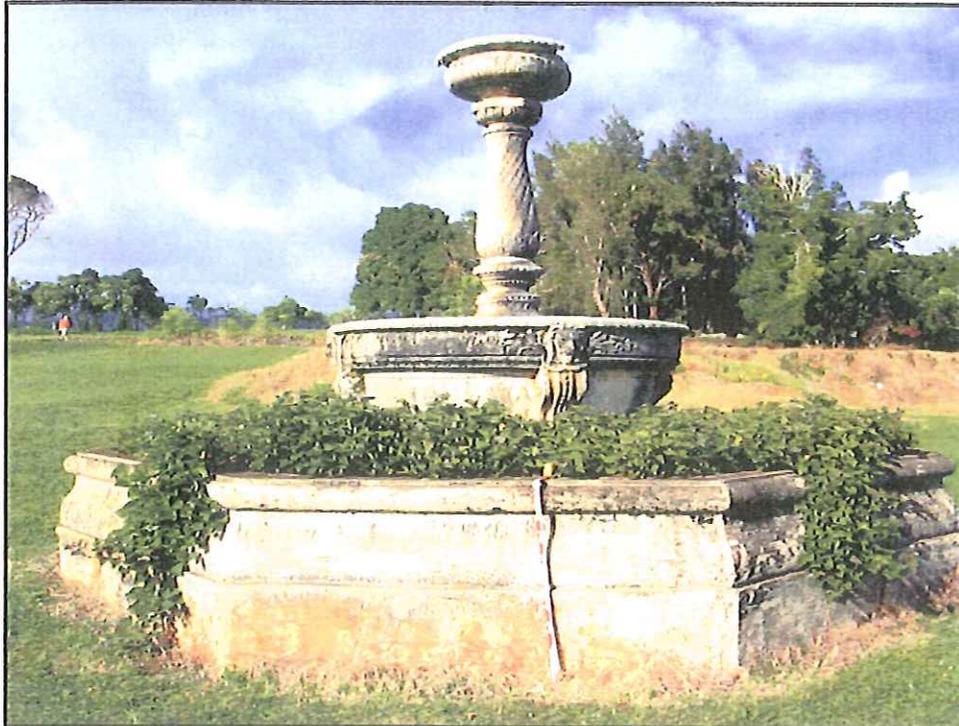
Figure 22. Site -3906 Feature C: Cement fountain within golf course grounds, view to north

Located within the golf course grounds are two large cement sculptures. The first is a large cement fountain, measuring approximately 10 ft (3 m) in height and 12 ft (3.7 m) in diameter (Figure 22). The fountain is composed of a hexagonal lower pool, a circular intermediate pool, a cylindrical pedestal, and small circular pool on top. The second sculpture is a cement pagoda, measuring approximately 7 ft (2.1 m) in height (Figure 23). The pagoda itself rests atop a rectangular, cement step-pyramid foundation.

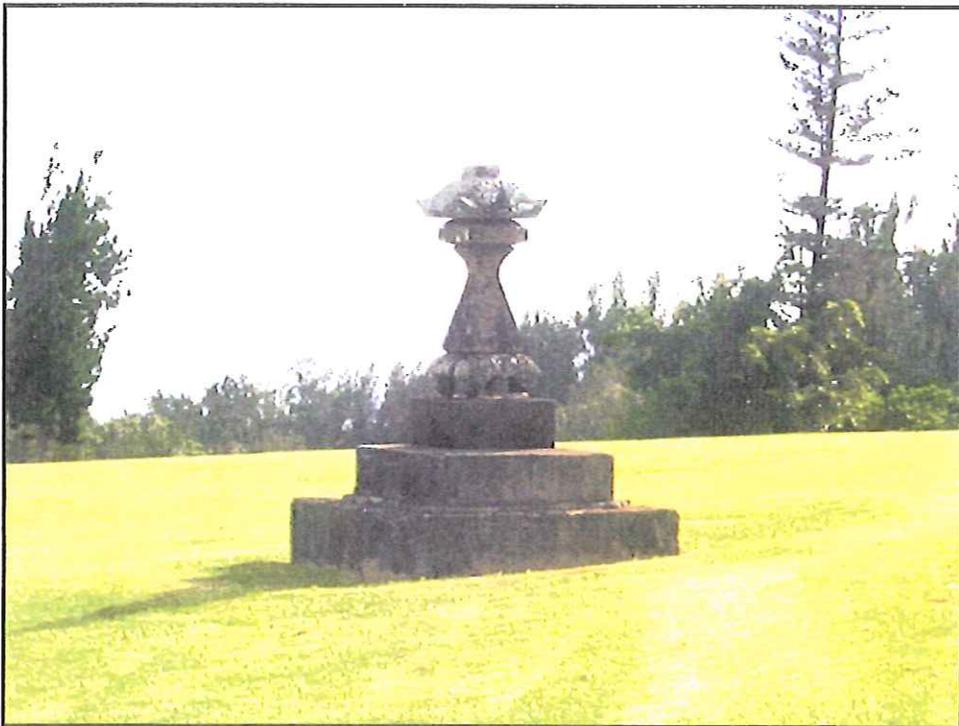
Figure 23. Site -3906 Feature C: Cement pagoda within golf course grounds, view to south

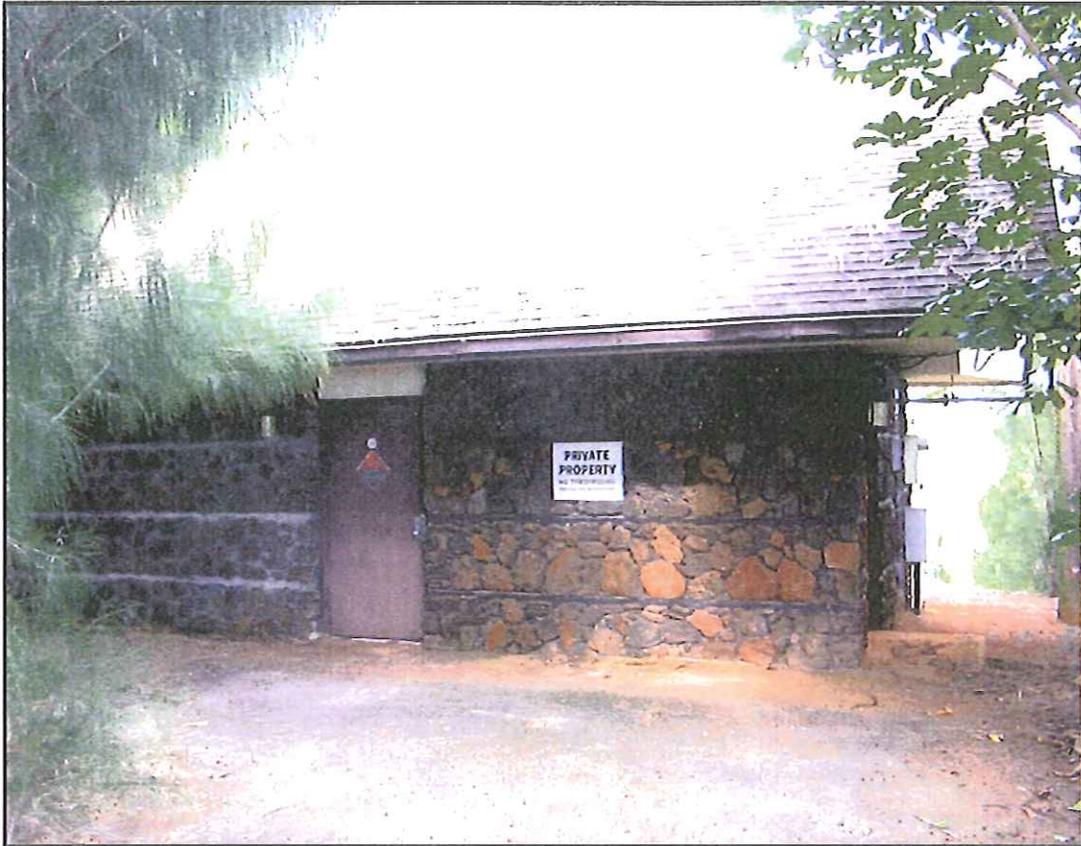
Figure 24. Site -3906 Feature D: Kukuilono microwave antenna Station, view to northeast

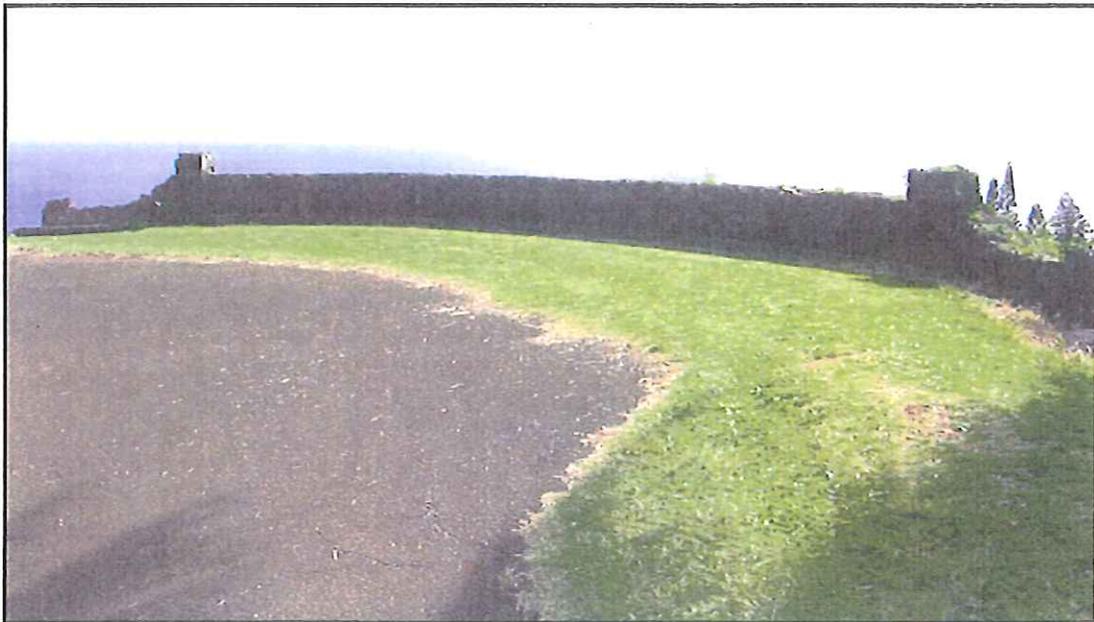
Figure 25. Site -3906 Feature E: Basalt boulder and mortar retaining wall at pavilion lookout, view to southeast
