SUBJECT: DRAFT ENVIRONMENTAL ASSESSMENT FOR KUKUIOLONO 0.5 MG TANK, KALĀHEO, KAUA'I, HAWAII. TMK: (4) 2-3-05: Por. 02, 06, and 25

The Kauai County Department of Water (DOW) hereby transmits the draft environmental assessment and anticipated finding of no significant impact (DEA-AFONSI) for the Kukuiolono 0.5 MG Tank situated at (4) 2-3-05: Por. 02, 06, and 25, in the Kalāheo District on the island of Kaua'i for publication in the next available edition of the Environmental Notice.

KUKUIOLONO 0.50 MG, 866' TANK
 JOB NO. 11-09, K-05A
 Kalāheo, Kaua'i, Hawai'i

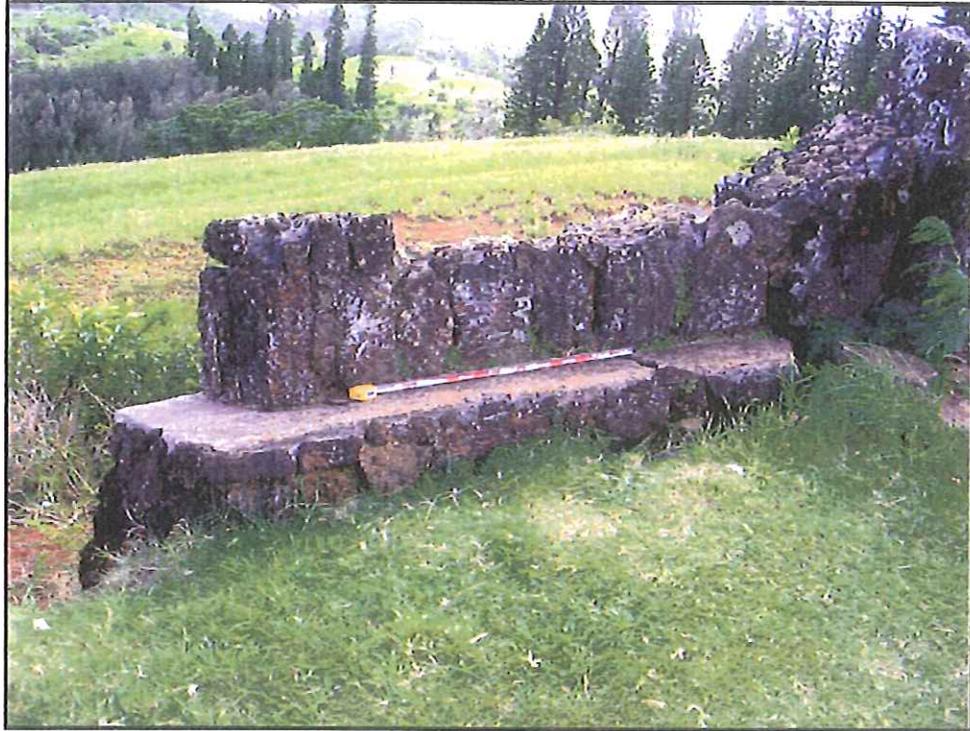
Figure 26. Site -3906 Feature E: Southern end of lookout retaining wall, showing erosion damage (since repaired), view to south

Located near the park pavilion, in the southern portion of Kukuioolono Park, is a historic retaining wall (see Figure 19). The area is used as a lookout point, associated with the park pavilion. It is believed that it is at this location that signal torches were kept lit for navigation purposes in traditional times (see Section II: Historical Background). The mortared basalt boulder and cobble wall is constructed along the top edge of a relatively steep slope (Figure 25). The wall measures approximately 15.5 m long, 80 cm high, 40 cm wide, and curves along the contour of the hill. At the time of the field inspection (January and March 2004) the south end of the retaining wall was being undercut by erosion, causing the wall to crack. Stabilization measures had addressed this problem satisfactorily by September 2005. (Figure 26).

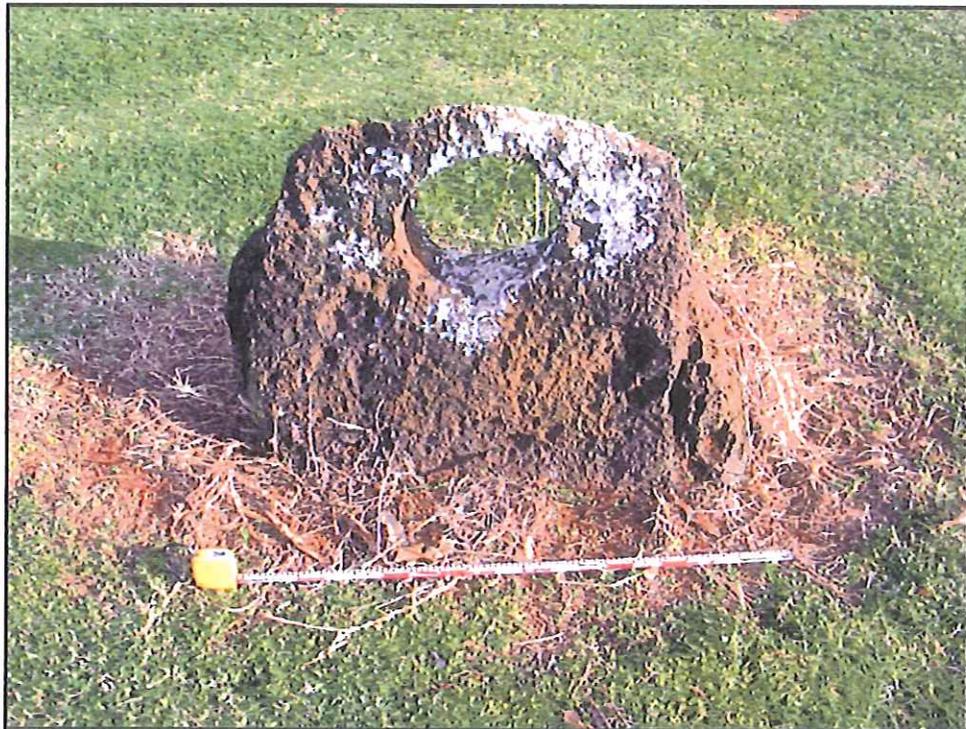
Figure 27. Site -3907 Feature K: Stone with circular hole, within golf course grounds

Located within the central portion of the golf course grounds, near the Hawaiian artifacts collection, is an unnamed basalt boulder (Figure 27). The boulder measures 100 cm by 44 cm wide and 70 cm in height, and is characterized by a 30 cm diameter circular hole through it. The origin and use of this stone are unknown.

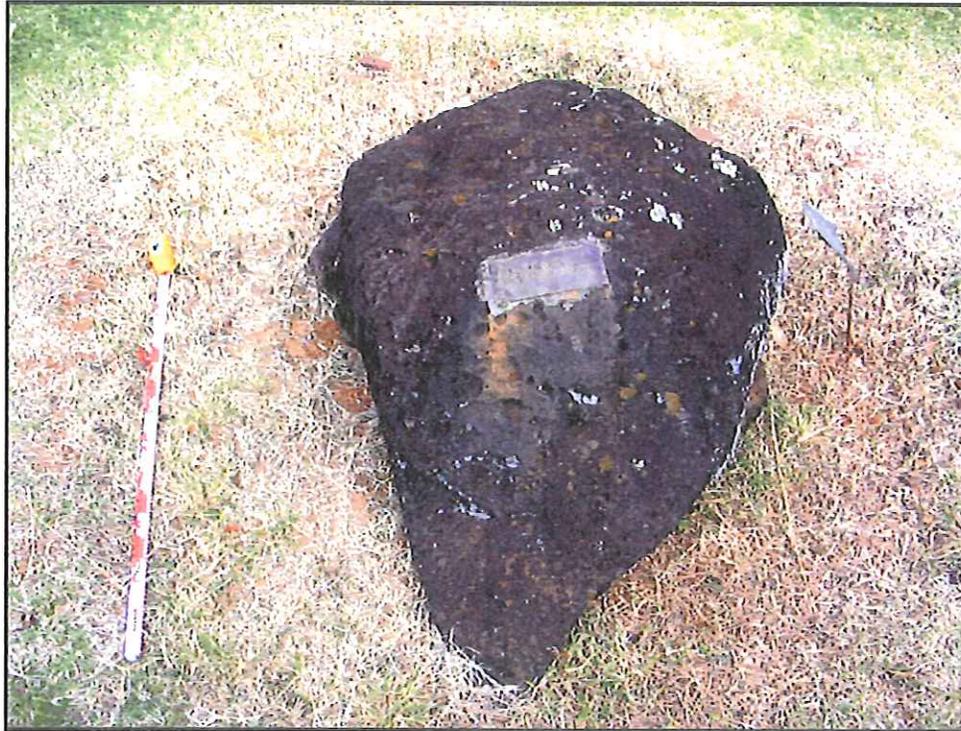
Figure 30. Site -3907 Feature B: “Pōhakahunaahuula: “the Feather Cloak Stone”

The "Pōhakuahua" stone is a large basalt boulder measuring 160 cm by 85 cm wide and 55 cm high (Figure 30). The shape of the boulder is such that when resting at its current position, an open crevice is created between the stone and the soil surface. Pōhakuahua was relocated to Kukuilono Park from its original location near Brydeswood. It is believed that this stone was used in traditional times by the chief Ola. During a time of war, in order to avoid capture, "the chief hid his feather cloak under the stone and draped sweet potato vines over it to camouflage it" (Sandison 1956).

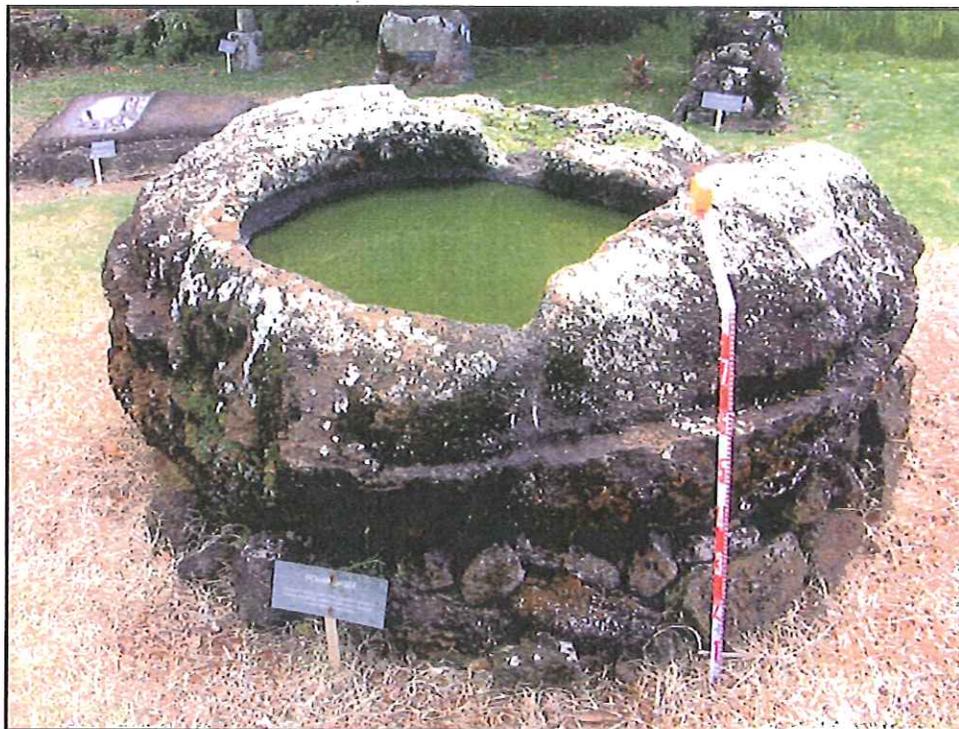
Figure 31. Site -3907 Feature C: “Pōhakuawa”

The "Pōhakuawa" stone is a large basalt boulder measuring 215 cm by 195 cm wide and 105 cm high (Figure 31). The boulder is currently supported by a base of stacked basalt boulders and cobbles. Within the top of the Pōhakuawa stone is a deep carved bowl. The bowl is able to contain a volume of water for a significant period of time, exemplified by the algal growth observed. Pōhakuawa was relocated to Kukuilono Park from its original location "about a mile west of Brydeswood on the trail to the upper Wahiawa lands." It is noted that the stone was used in traditional Hawaiian times by fisherman transporting *awa* (milkfish) from the brackish Nōmilu fishpond to a large pool in the Wahiawa Stream. "The fisherman stopped the night at Pōhakuawa and kept his catch alive in cool fresh water in the bowl of the rock that was draped over with vines to keep the stone cool and keep the fish from jumping out" (Sandison 1956). It is also noted that Wahiawa (Wahi-awa) Valley, or "the place where the awa fish was stored," was named after this stone (Kikuchi 1963).

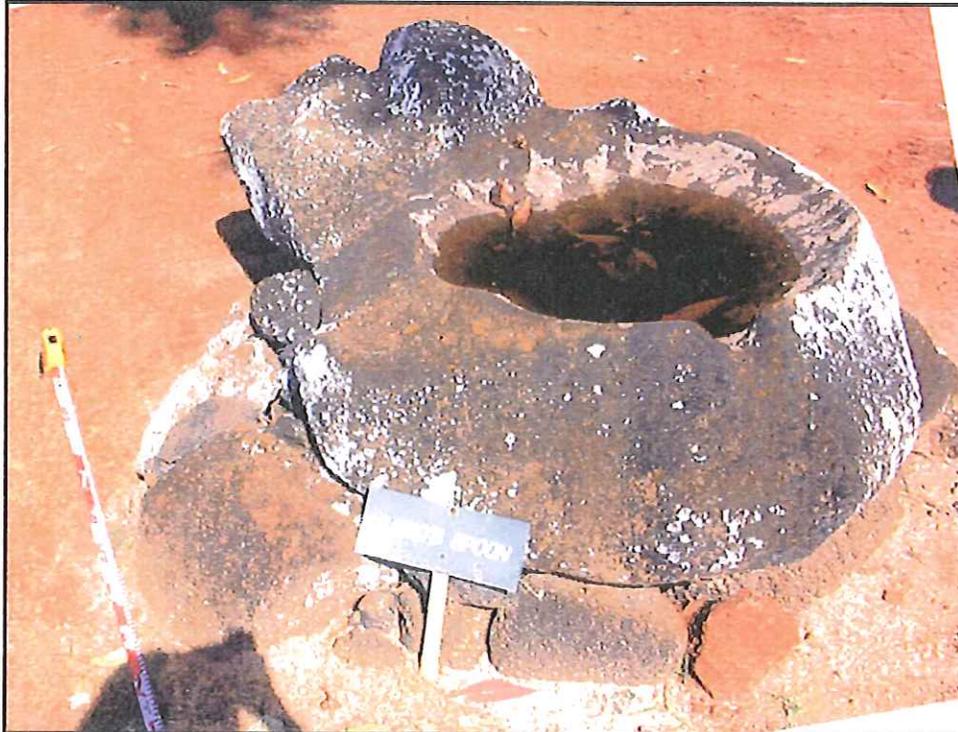
Figure 33. Site -3907 Feature E: “Lono’s Spoon”

The “Lono’s Spoon” stone is a large basalt boulder measuring 132 cm by 102 cm wide and 65 cm high (Figure 33). The stone is currently supported by a base of basalt boulders and cobbles. Lono’s spoon contains a central carved depression measuring 75 cm in diameter and 16 cm deep. The rim of the depression also appears to have a small notch carved into it.

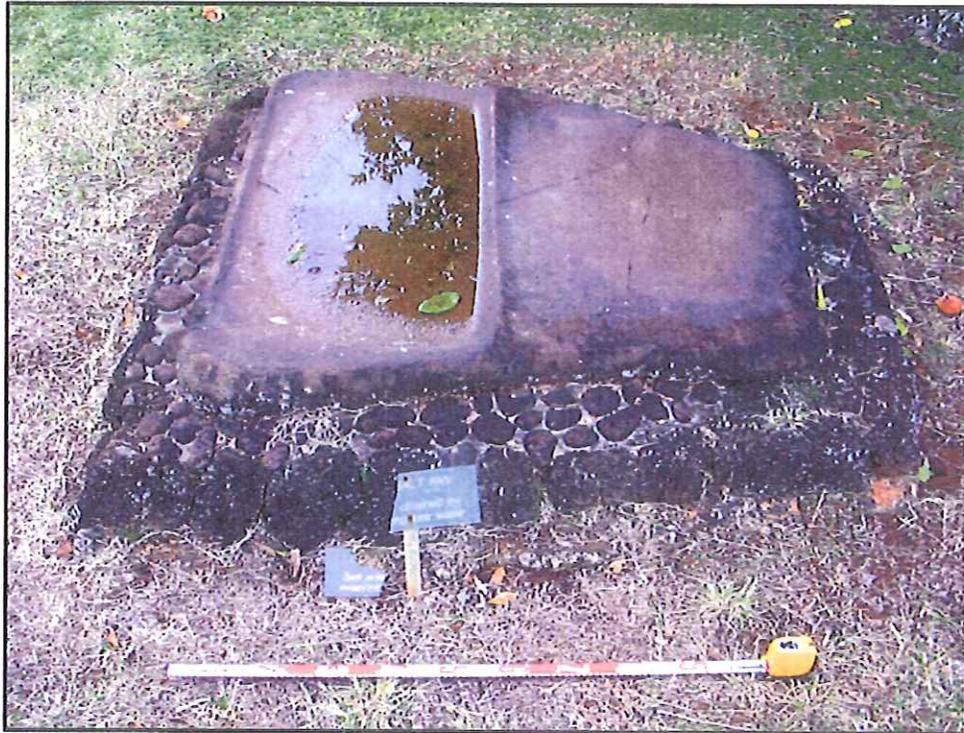
Figure 34. Site -3907 Feature F: "Salt Pan" artifact

The “Salt Pan” measures 129 cm by 126 cm wide and 17 cm high (Figure 34). The salt pan is currently supported by a platform constructed of mortared basalt boulders with a water-worn basalt cobble paving. It is a traditional Hawaiian artifact and is an excellent example of such stones. The artifact consists of two adjacent compartments carved into a single flat stone. The base of each of the compartments is very flat and smooth. One side of the salt pan is bordered by a low rim, such that a volume of water can be retained within the compartment. The second compartment consists of a flat stone surface.

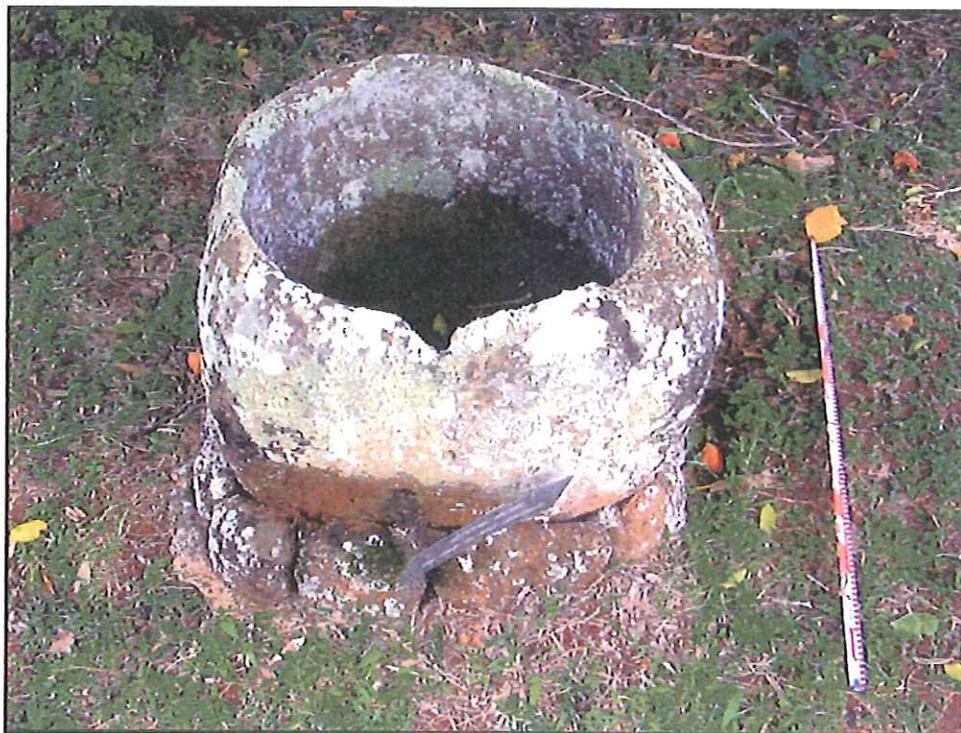
Figure 35. Site -3907 Feature G: "Stone Bowl" artifact

The “Stone Bowl” measures 65 cm by 62 cm wide and 49 cm high (Figure 35). This artifact consists of a carved bowl within a basalt boulder. The interior of the bowl is 53 cm in diameter and 42 cm deep. The stone currently rests on a foundation of cemented basalt cobbles. The origin of the stone is unknown and it is noted that: “its use is still unknown.”

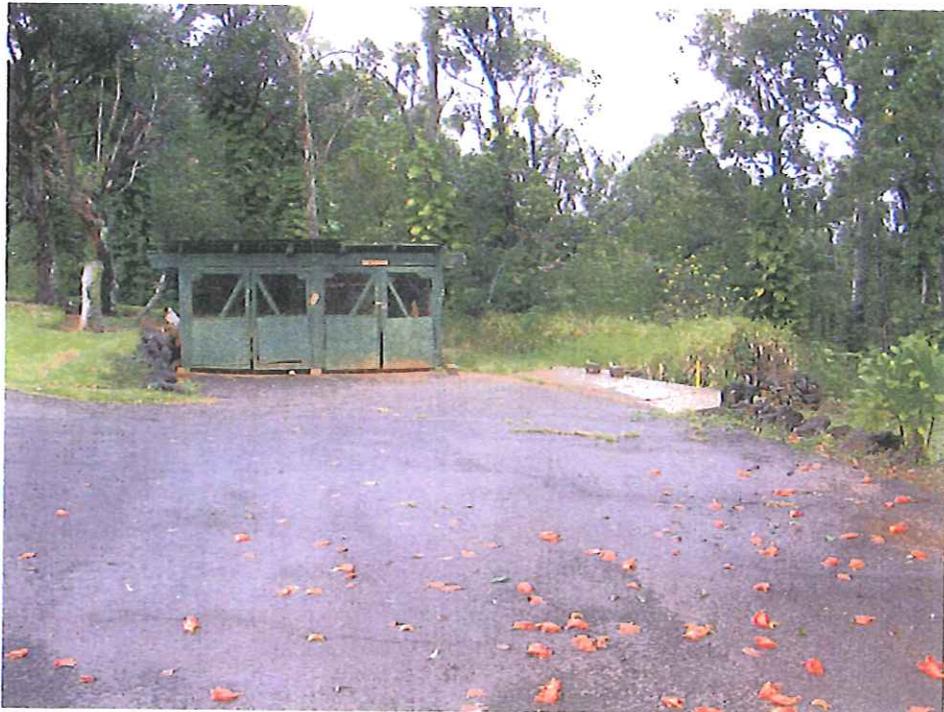
Figure 47. Site –3906 Feature G: Terraced former Park Hall structure foundation and associated garage, view to north

The foundations of what is believed to be the former park hall were located immediately east of the golf course access road, near an existing maintenance storage shed (see Figure 19). The structure was demolished in 1992 following heavy damage sustained during hurricane 'Iniki. The site consists of a stacked basalt boulder and cobble retaining wall, which creates a level area that has been paved for parking (Figure 47). Community consultation with Mr. Ferrera as well as historic photographs he had in his possession described this as being the location of the Park Hall. The Park Hall was constructed on wooden post foundations with a gangway that connected the building to the terraced level parking area that still exists to this day. Figure 46 shows where the gang way connected from the building to the terrace area. Due to the damage caused by the hurricane there is no other physical remnants of the Park Hall.

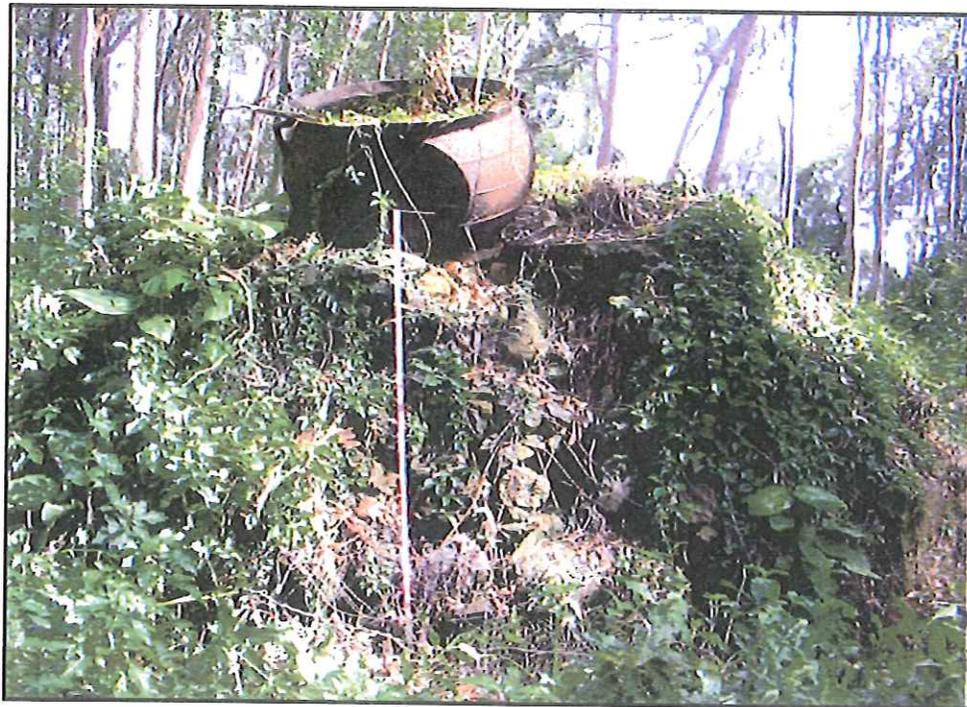
Figure 48. Site –3906 Feature H: Whaler’s try-works pot atop stone platform, view to east

A whaler's try-works pot was located in the wooded area in the eastern portion of the park, immediately north of the existing jogging path (see Figure 19). The large iron pot measured 120 cm in diameter and 65 cm high (Figure 48). The pot was flat on two sides with two handles on opposite sides. The whaler's pot was resting atop a three-tiered, stacked basalt boulder platform. The base of the platform measured 5.3 m by 6.3 m wide, with a maximum height of 175 cm. The boulders were loosely stacked, though cement was observed attached to some of the boulders, indicating they were reused from a destroyed historic structure. The whaler's pot was observed to be resting in a tilted position and appeared to be in danger of collapsing off of the platform without proper stabilization measures.

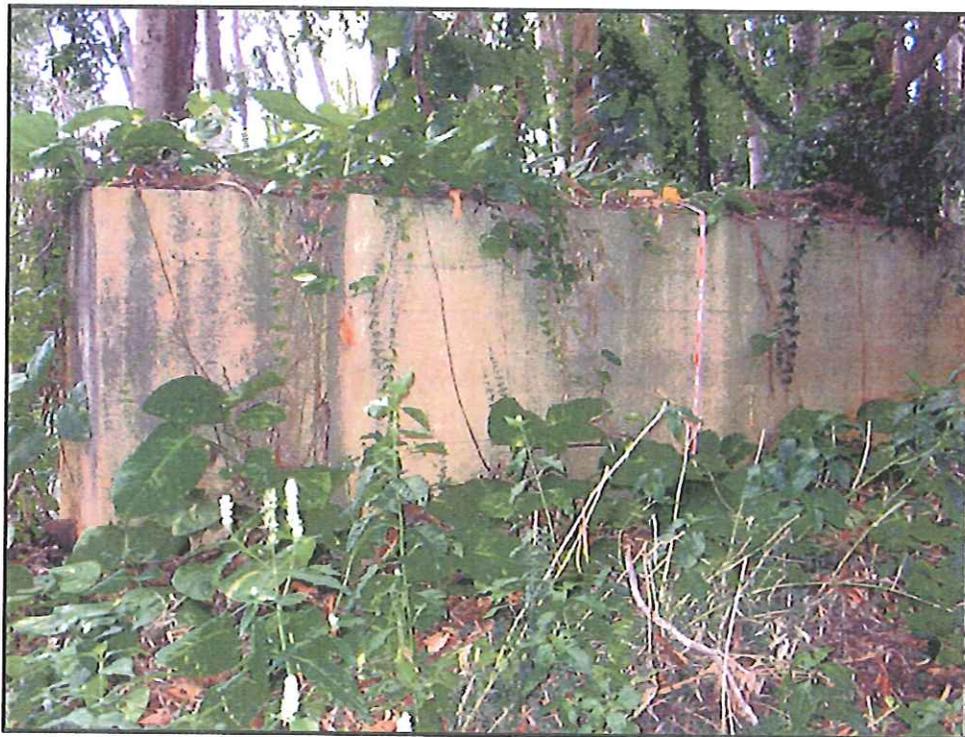
Figure 50. Site -3906 Feature J: Historic military infrastructure (sewage treatment), view to west

The structure is associated with the military occupation of the park during the 1940's and functioned as a sewage treatment facility directly associated with site 3906 feature J. The two features are located in close proximity to one another and have similar construction techniques.

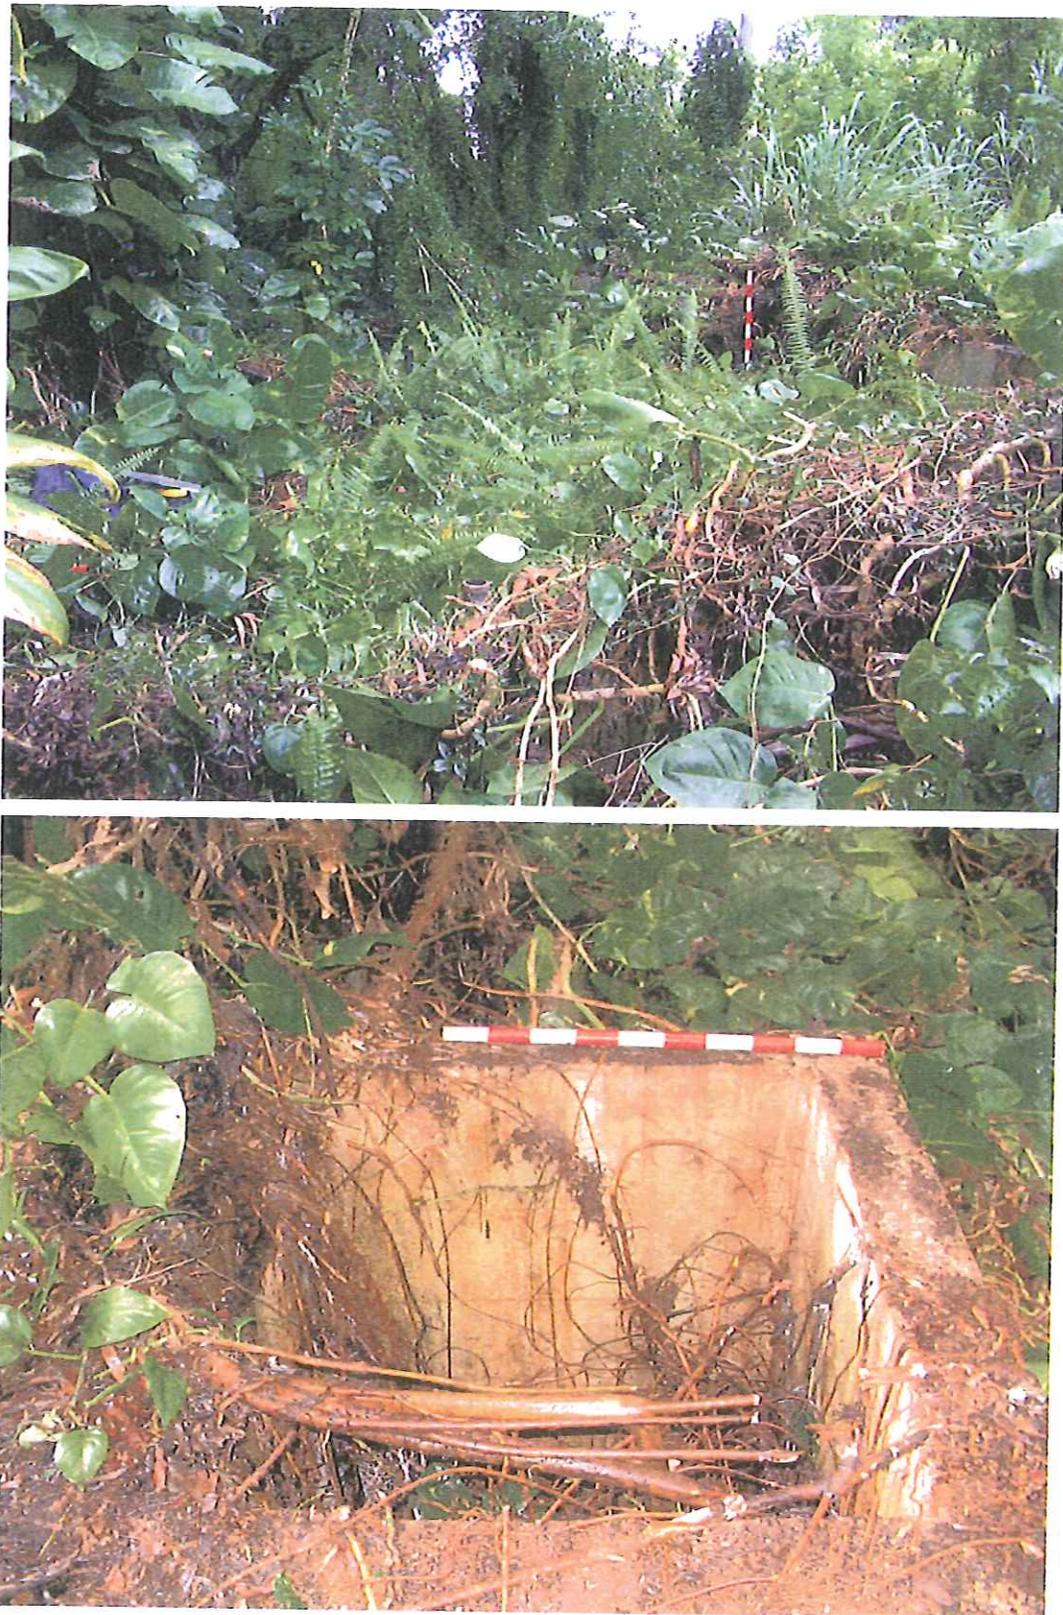
Figure 51. Site – 3906 Feature K: Historic military infrastructure (sewage treatment)

Approximately 20 m west of the historic military infrastructure feature J, is a large rectangular shaped concrete structure measuring approximately 11.2 m X 5.5 m (Figure 51). The structure is bisected in the middle with a low freestanding wall 30cm high creating two symmetrical enclosures. On the down slope side (east) is a square structure measuring approximately 1.2m square and 1.7m deep in the interior with standing water at the bottom (Figure 52). An iron ladder is constructed into the side of the wall. Two metal pipes and two clay

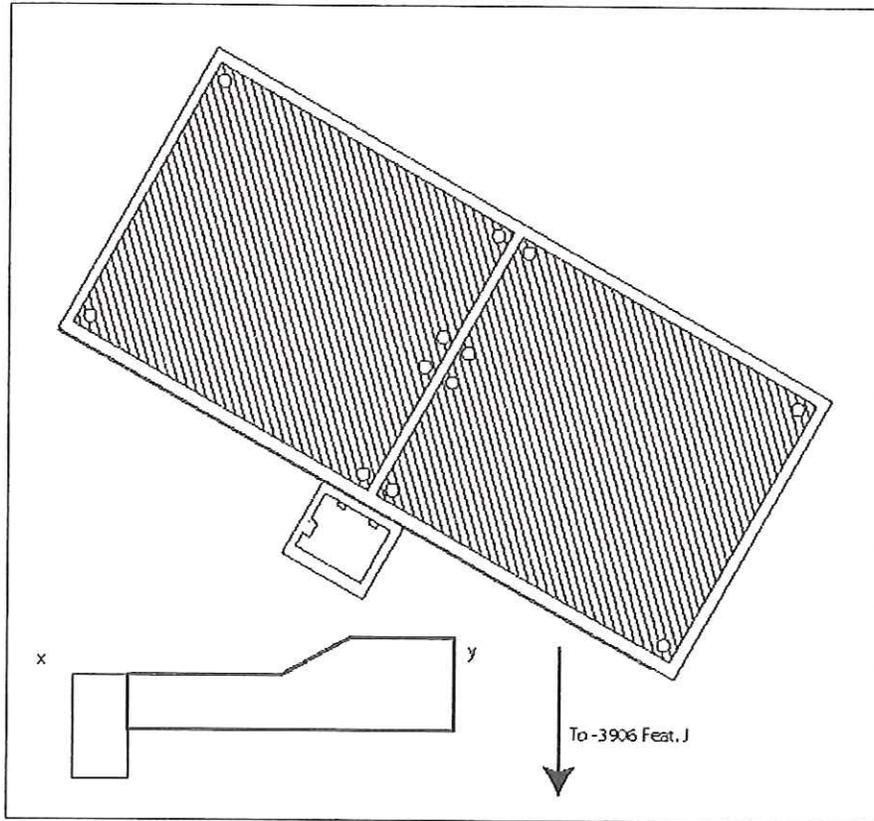
Figure 52. Sketch map of Site -3906 Feature K with profile

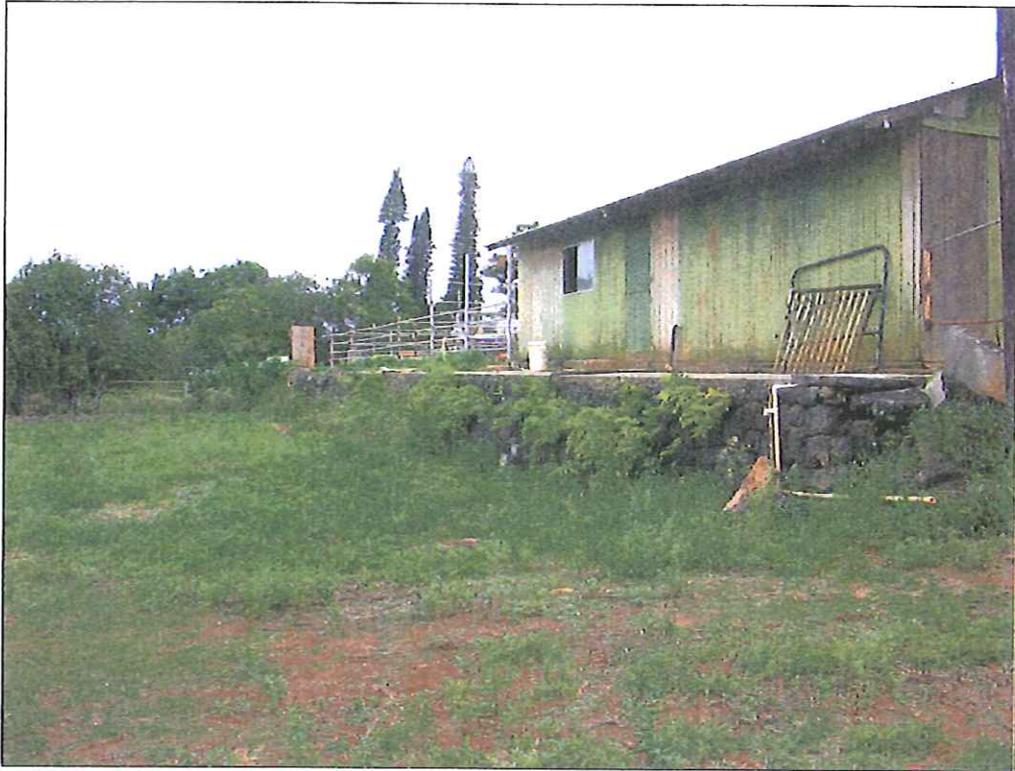
Figure 54. Site – 3906 Foundation for Kaua'i Pineapple Co. Terrace

Located at the northeast corner of the property adjacent to Papalina Rd. is a large concrete slab on top of a basalt boulder terrace facing stacked 5 levels high (Figure 54 - Figure 55). The platform is approximately 120' by 60'. Historic photos as well as community consultation indicate the concrete slab was a Kaua'i Pineapple Company work area. Currently a fishing boat and a large tool shed are on top of the concrete platform which is part of the Kukuioolono Park managers property.

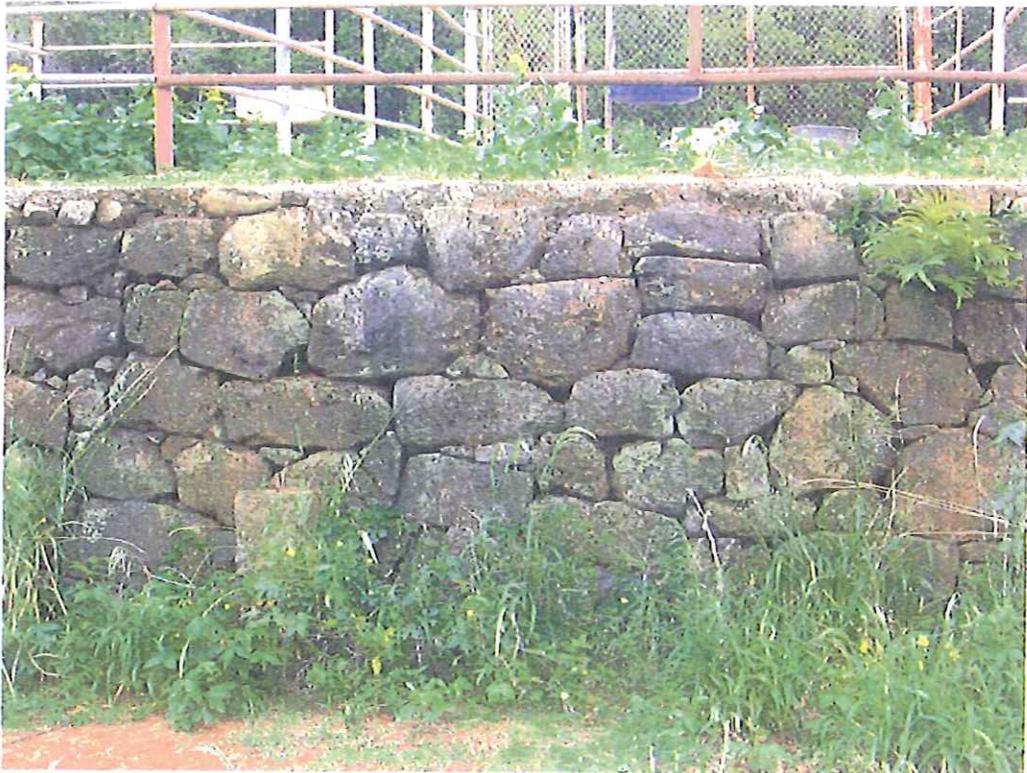
Figure 55. Site – 3906 Front of terrace for Kaua'i Pineapple Co. Terrace

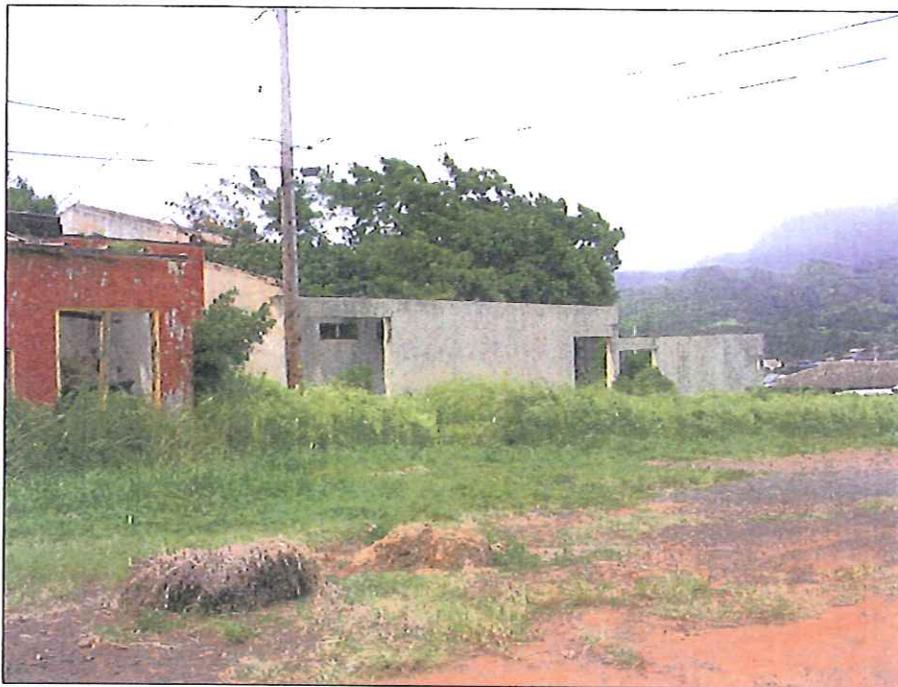
Figure 56. Site – 3906 Feature N Remains of Kaua‘i Pineapple Co. buildings

On the perimeter of the project areas boundary, located along Papalina Rd. are the remains of two structures understood as part of the Kaua'i Pineapple Company infrastructure (Figure 56). The first building located closest to the road is two-tiered with inside measurements of each level measuring approximately 17.7m X 10m. The function of this building according to anecdotal accounts was for storage, the large doorways elevated above the ground approximately 1m provides evidence to support these accounts as they are good indicators of a loading dock for a warehouse. The concrete building floors and exterior wall are all that remain.

The second structure is a two-story red painted building (Figure 56) measuring approximately 14m square. The second floor was partially collapsed to the first floor with little support for the remaining structure. Investigation from the exterior of the building suggests a habitation function based on what appeared to be a kitchen on the ground floor of the building.

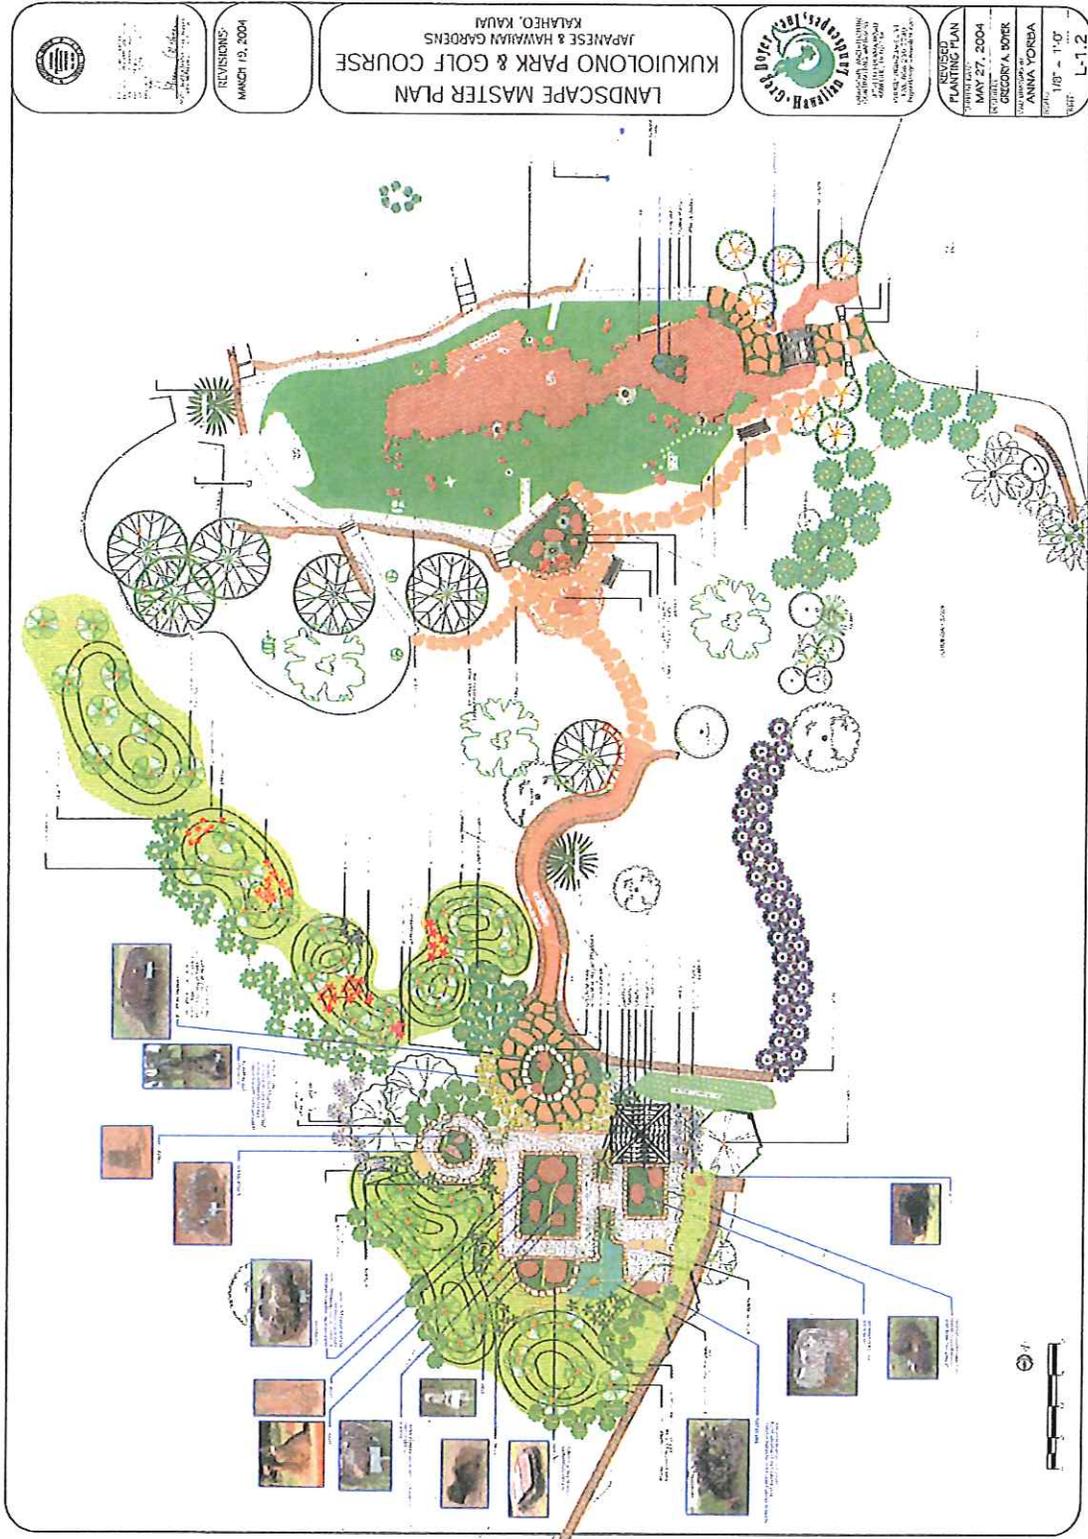
Figure 60. "Landscape Master Plan: Kukuilolo Park & Golf Course" (Greg Boyer Hawaiian Landscapes, Inc.), Showing Proposed Landscaping Improvements in the Vicinity of Site -3907: Hawaiian Artifacts Collection

Relatively substantial improvements are proposed for the Hawaiian artifacts collection (Site -3907) (Figure 60). Major proposed improvements involve the repositioning of the stones comprising the Hawaiian artifacts collection. Each of the stones would be moved into small groups of 2-5 stones bordered by stone edgers, creating a buffer between the artifacts and the viewing public. A system of gravel-paved pathways would also be constructed between the groups of artifacts in the collection. In addition, proposed landscaping improvements include new plantings of various lawn grasses, shrubs, and trees, and the construction of a small thatched *hale* (house). In all, the Hawaiian artifacts had been previously relocated to Kukuiolono Park by Walter D. McBryde, and are not in their original historical locations. Therefore, the relocation of the artifacts within the Hawaiian artifacts collection would not detract from the integrity of the historical features.

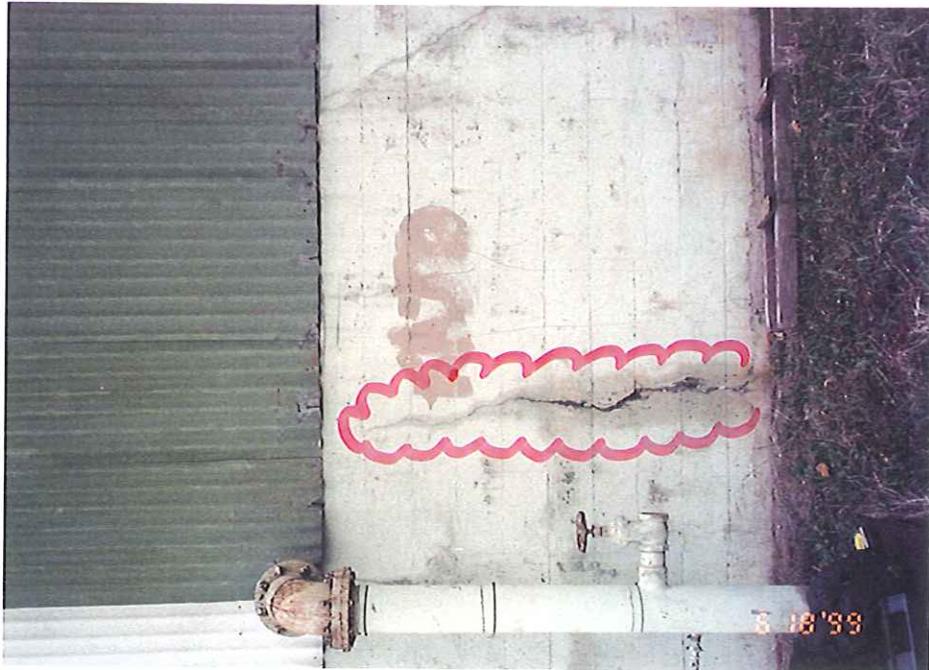
PHOTO 1: West Wall

Large Crack

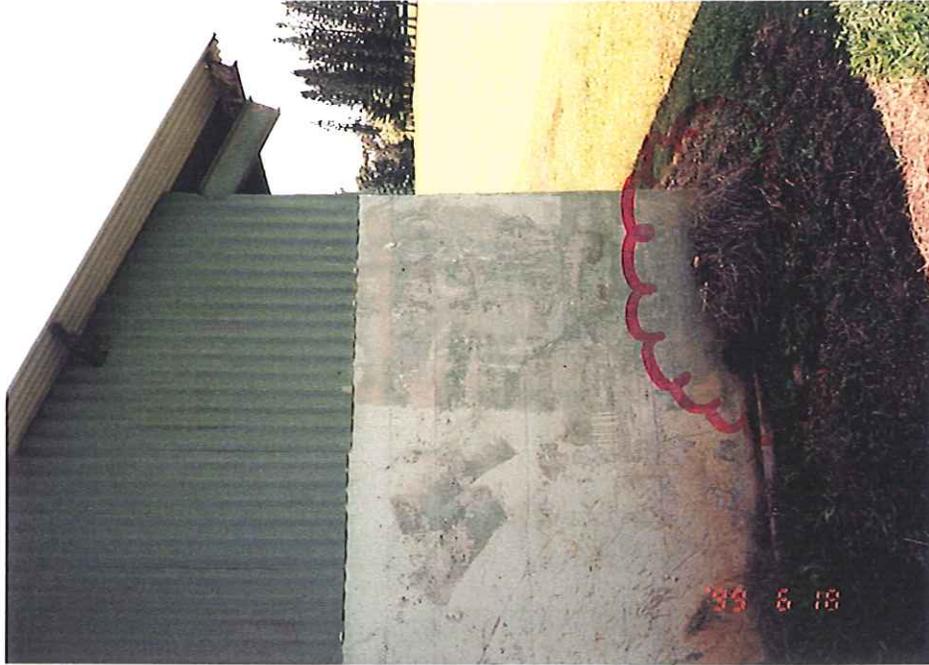
PHOTO 2: West Wall

Ponding in corner

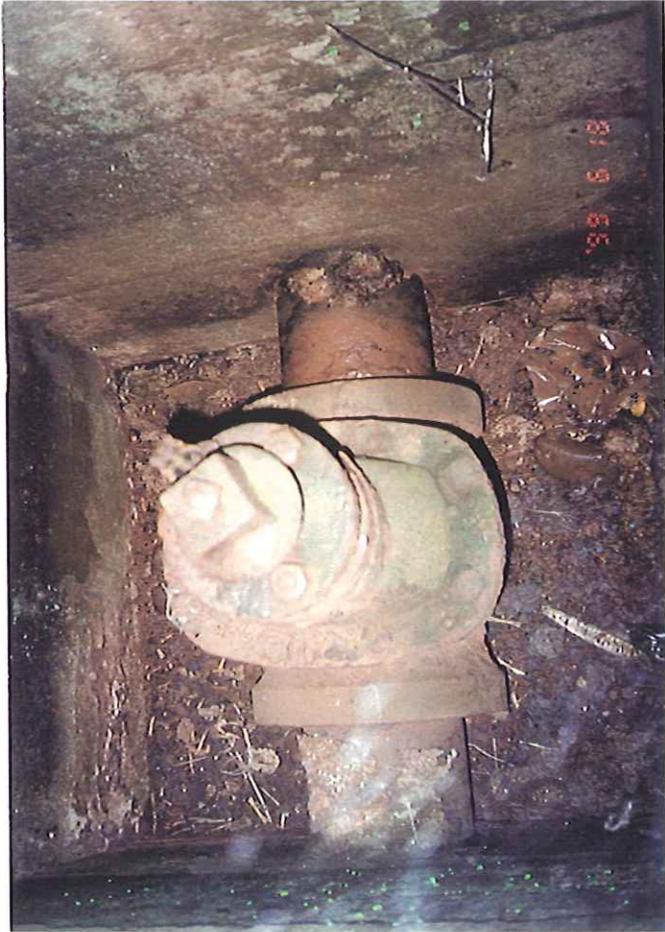
PHOTO 3: West Wall
6" Gate Valve in Box

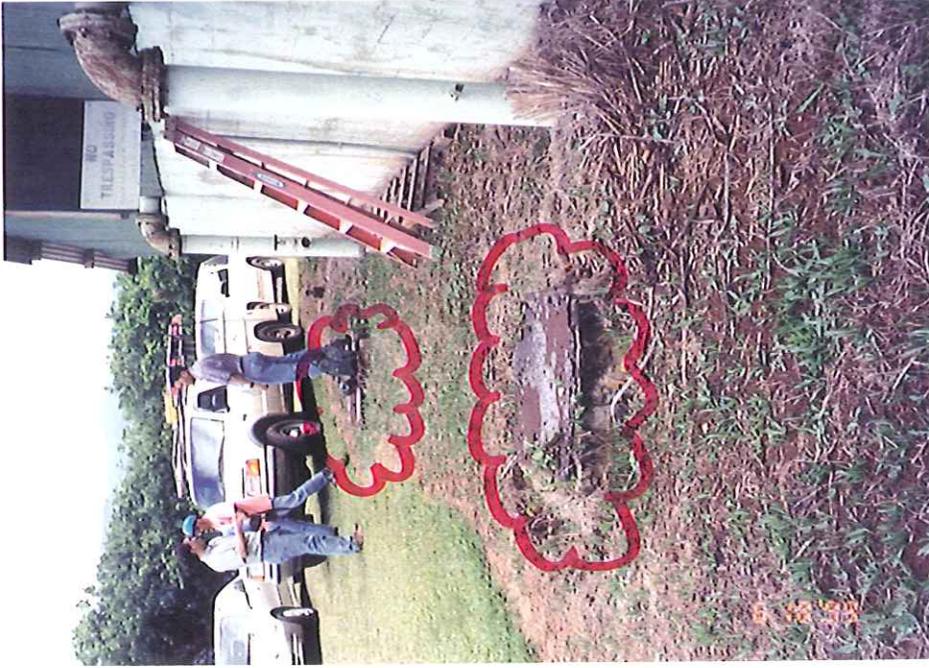
PHOTO 4: West Wall
Rusted Box Covers and 8" Gate Valve

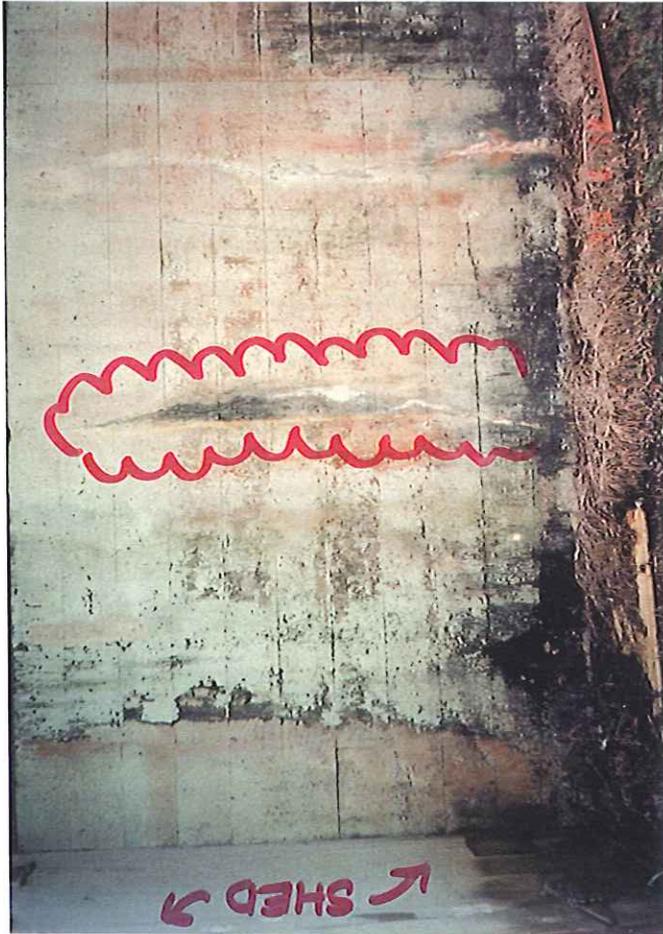
PHOTO 5: North Wall
Large Crack

- There is one large crack that runs along the height of the north wall. It is wet to the touch and shows signs of algae growth (**Photo 5**). The soil next to the wall and directly below the eaves is saturated with water. This saturation may be due to storm runoff from the roof or from tank leakage (**Photo 6**).

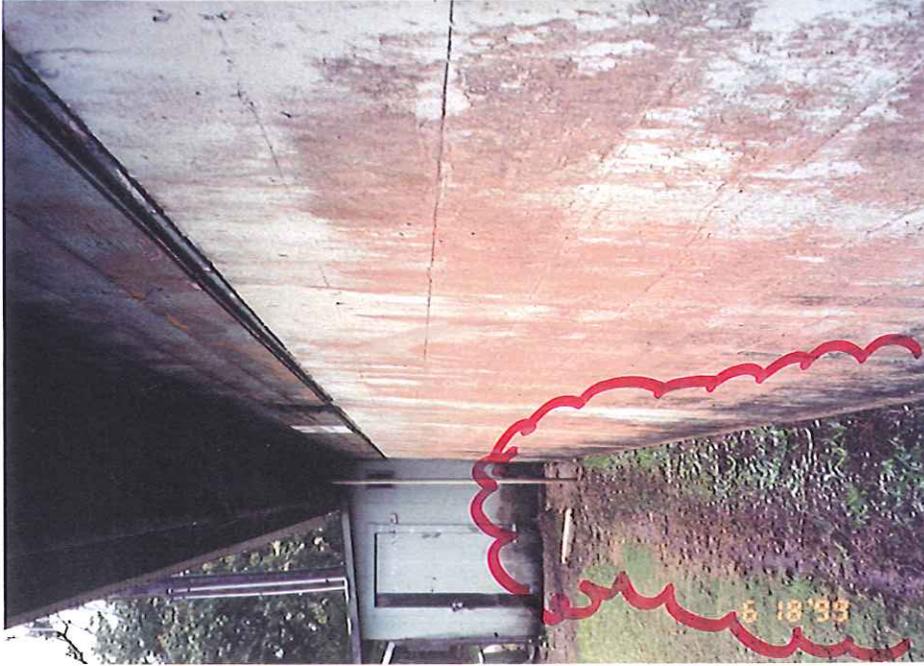
PHOTO 6: North Wall
Saturated Soil Next to Wall

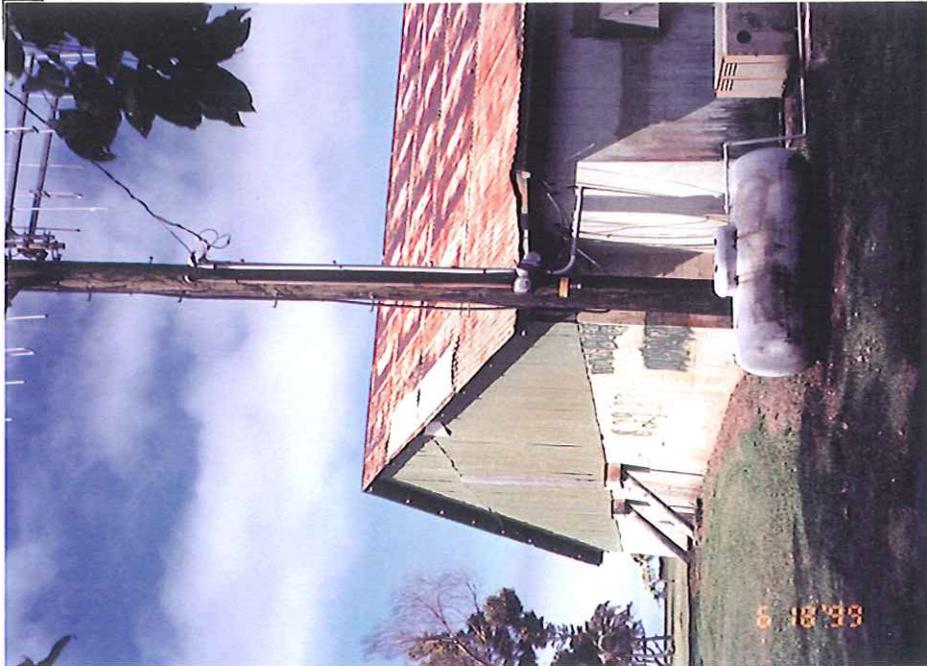
PHOTO 8: East Wall
Overview

- An overview of the east wall is shown in **Photo 8**. There is one large crack on the east wall, near the northeast corner of the building. This crack runs a short length along the bottom of the structure (**Photo 9**). It is slightly wet to the touch, and shows signs of algae growth (**Photo 10**).

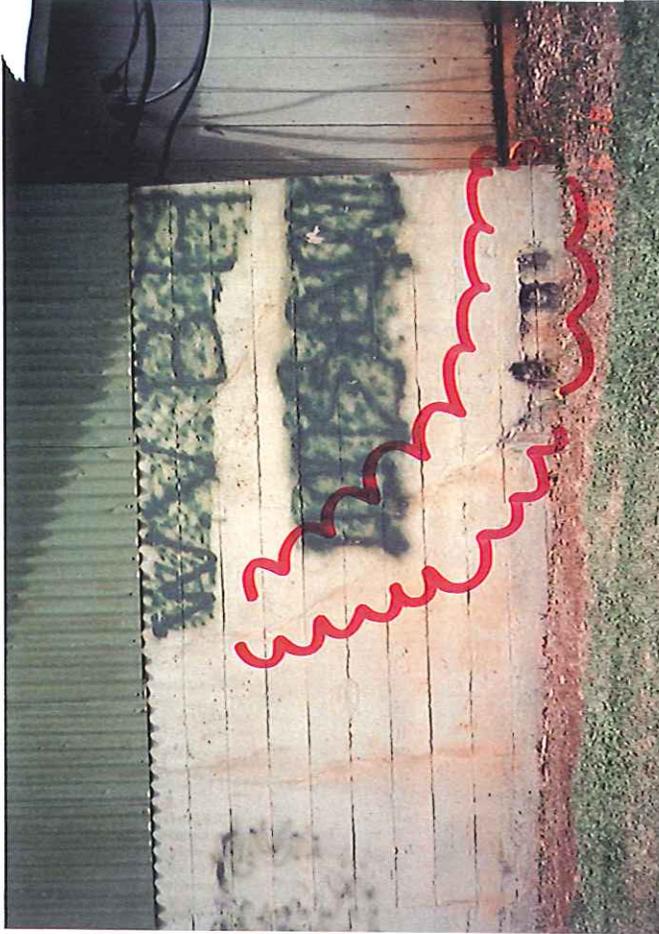
PHOTO 9: East Wall
Large Crack

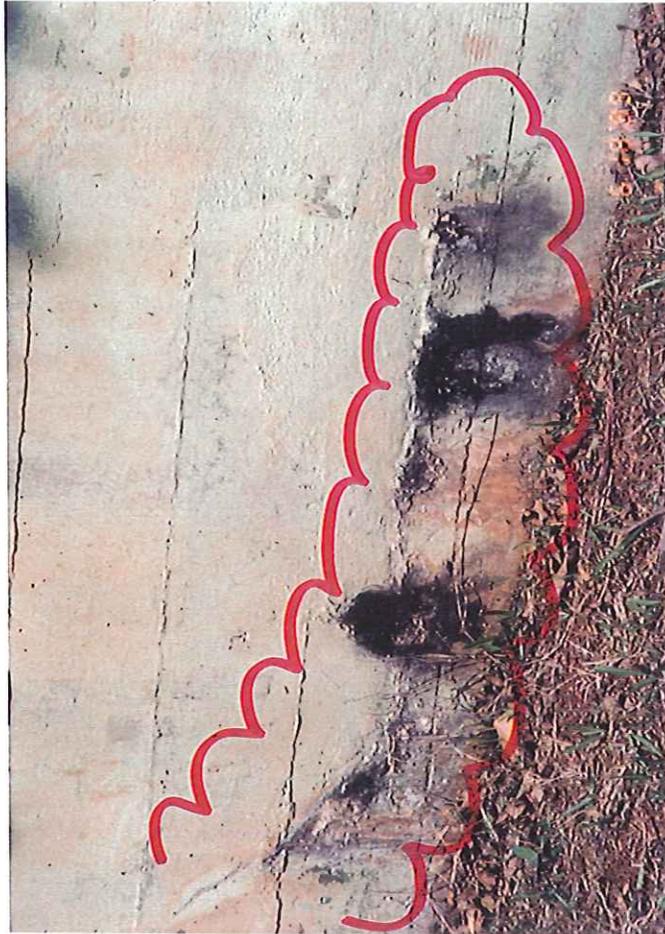
PHOTO 10: East Wall
Large Crack with Algae Growth

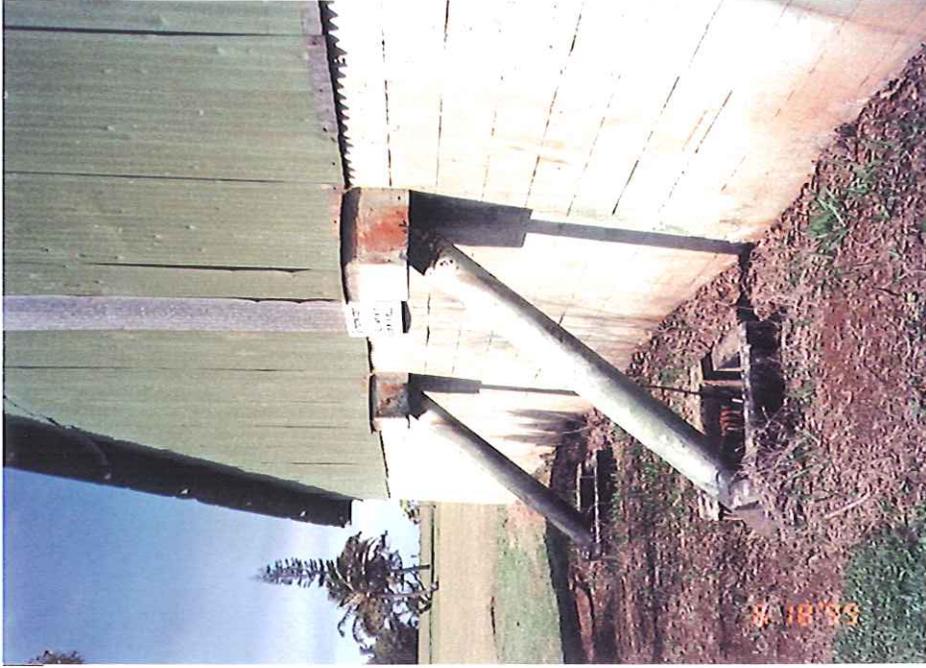
PHOTO 11: East Wall
Overview of Overflow Lines

- The two 6-inch steel overflow pipes that protrude from the east wall are rusted on the surface (**Photo 11** and **Photo 12**). The overflow pipes penetrate the ground at the location of two uncovered valve boxes that house two 6-inch valves along the outflow pipe. Vegetative growth and other debris were found in the valve boxes.
