SUBJECT: DRAFT ENVIRONMENTAL ASSESSMENT FOR KUKUIOLONO 0.5 MG TANK, KALĀHEO, KAUA'I, HAWAII. TMK: (4) 2-3-05: Por. 02, 06, and 25

The Kauai County Department of Water (DOW) hereby transmits the draft environmental assessment and anticipated finding of no significant impact (DEA-AFONSI) for the Kukuiolono 0.5 MG Tank situated at (4) 2-3-05: Por. 02, 06, and 25, in the Kalāheo District on the island of Kaua'i for publication in the next available edition of the Environmental Notice.

KUKUIOLONO 0.50 MG, 866' TANK
 JOB NO. 11-09, K-05A
 Kalāheo, Kaua'i, Hawai'i

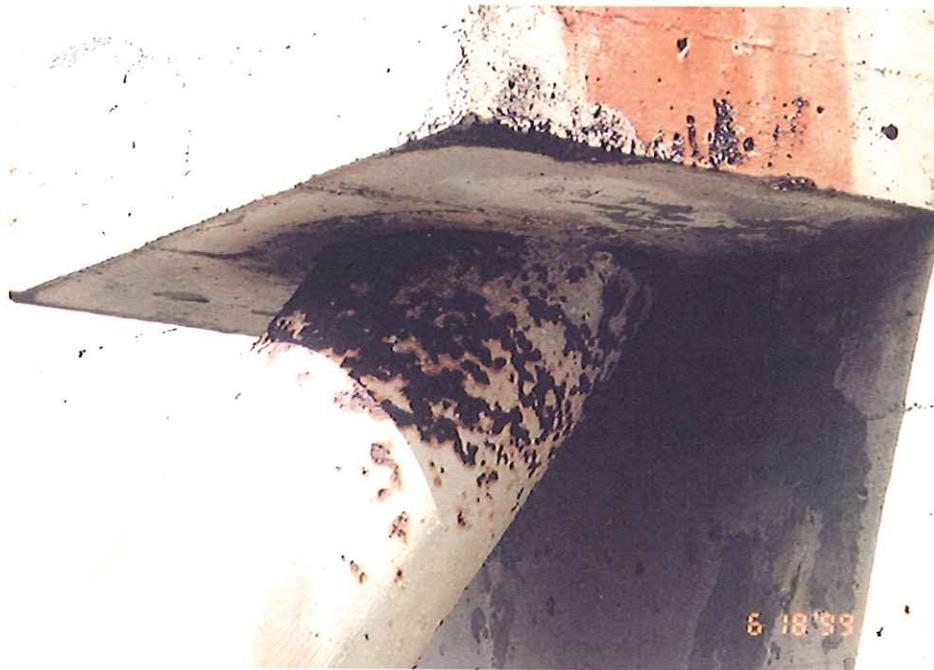
PHOTO 12: East Wall
Rusted Pipe Surface

- The two 6-inch steel overflow pipes that protrude from the east wall are rusted on the surface (**Photo 11** and **Photo 12**). The overflow pipes penetrate the ground at the location of two uncovered valve boxes that house two 6-inch valves along the outflow pipe. Vegetative growth and other debris were found in the valve boxes.

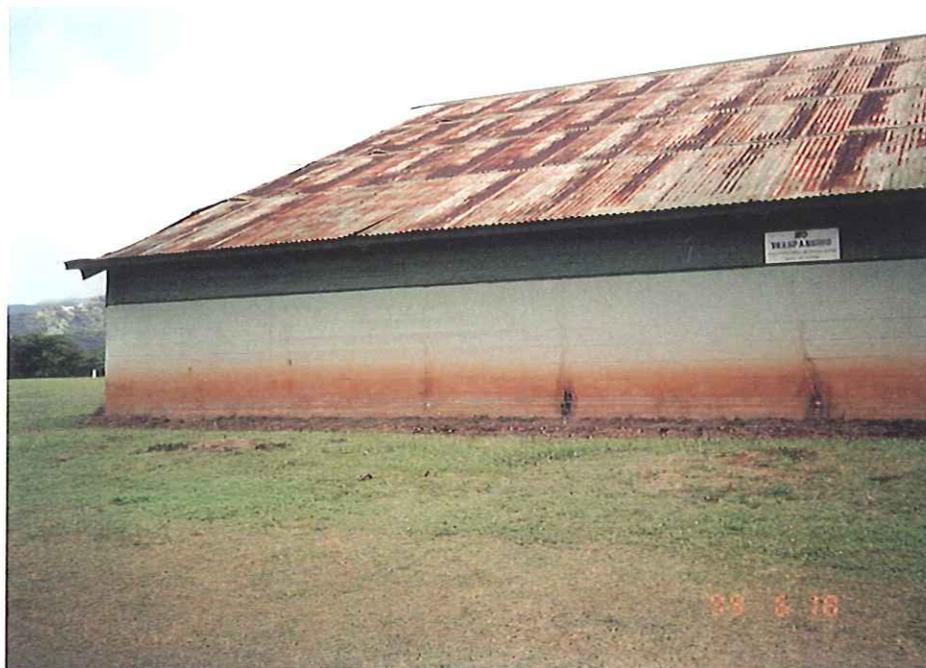
PHOTO 13: South Wall
Overview

- Although there are no large cracks along the south wall, there are various small, hairline cracks along the height of the wall (**Photo 13**). These cracks were dry to the touch. The soil next to the wall and directly below the eaves is saturated with water. This saturation may be due to storm runoff from the roof or from tank leakage (**Photo 14**).

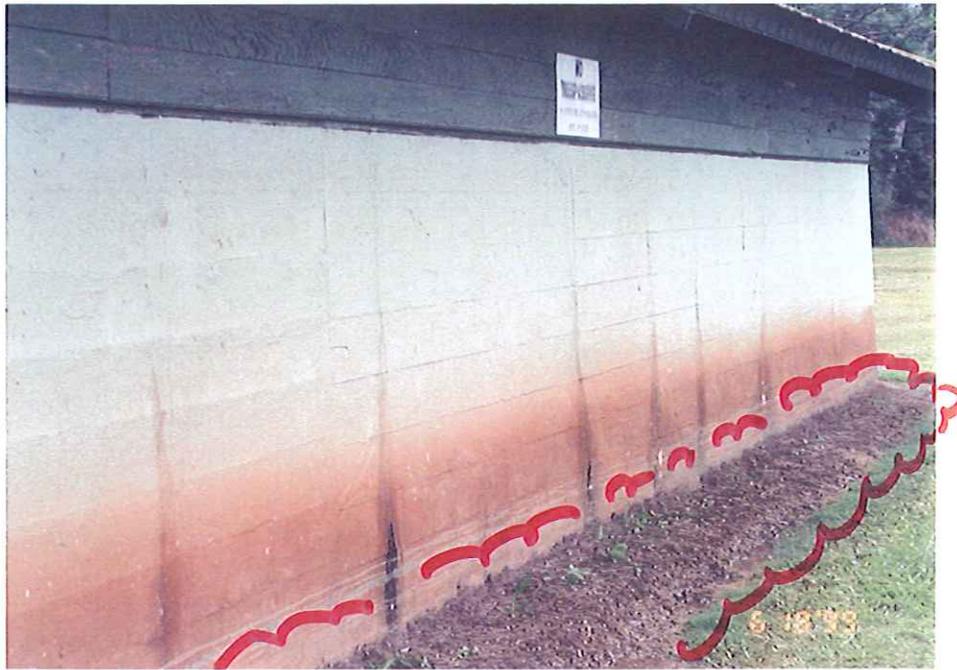
PHOTO 14: South Wall
Saturated Soil Next to Wall

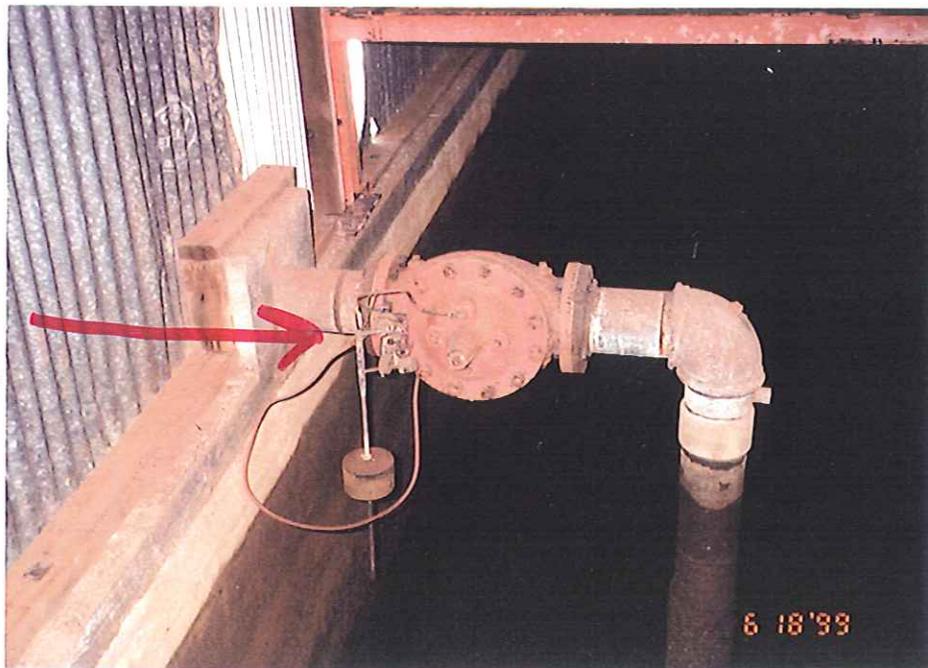
PHOTO 15: Interior
6" Influent Line with Control Valve

- The observation of the tank interior was taken from above the water surface along the common wall (dividing the tank into two compartments).
- The interior tank walls are unlined and relatively clean. Various hairline cracks were observed on the surface of the tank walls. A light film of scum and settlement are observed in the water. Rust and settled dust were also observed floating on the water surface. Algae was found growing on the tank floor. The corrugated metal roof and steel trusses were noticeably rusted and covered with dust.
- The 6-inch inlet piping was verified for the left tank compartment (**Photo 15** and **Photo 16**). The piping, control valve, and fittings were found to be in satisfactory condition for short-term use. The inlet piping for the right compartment was observed without a control valve (**Photo 17**).

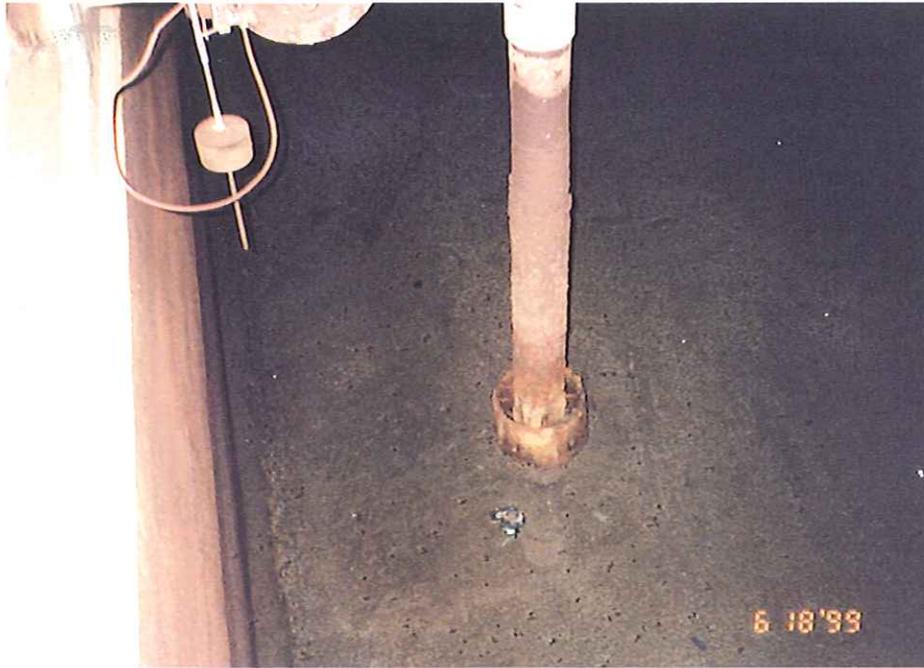
ALGAE
&
SEDIMENT

PHOTO 16: Interior
Influent Piping

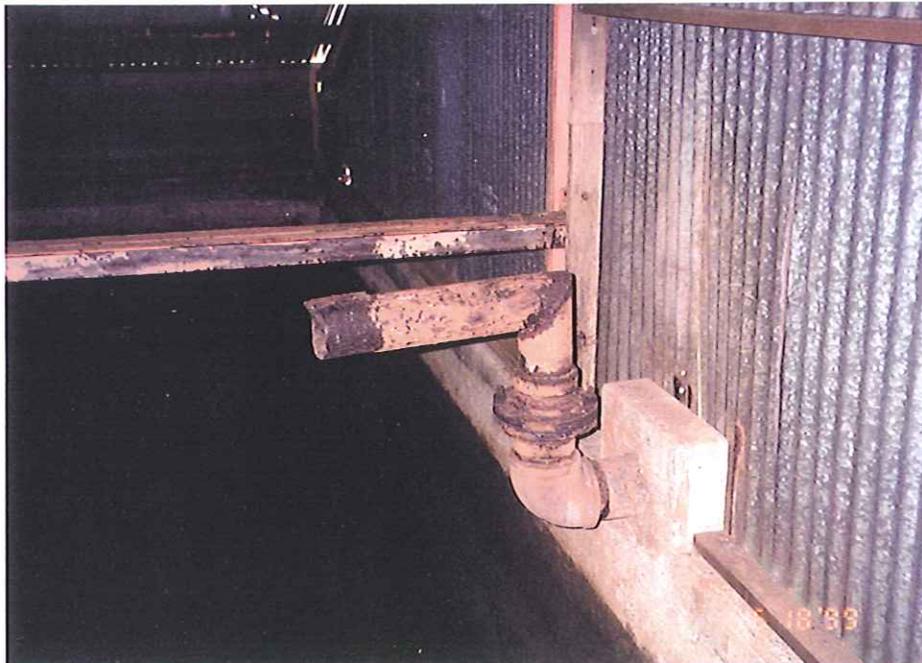
PHOTO 17: Interior
Influent without Control Valve

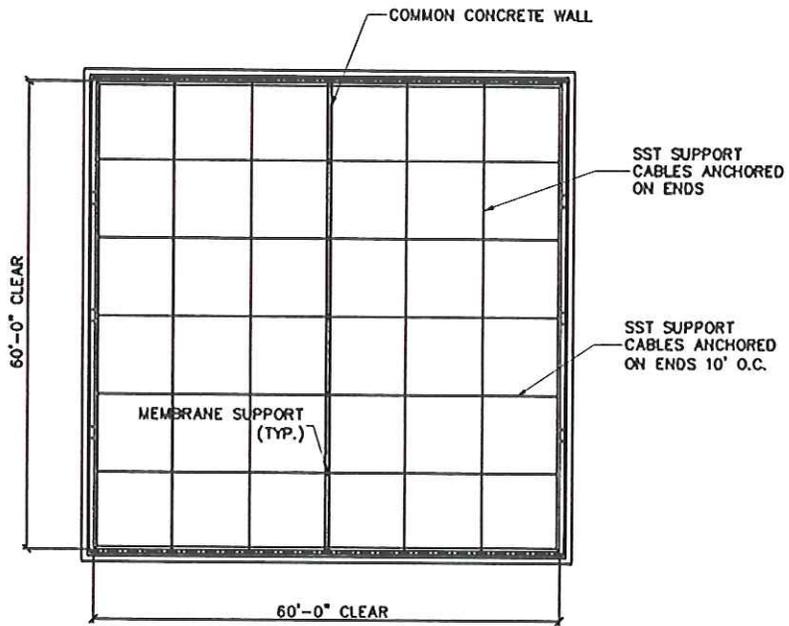
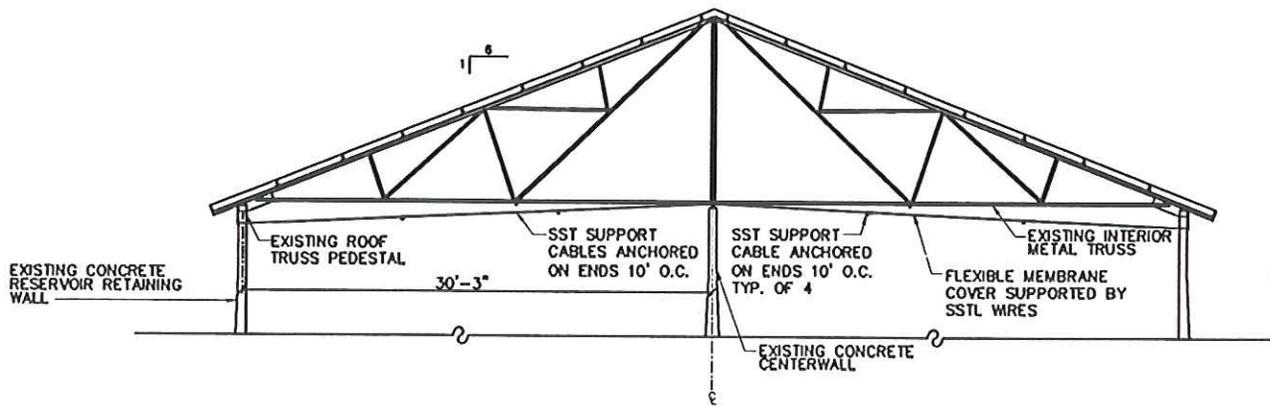
Figure 3
PROPOSED REMOVABLE MEMBRANE COVER

PLAN
SCALE: NTS

CROSS SECTION
SCALE: NTS

It is also suggested to attach a removable membrane cover to the walls of the tank and to drape it over wires strung up from wall to wall above the water surface so that the water is protected from dust and other debris. A drawing of the proposed membrane cover is presented in **Figure 3**. The paint and oxide flakes on the steel roof trusses should be removed. The existing interior and exterior piping are in satisfactory condition for short-term use. All existing isolation valves should be inspected by DOW and exercised on a six-month interval or more frequently as needed.

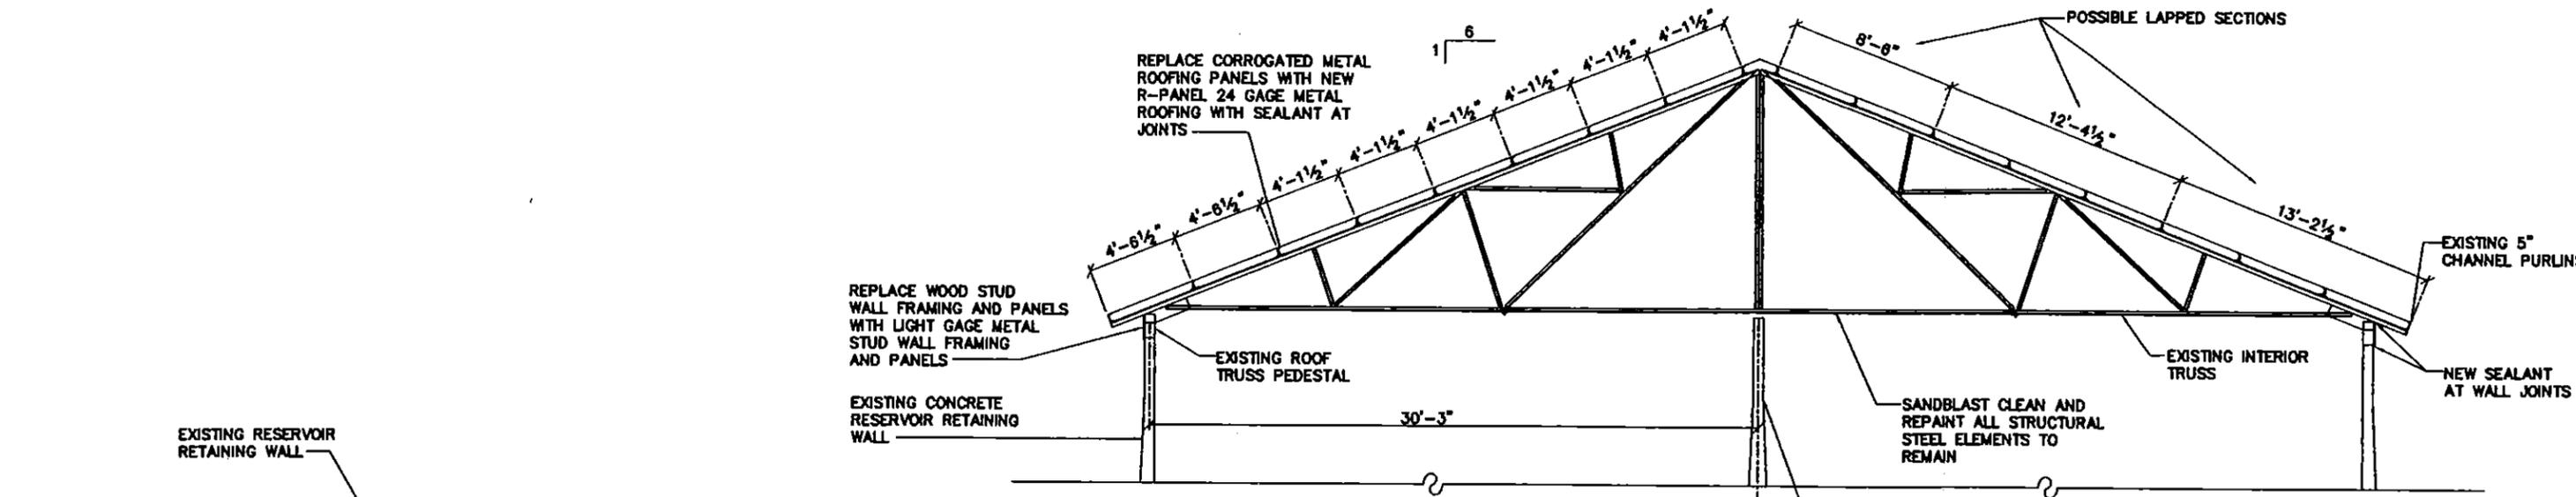
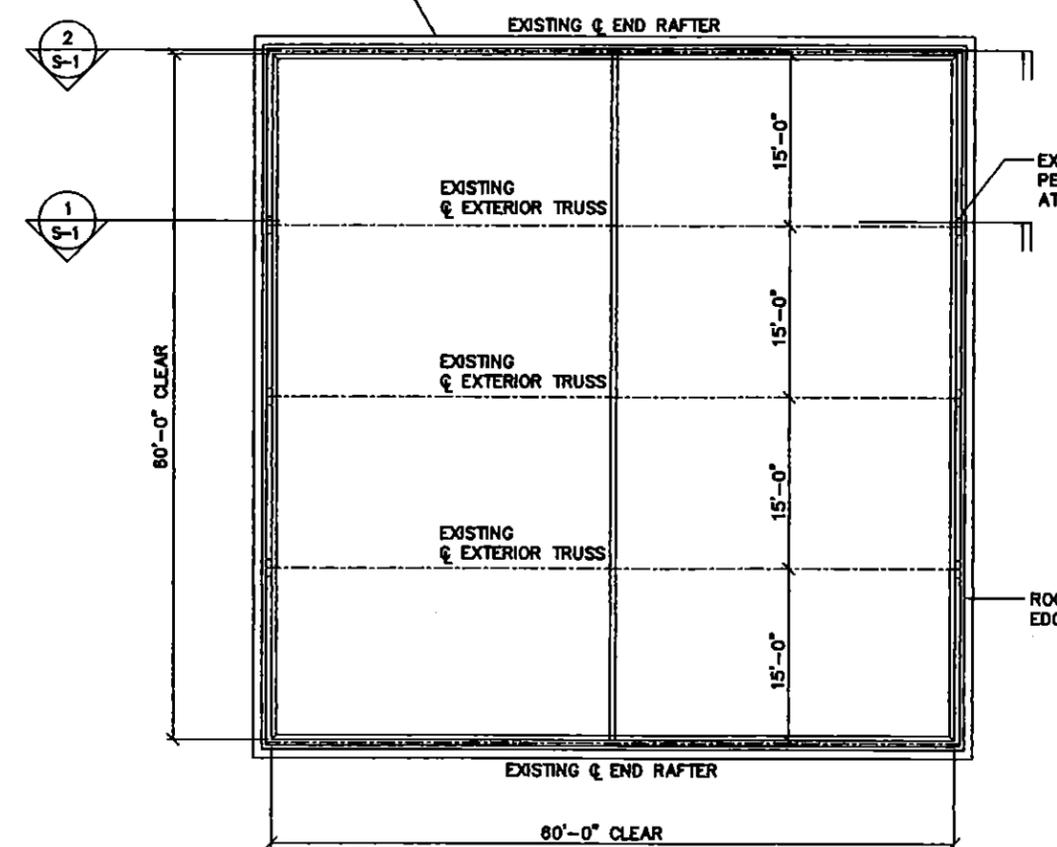
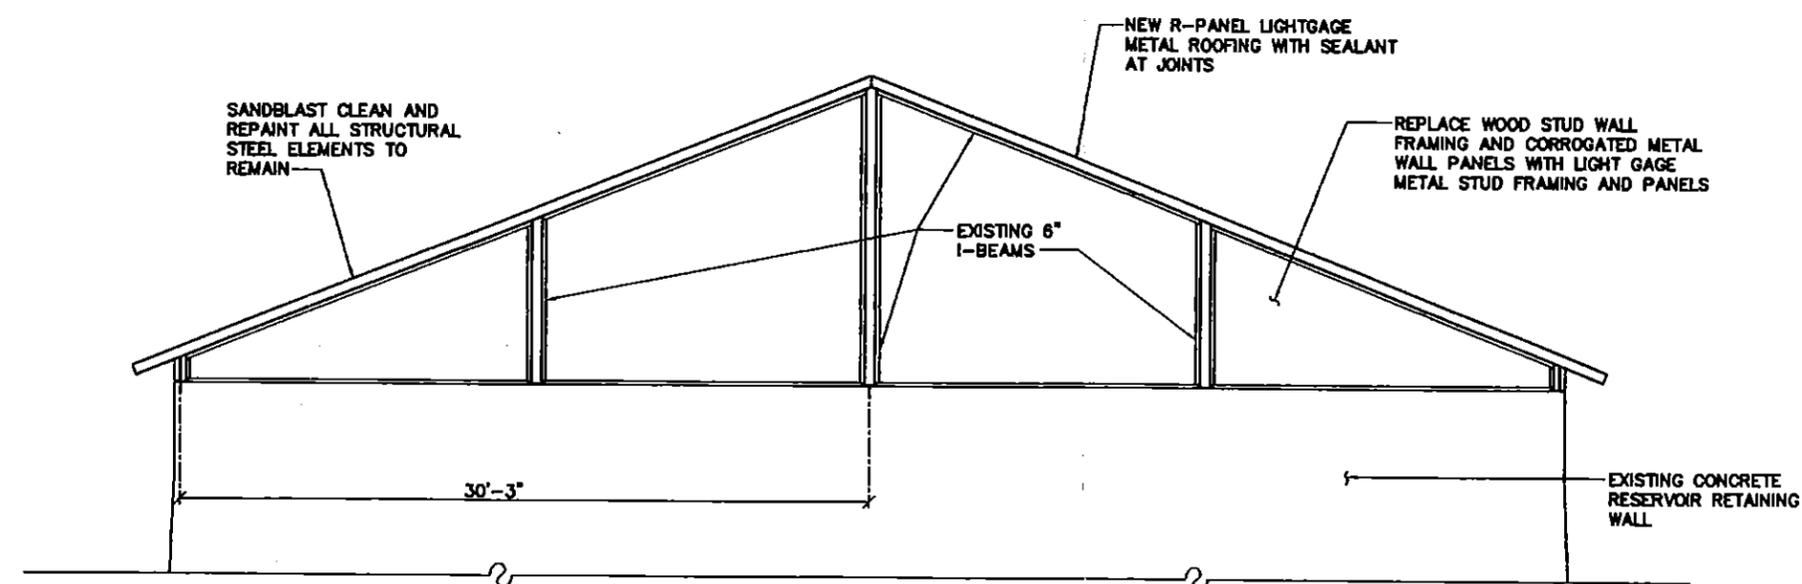
1 SECTION AT INTERIOR TRUSS
SCALE: 1/4"=1'-0"

2 SECTION AT END RAFTER
SCALE: 1/4"=1'-0"

- Remove corrosion by sandblasting and repaint all structural steel elements.
- Remove and replace all corrugated steel roof panels with new light gage metal roof panels.
- Remove and replace all wood wall stud framing and corrugated steel and wood wall paneling with new light gage steel studs and panels.
- Seal panel and wall/roof interface joints.
- Install new watertight and lockable manhole entry at the gabled end of the tank, at the same location as original entry.
- Epoxy inject concrete wall cracks. Alternatively, waterproofing the inside face of the reservoir should address water infiltration through the cracks in the concrete walls.

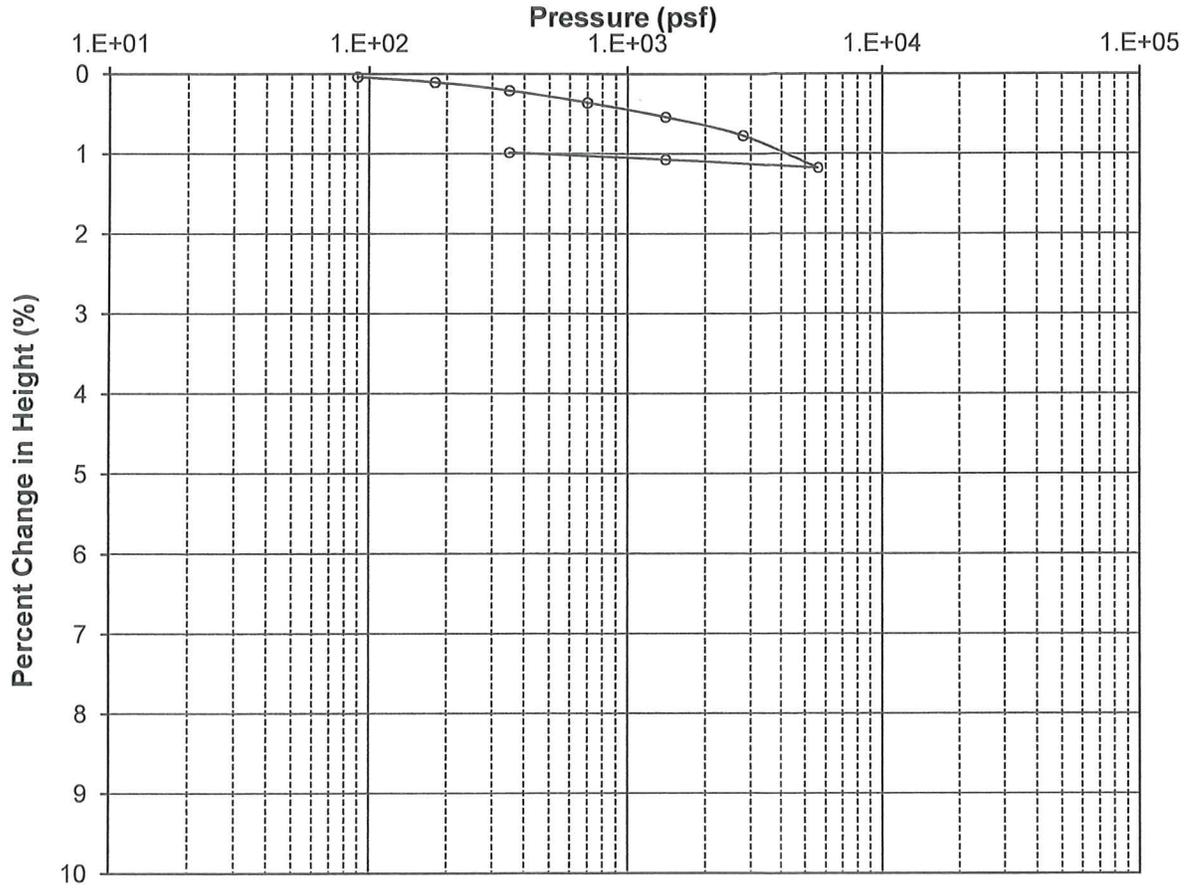
Plate B2.2

Consolidation Test Results

Boring No.: B2 Depth (ft): 5
 Soil Description: Reddish brown clayey silt

Moisture Content (%)	Dry Density (pcf)
Initial	43.0	72.0
Final	41.5	72.7

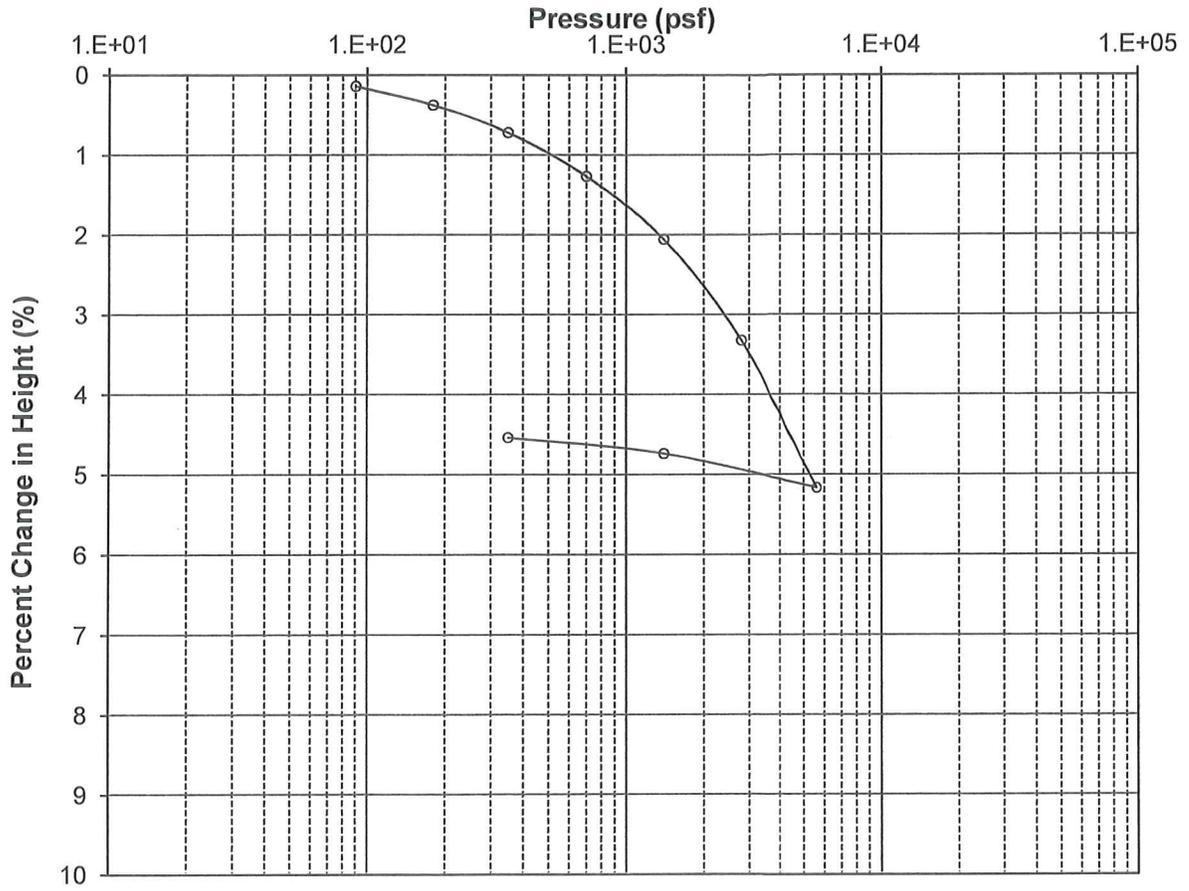
Plate B2.3

Consolidation Test Results

Boring No.: B3 Depth (ft): 5
Soil Description: Reddish brown clayey silt

Moisture Content (%)	Dry Density (pcf)
Initial	54.0	67.0
Final	46.0	70.2

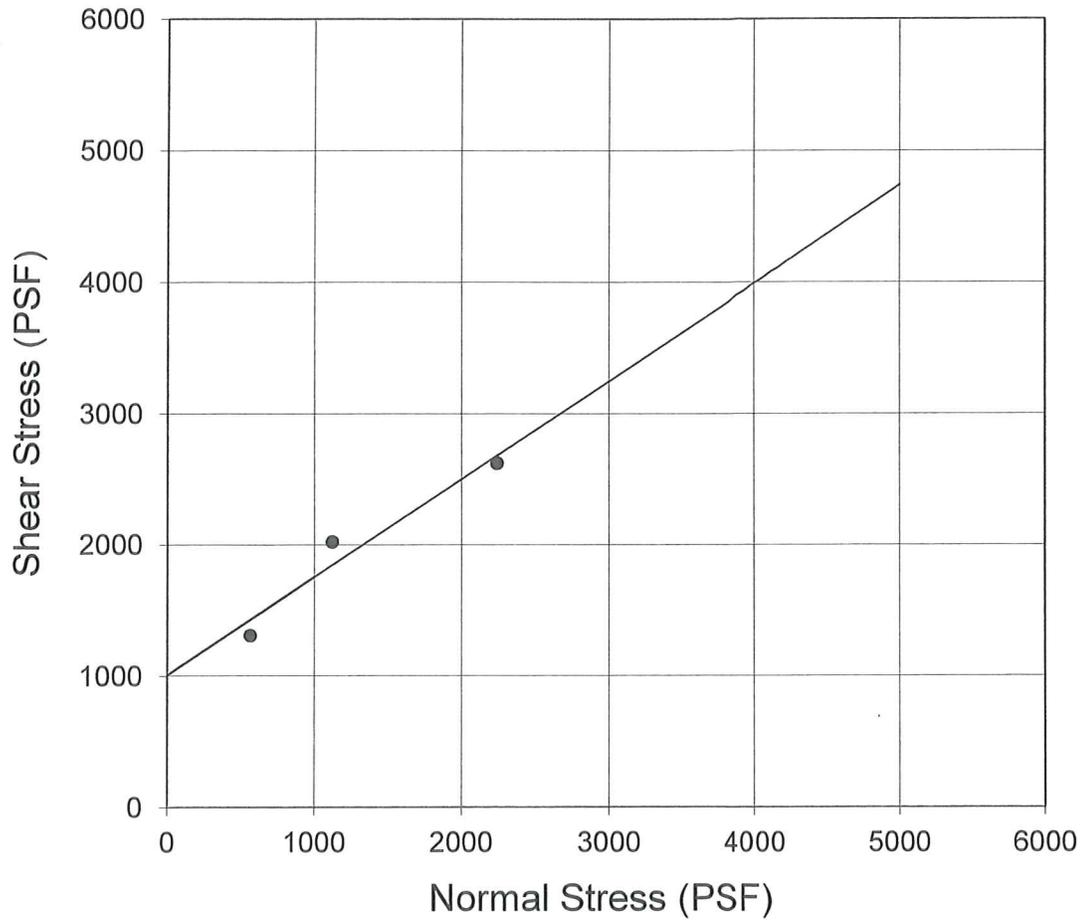
Plate B3.2

Direct Shear Test Results

Boring No.: B4	Depth (ft): 4	
Soil Description: Reddish brown clayey silt		
Strength Intercept (C): 1009.9 PSF		(Peak Strength)
Friction Angle (ϕ): 36.7 DEG		(Peak Strength)

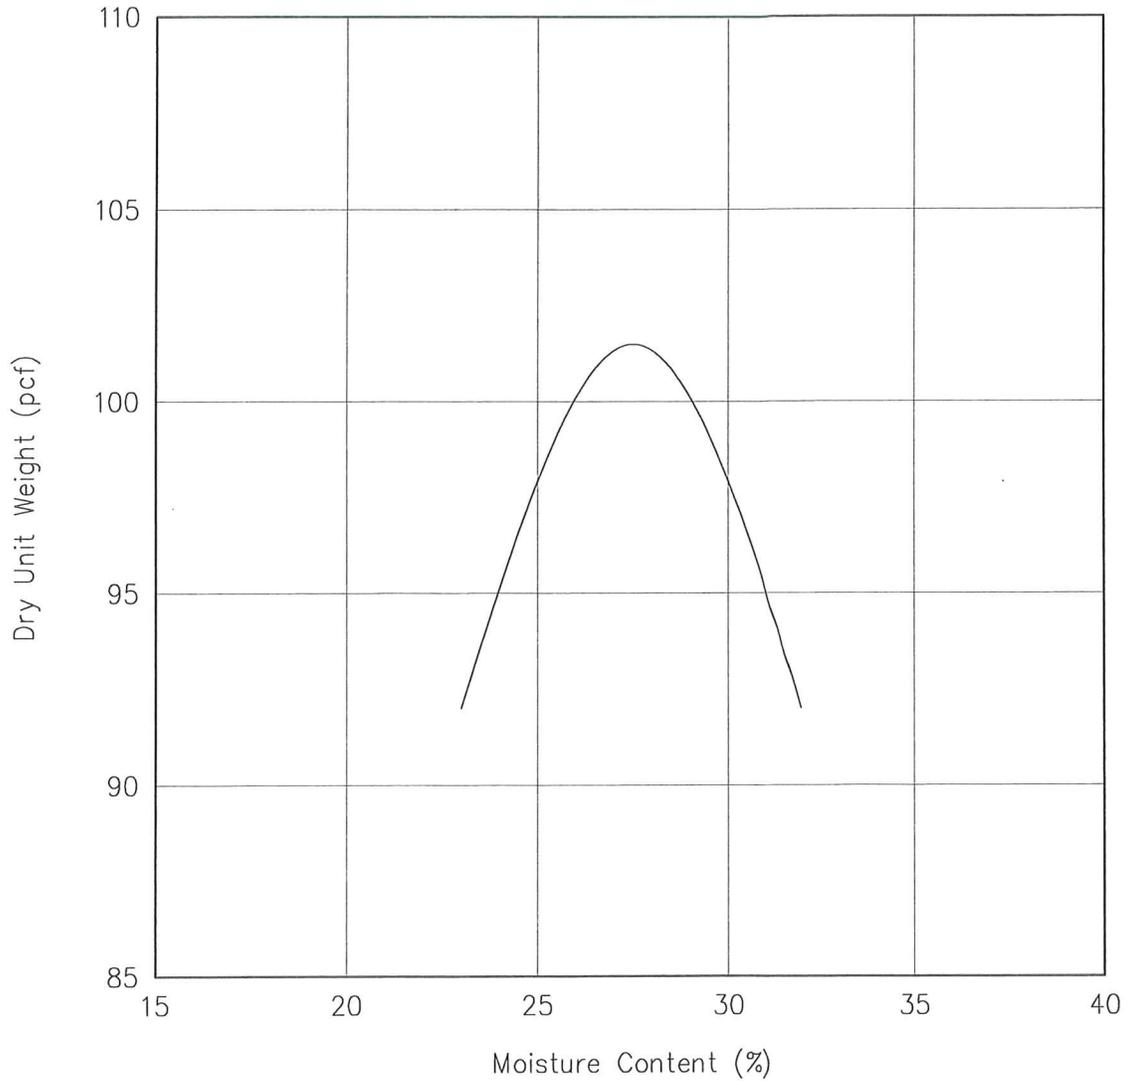
Plate B4.1

Location: Boring B2 between 0.5 and 2 feet

Optimum Moisture Content: 27.5%

MODIFIED PROCTOR CURVE

A Modified Proctor test was performed on a bulk sample, obtained from boring B2 at depths of about 0.5 to 2 feet, in general accordance with ASTM D 1557. The test is used to determine the optimum moisture content at which the soil compacts to 100 percent density. Results are shown on Plate B4.1.

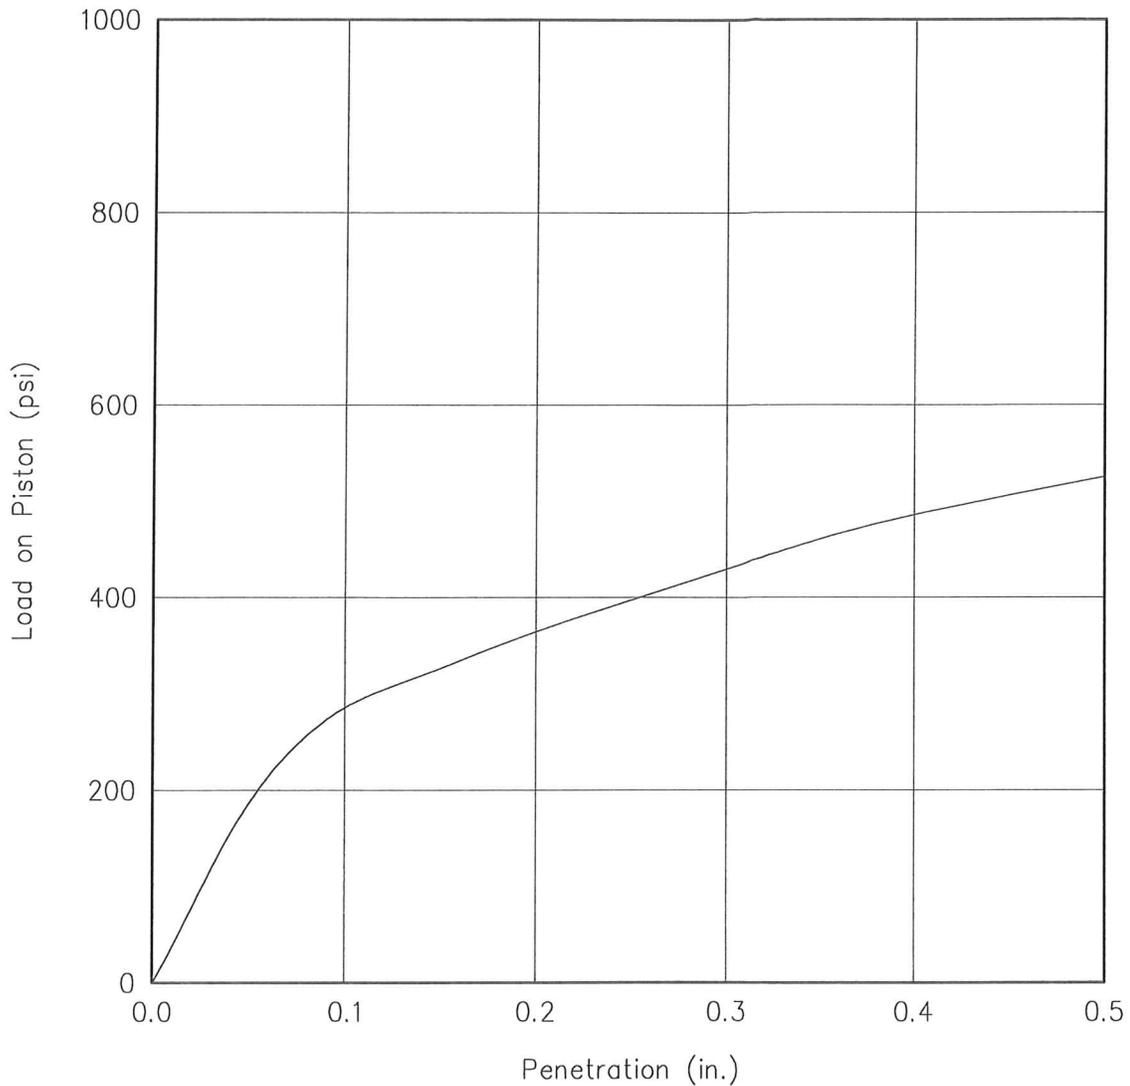
Location: Boring B2 between 0.5 and 2 feet
 Description: Reddish brown clayey silt
 Sample Dry Density: 95.5 pcf
 Sample Moisture Content: 30%
