**HANA RAMP – IMPROVEMENTS TO
ROCK REVETMENT AND BOAT RAMP
LOADING DOCK, MAUI**

**FINAL ENVIRONMENTAL ASSESSMENT and
FINDING OF NO SIGNIFICANT IMPACT (FONSI)**

**State of Hawaii, Department of Land and Natural Resources:
Division of Boating and Ocean Recreation**

Sea Engineering, Inc.

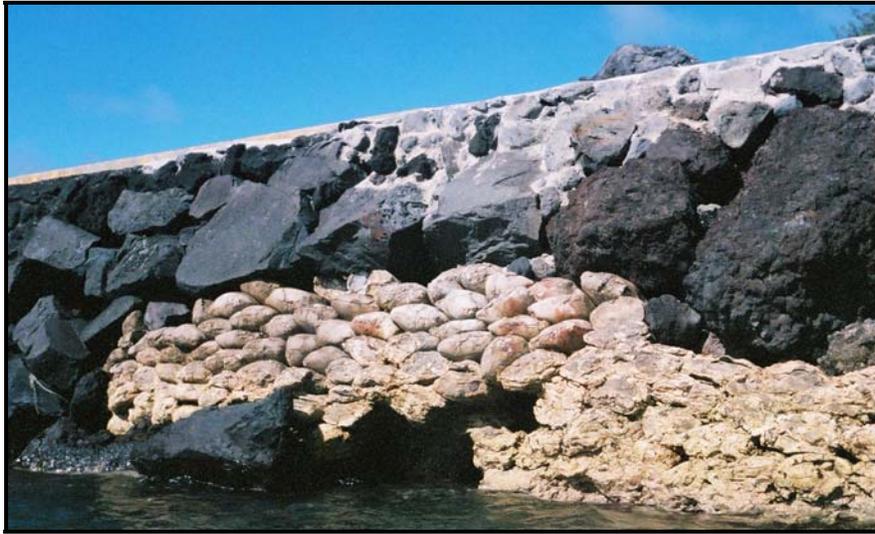
Figure 2.1 CRM and Grout Bag Repairs in the Breakwater

Recent repairs are evident on the crest of the breakwater, extending down both sides. These repairs are constructed from cemented rubble masonry (CRM). Other previous repairs types include the use of grout bags to pack voids in the breakwater. Figure 2.1 shows typical breakwater repairs.

The boat ramp facility is in the lee of the short but massive breakwater. Hana Breakwater is a large masonry and rubble mound structure that forms a narrow salient on the southeast end of Hana Bay (see Figures 2.1 and 2.3). The salient provides modest protection from prevailing trade wind waves for the launch ramp and existing loading dock. The breakwater transitions to Hana Wharf, a large concrete pile-supported pier. The wharf is in a state of extreme disrepair and is not considered safe.

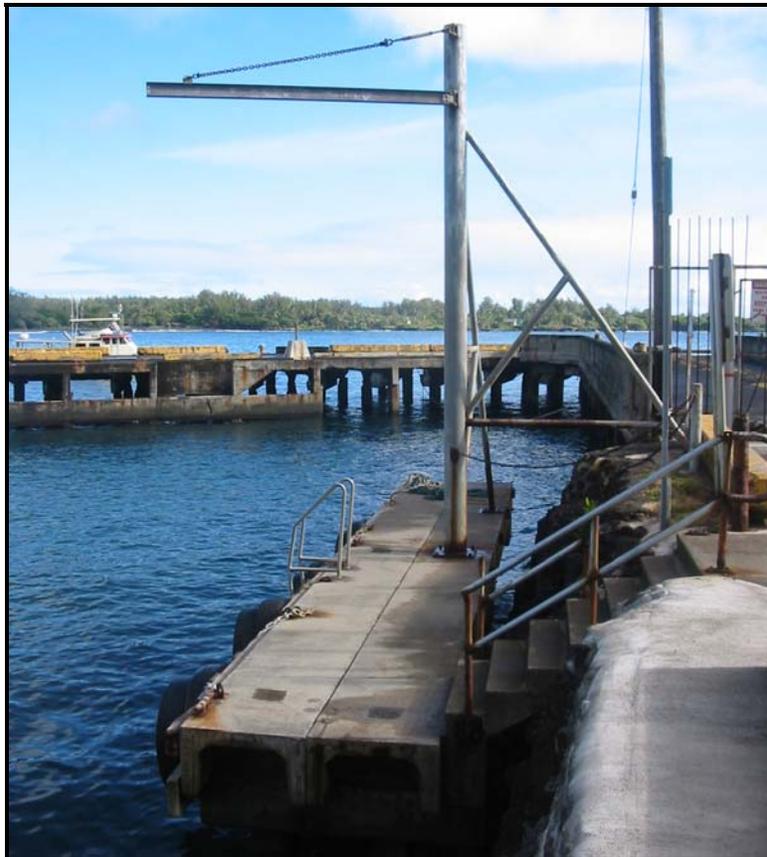
Figure 2.2 Existing Loading Dock

The existing loading dock is in a deteriorated condition but is still a serviceable structure (Figure 2.2). The abutting concrete channels that form the deck are cracked in places, and show stains due to corrosion of rebar reinforcement. However, they appear structurally sound for the present use requirements. The deck hardware is corroded but still in place and useable, although replacement is warranted. The jib crane did not appear to be in service. The existing dock does not have ADA access. It is a relatively high structure, at +5 ft MLLW, which further reduces ease of boat access.

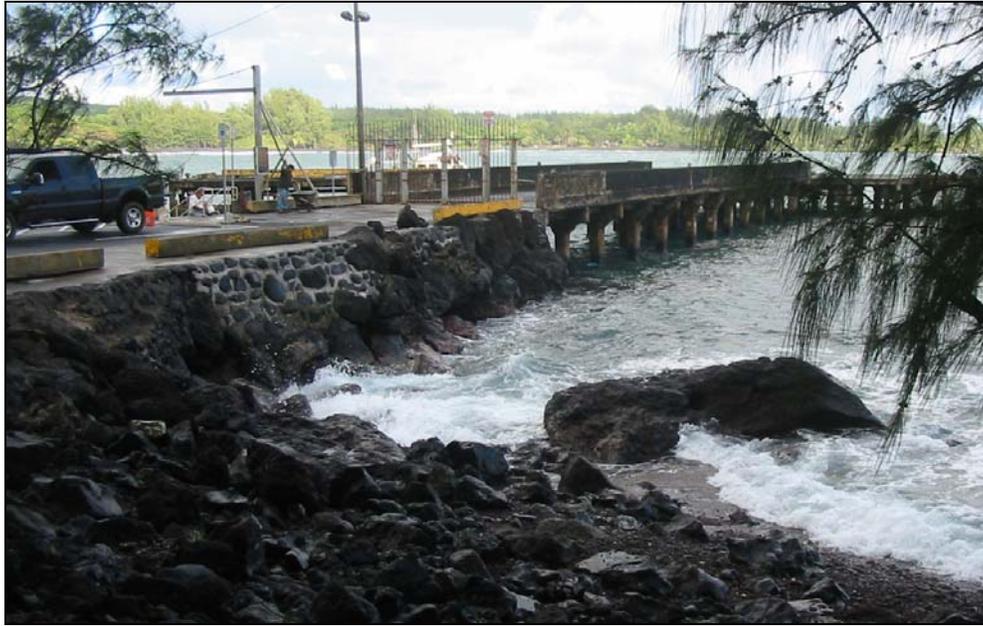
Figure 5.2 Boulders and Rocks on the Seaward Side of the Breakwater

The seaward side of the breakwater has numerous large basalt boulders scattered in front of the breakwater. Nominal 6-foot depths also end abruptly at a ledge that plunges down to about 20 feet. The boulders rise close to the water surface and can be exposed during low tide and surge conditions (Figure 5.2).

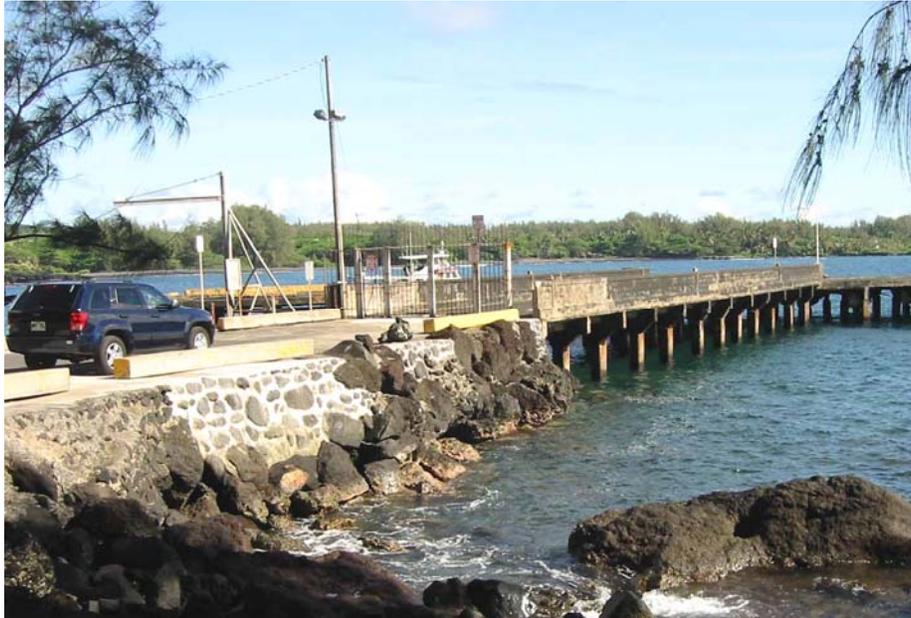
The boulder revetment on the east side of the wharf faces the open ocean and thus experiences Tradewind driven waves on a regular basis (Fig. 8).

Figure 8. Marine biological survey Area 3, includes the east revetment boulders and adjacent bottom.

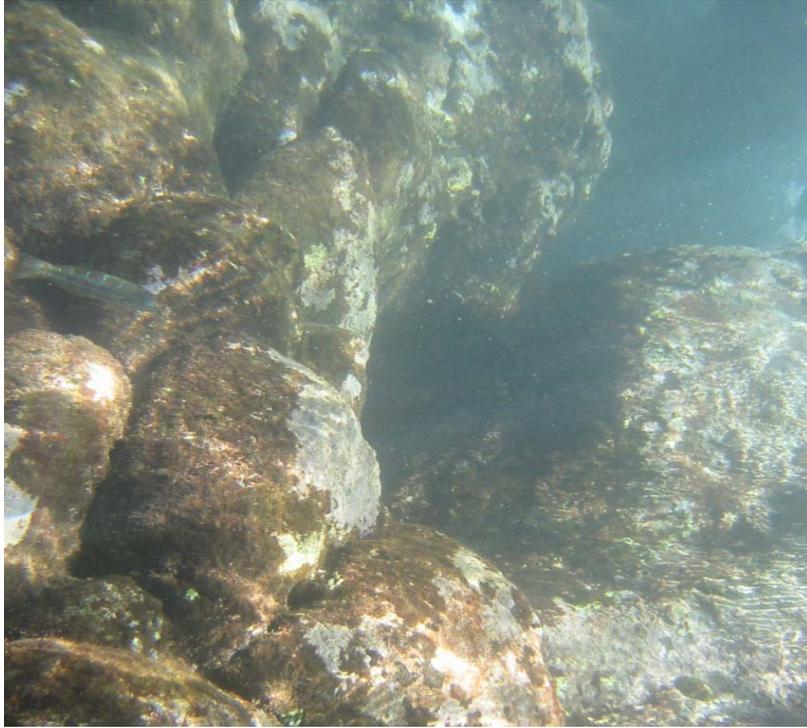
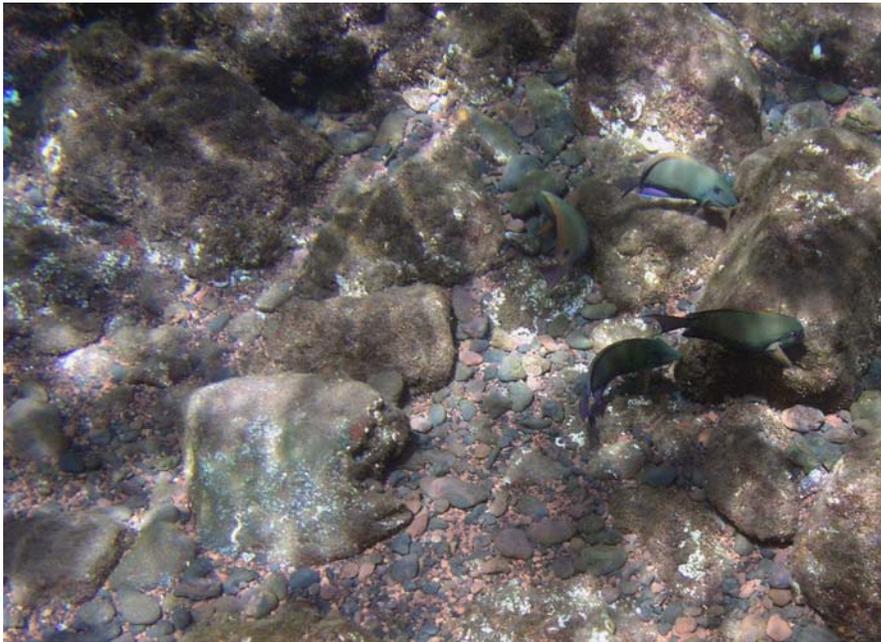
Black-foot limpet and black nerite dot boulders above and at the water line, while thin-shelled rock crab (*Grapsus tenuicrustatus*) scramble in the splash zone. The submerged boulders (Fig. 9) are fairly void of macroalgae with only a thin layer of algal turf with scattered patches of calcareous red algae and rice coral. Several small lace coral colonies also adhere to the boulders. The sea floor adjacent to the east revetment is an unconsolidated mixture of red and black gravel, boulders, and coarse sand (Fig. 9). White-spotted sea cucumber and clumpy nudibranch (*Asteronotus cespitosus*) are among the few invertebrates noted here. Fishes observed include the 'ulae lizardfish (*Synodus ulae*), manybar goatfish, ornate butterflyfish, white-spotted surgeonfish, lavender tang, orangeband surgeonfish, and *manini*. Few fishes were observed along the east revetment, although certainly there is greater overlap of species with the surrounding area than was observed. Below roughly 15 ft (5 m) depth, turf algae adhere to cobbles and rubble, with little sand present.

Figure 9. Marine biological survey Area 3, includes the east revetment boulders and gravel of the adjacent bottom.

“Black-foot limpet and black nerite dot boulders above and at the water line, while thin-shelled rock crab (*Grapsus tenuicrustatus*) scramble in the splash zone. The submerged boulders (Fig. 9) are fairly void of macroalgae with only a thin layer of algal turf with scattered patches of calcareous red algae and rice coral. Several small lace coral colonies also adhere to the boulders. The sea floor adjacent to the east revetment is an unconsolidated mixture of red and black gravel, boulders, and coarse sand (Fig. 9). White-spotted sea cucumber and clumpy nudibranch (*Asteronotus cespitosus*) are among the few invertebrates noted here. Fishes observed include the ‘*ulae* lizardfish (*Synodus ulae*), manybar goatfish, ornate butterflyfish, white-spotted surgeonfish, lavender tang, orangeband surgeonfish, and *manini*. Few fishes were observed along the east revetment, although certainly there is greater overlap of species with the surrounding area than was observed. Below roughly 15 ft (5 m) depth, turf algae adhere to cobbles and rubble, with little sand present.

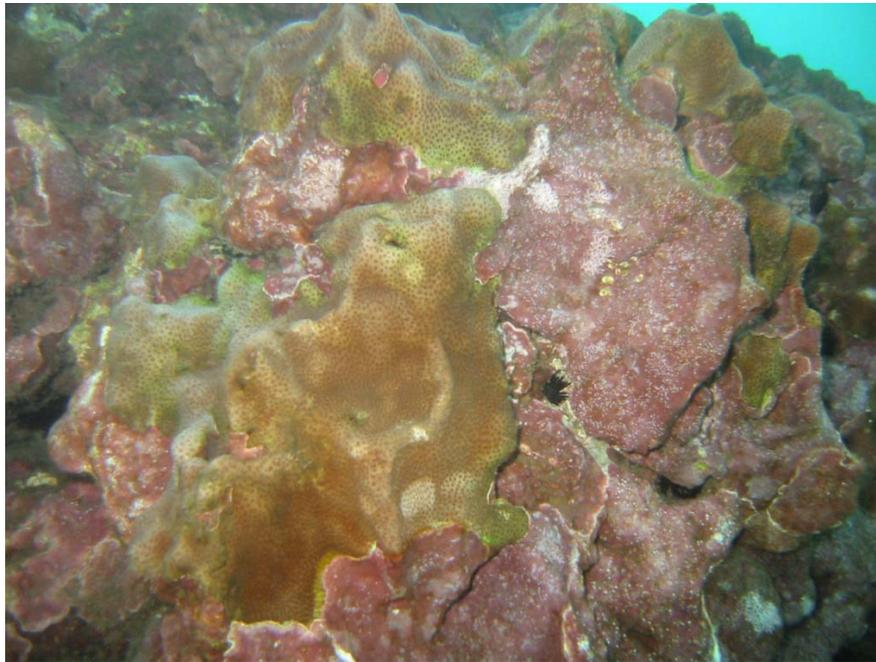
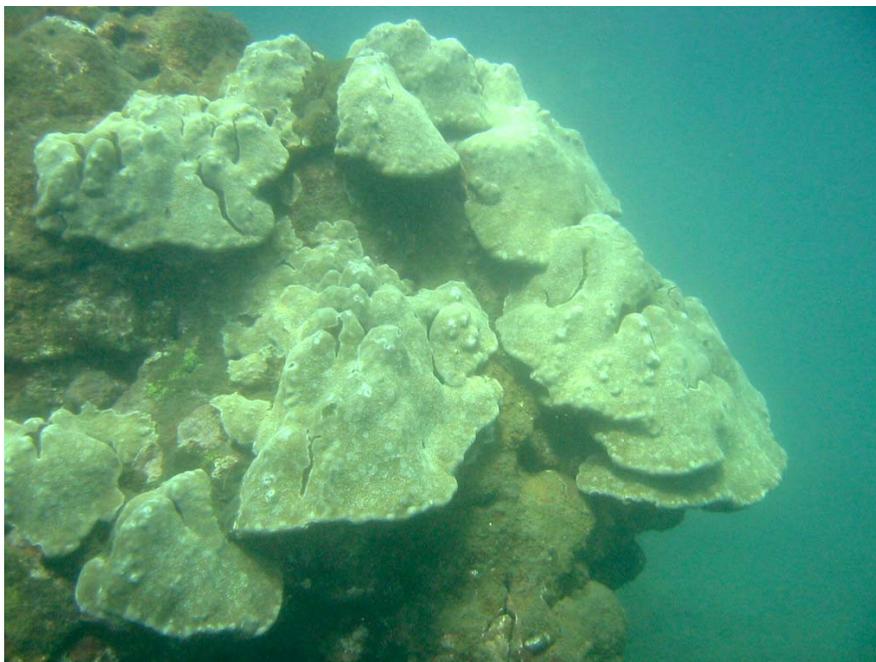
At the end of the revetment, where the water depth drops off beneath the wharf, the upper revetment boulders are almost entirely encrusted with red coralline algae (Fig. 10). The lower revetment boulders, on the other hand, support a mixture of coralline algae and

mounds of ocellated coral. Below the revetment boulders the wall of the dropoff beneath the wharf hosts heads of lobe coral (Fig. 10).

Fig. 10. Marine biological survey Area 3. The revetment end beneath wharf with ocellated coral and coralline red algae. Lobe coral at wharf drop off.

At the end of the revetment, where the water depth drops off beneath the wharf, the upper revetment boulders are almost entirely encrusted with red coralline algae (Fig. 10). The lower revetment boulders, on the other hand, support a mixture of coralline algae and mounds of ocellated coral. Below the revetment boulders the wall of the dropoff beneath the wharf hosts heads of lobe coral.”

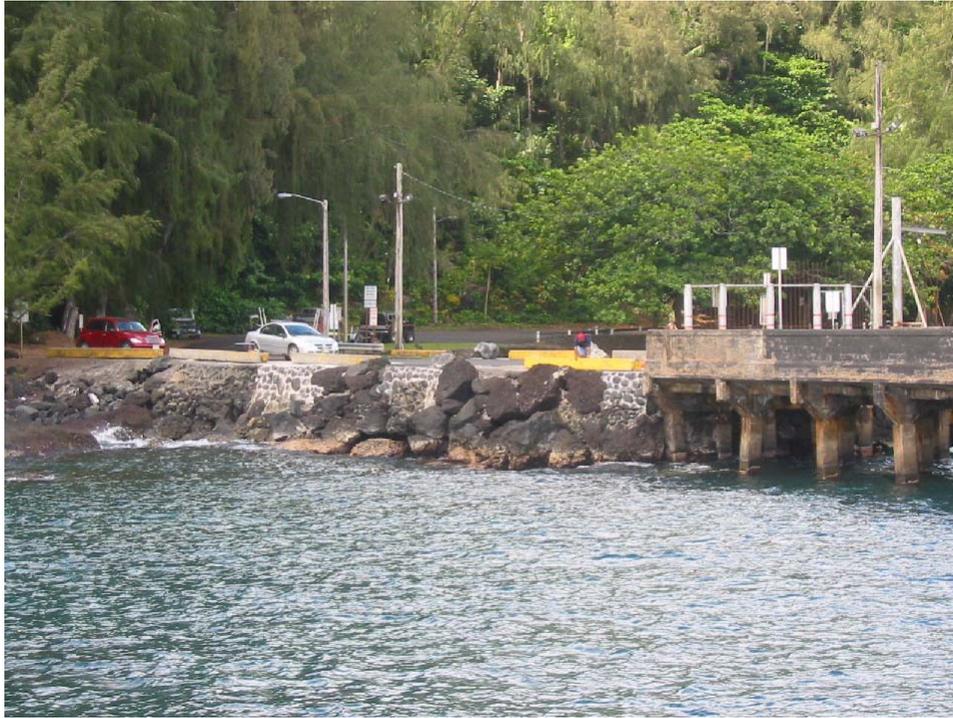
The reef located east or seaward (Fig. 11) from the wharf is made up of several very large boulders amid a field of smaller boulders.

Figure 11. Marine biological survey Area 4, includes reef east of the wharf (in foreground) and first five wharf pilings. Photo by: SEI, Inc.

“The reef located east or seaward (Fig. 11) from the wharf is made up of several very large boulders amid a field of smaller boulders. Atop the large boulders occur cauliflower and rice coral colonies of varying sizes. Macro-invertebrates on the east reef include sea cucumbers, blue-black urchin, rock-boring urchin, and oblong urchin (*Echinometra oblonga*). The east reef has the greatest fish diversity of the four areas, with 41 species

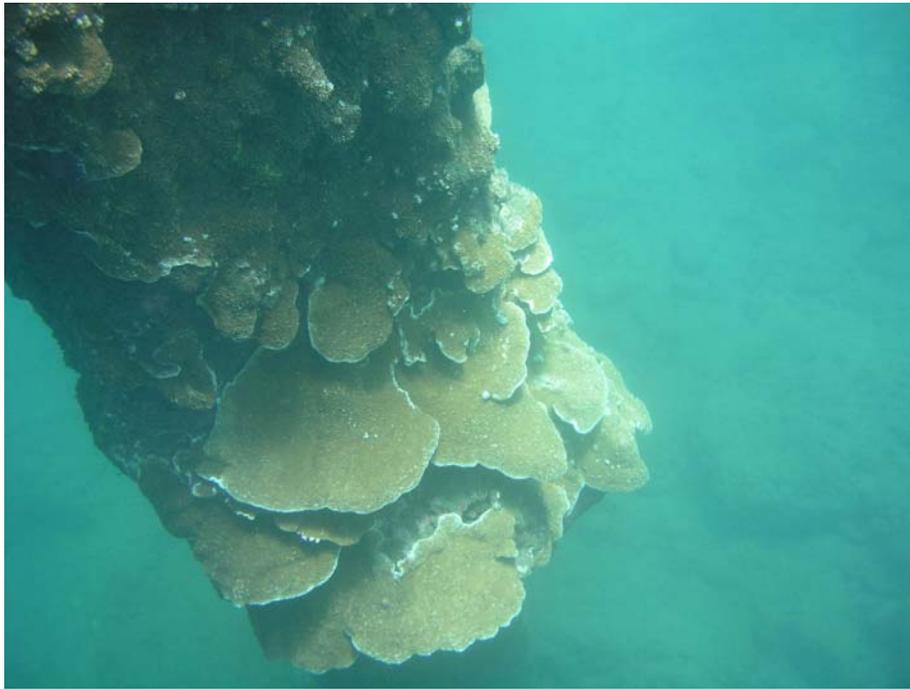
The pilings located on the east side of the wharf (Fig. 13), out to the fifth piling, are included in the discussion of the east reef and not the east revetment because they are similarly distanced from the revetment and less likely to be impacted than the revetment itself. Between the east reef and wharf pilings, encrusting colonies of rice coral, blue rice coral, lobe coral, and ocellated coral are somewhat sparsely situated on a slightly undulating bottom amid silt covered turf algae. Bottom depth increases as it approaches the wharf and lobe coral colony mounds line the face of the drop off associated with the wharf (Fig. 13). The upper parts of the concrete wharf pilings are encrusted with rice coral colonies, whereas the deeper portions are rimmed by plate-like growths of the same.

Figure 13. Marine biological survey Area 4. Wharf pilings with plate-like rice coral colonies

The pilings located on the east side of the wharf (Fig. 13), out to the fifth piling, are included in the discussion of the east reef and not the east revetment because they are similarly distanced from the revetment and less likely to be impacted than the revetment itself. Between the east reef and wharf pilings, encrusting colonies of rice coral, blue rice coral, lobe coral, and ocellated coral are somewhat sparsely situated on a slightly undulating bottom amid silt covered turf algae. Bottom depth increases as it approaches the wharf and lobe coral colony mounds line the face of the drop off associated with the wharf (Fig. 13). The upper parts of the concrete wharf pilings are encrusted with rice coral colonies, whereas the deeper portions are rimmed by plate-like growths of the same.
