ENVIRONMENTAL ASSESSMENT

*WAIALAE COUNTRY CLUB

SHORELINE PROTECTION*

FEBRUARY 1990

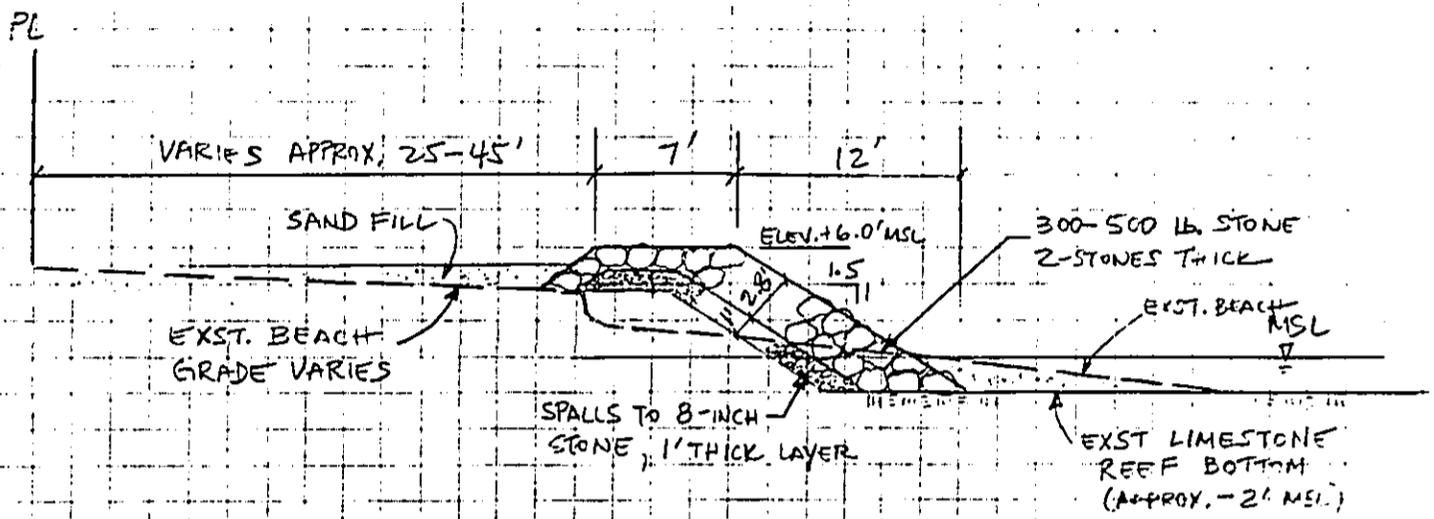
TYPICAL REVETMENT SECTION

FIGURE 2. PROPOSED REVETMENT TYPICAL SECTIONS

The recommended method for maintaining the beach area at the project site is construction of a sloping rock revetment. Figure 2 shows a sketch of the typical sections, and Figure 3 shows the plan view of the proposed revetment. The revetment layout is superimposed on a portion of the shoreline and topographic survey of the parcels prepared by Engineers Surveyors Hawaii, Inc.

The revetment is designed with a two-stone thick armor layer of 300-500 pound stones (nominal stone diameter 1.4 feet) placed on a 1V:1.5H slope. The armor layer is underlain with a 1-foot thick underlayer of spalls to 8 inch stone, which is placed on a prepared supporting slope. The toe of the revetment should be excavated in order to place the revetment footing directly on the existing limestone reef platform. The excavated materials will be screened and the sand sized particles will be replaced on the existing beach backshore to restore eroded areas and to cover the existing exposed coral rubble fill material. The remaining large coral rubble pieces can be used for the revetment foundation and underlayer.

The crest elevation is +6.0 feet MSL, which will not sustain significant overtopping during typical wave conditions, but which will be overtopped during storm conditions. The underlayer and armor layer are extended at the revetment crest to prevent potential damage to the revetment due to the overtopping water. In contrast, the existing riprap slope on the shorefront adjacent to the project site shows evidence of overtopping damage due to the low crest elevation (+5' MSL) and inadequate design for overtopping.

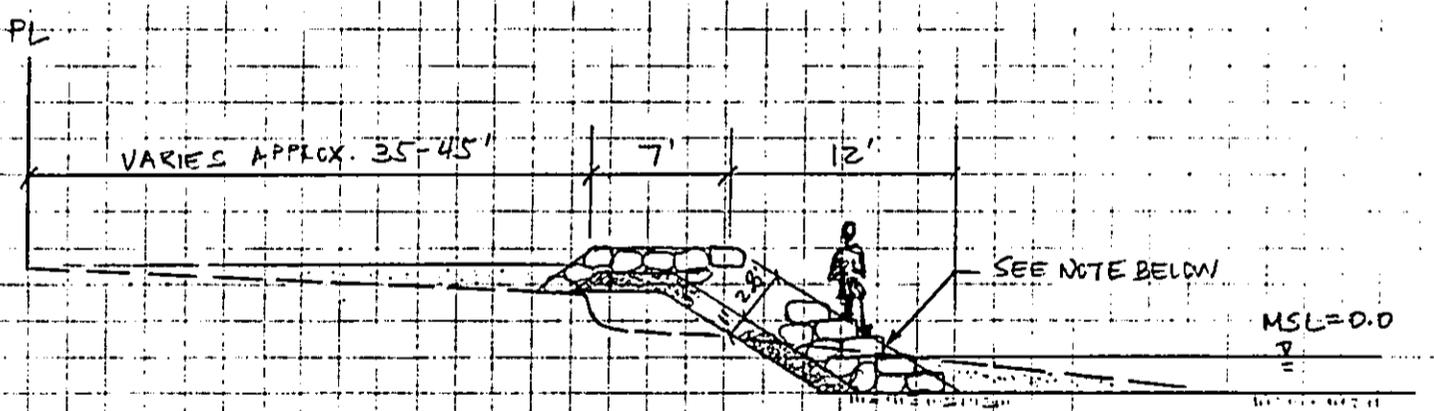
TYPICAL SECTION AT STAIRS

NOTE: USE FLATTENED STONES OR CONCRETE BLOCKS IN OUTER LAYER FOR STEPS. DO NOT CAST IN PLACE OR GROUT.

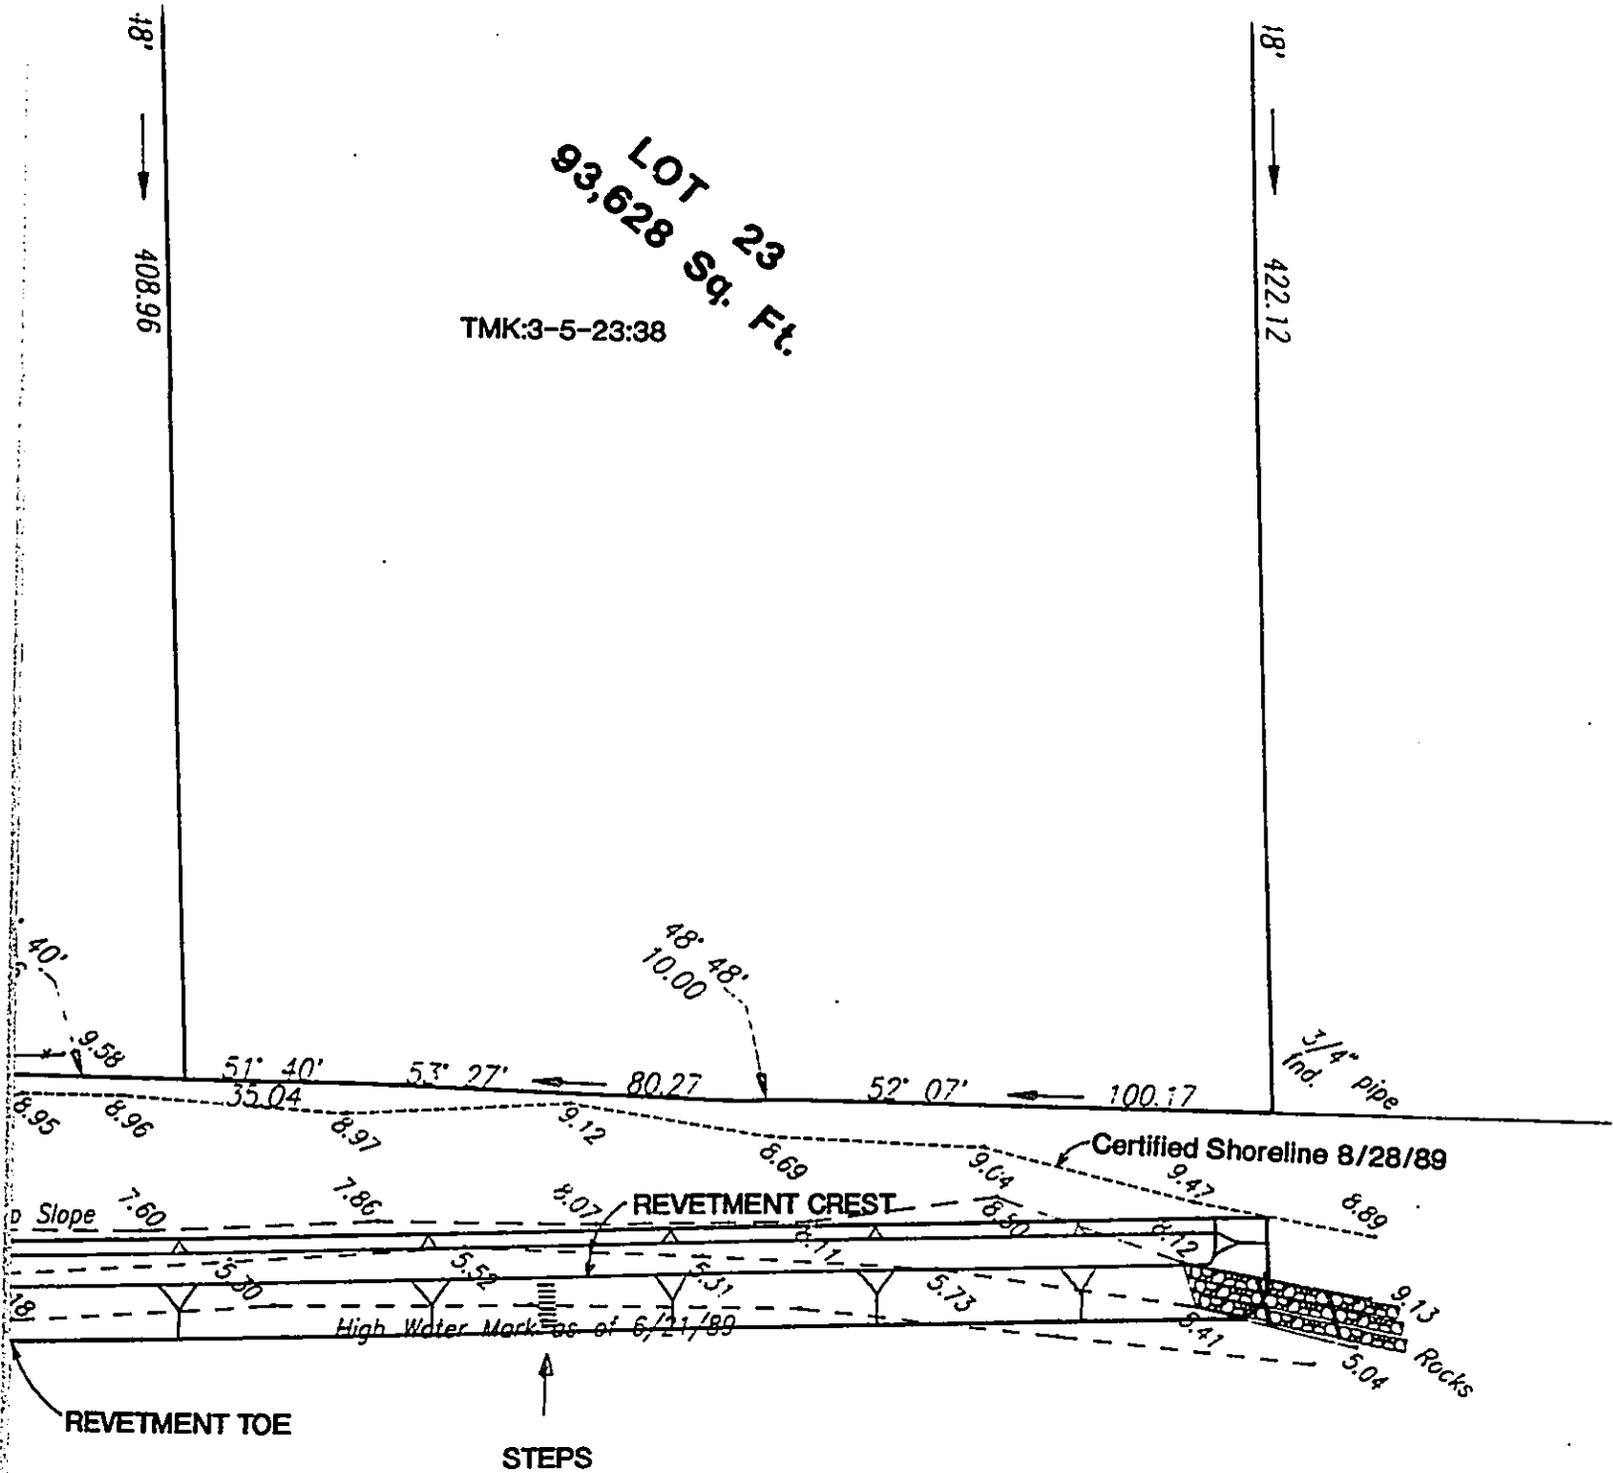
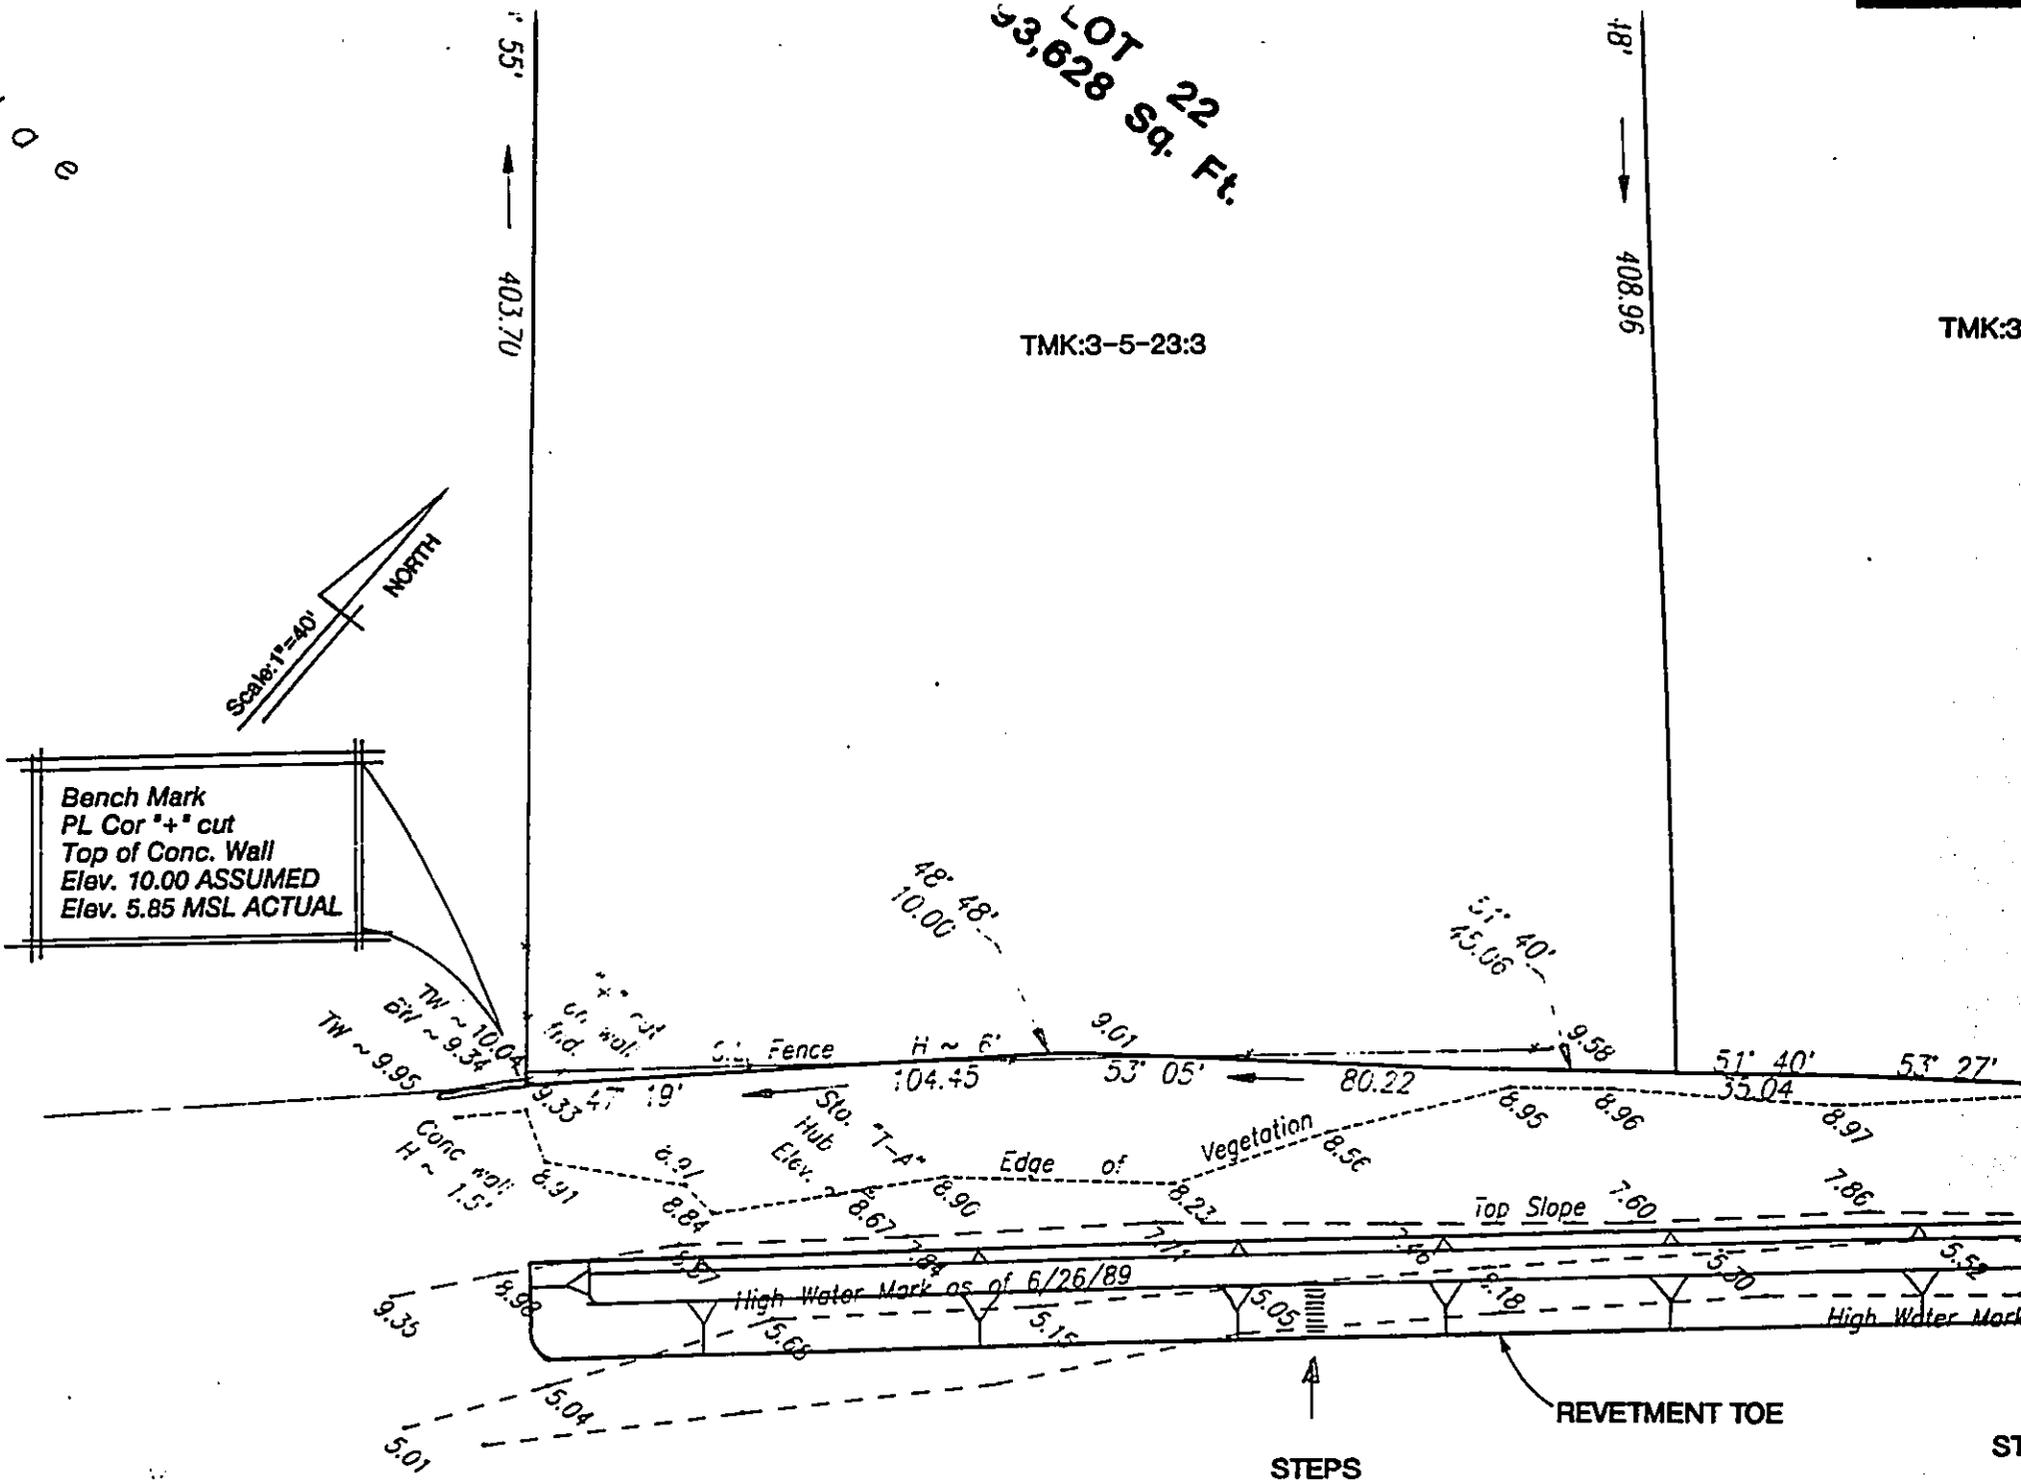
FIGURE 3. PROPOSED LAYOUT PLAN FOR REVETMENT

1. Shoreline and Topographic Survey by Engineers Surveyors Hawaii, Inc. June 26, 1989.
2. All elevations based on assumed elev. of Bench Mark. Subtract 4.15' to obtain actual elevations referenced to MSL Datum.

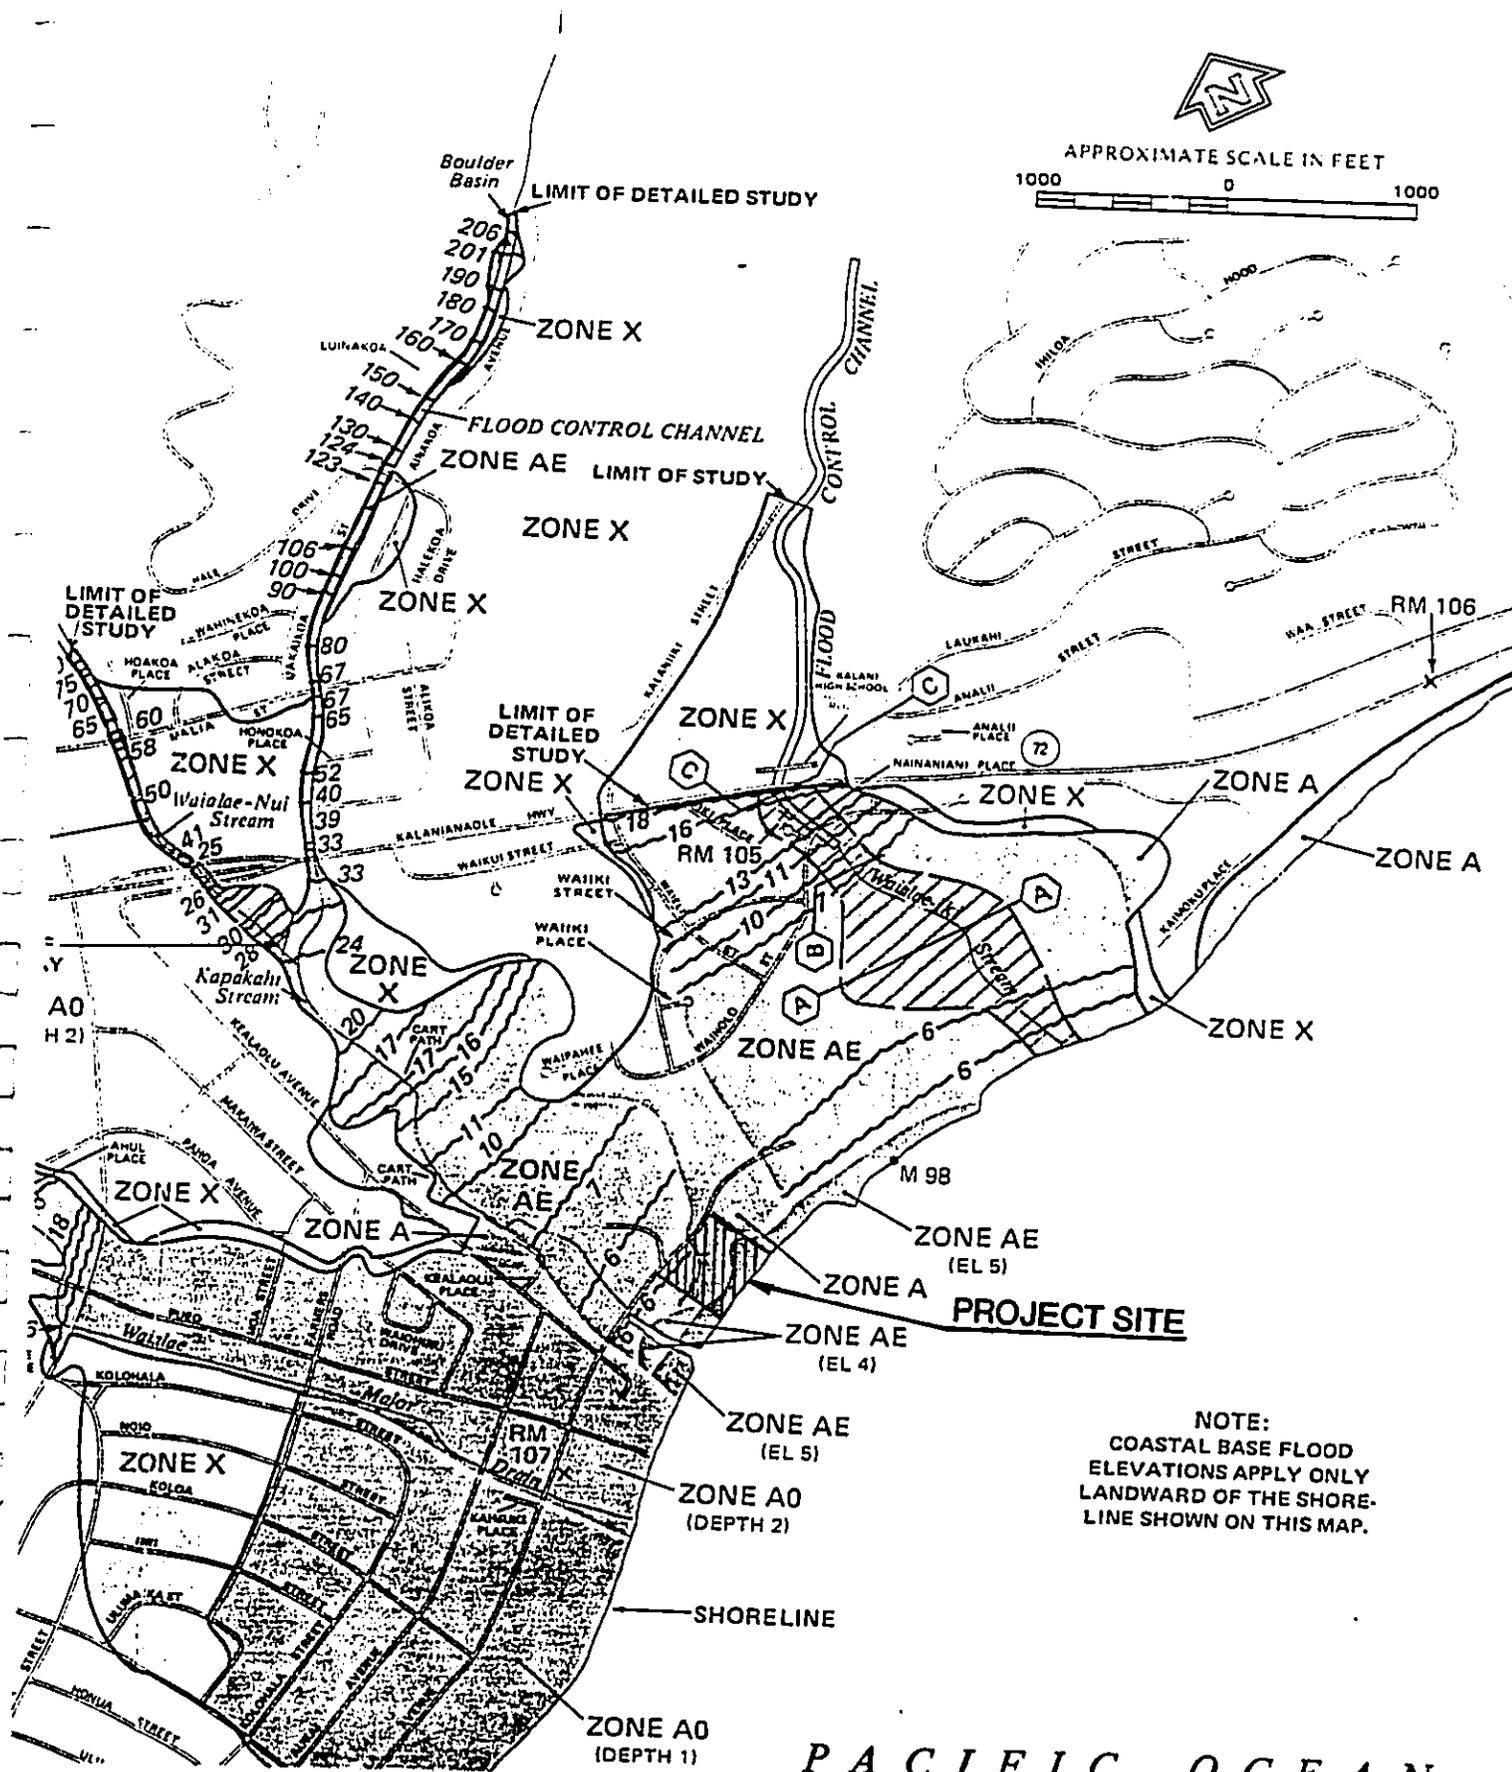
NOTE:
 COASTAL BASE FLOOD
 ELEVATIONS APPLY ONLY
 LANDWARD OF THE SHORE-
 LINE SHOWN ON THIS MAP.

PACIFIC OCEAN
 FIGURE 4. PORTION OF FEMA FLOOD INSURANCE RATE MAP (FIRM).
 PANEL NO. 150001 0120C, REVISED SEP 4, 1987.

The subject shoreline area is located within a coastal flood hazard zone designated Zone AE (base flood elevation 5 feet on the Federal Flood Insurance Rate Map (FIRM), as indicated in Figure 4. The shore protection construction may have a mitigating effect on the flood characteristics since the revetment crest elevation is 1 foot higher than the base flood elevation.
