Re: Chapter 343, Hawaii Revised Statutes
Final Environmental Assessment (EA)

Landowner/
Applicant: Charles B. Wang
Agent: PlanPacific (Robin Foster)
Location: 1368 Mokulua Drive – Kailua (Lanikai)
Tax Map Key: 4-3-4: 81
Request: Shoreline Setback Variance
Proposal: To allow (retain) a seawall constructed within the shoreline setback area.
Determination: A Finding of No Significant Impact is Issued

Repair Seawall at 1368 Mokulua Drive
TAX MAP KEY : 4 - 3 - 04 : 81

Subject: Draft Environmental Assessment (DEA)
Shoreline Setback Variance for Seawall Repairs
1368 Mokulua Drive - Lanikai
TMK: 4-3-004:081

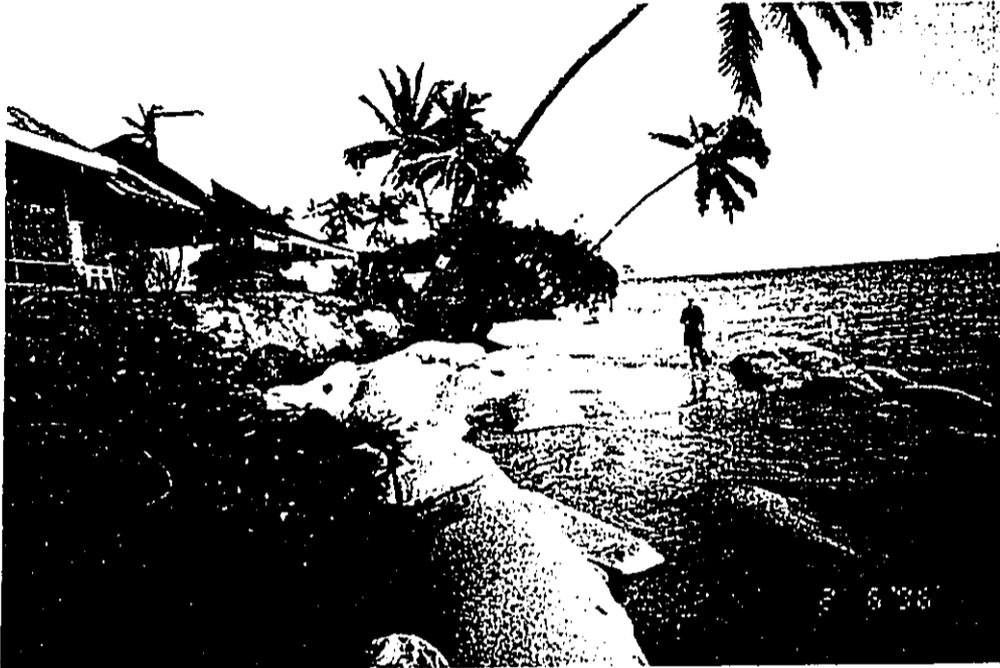
Photo 4: View northward showing damaged condition of sandbags fronting adjacent parcel 98 (Carpenter).

the beach. The SEAbags on the adjacent properties did not survive the 1995-1996 winter season very well. The SEAbag revetment on adjacent parcel 98 had to be rebuilt in February-March 1996, and by that time, the property owner of the two subject parcels had suffered extensive erosion damage. Photos 1 through 8 show the condition of the subject properties and adjacent properties in February-March 1996.

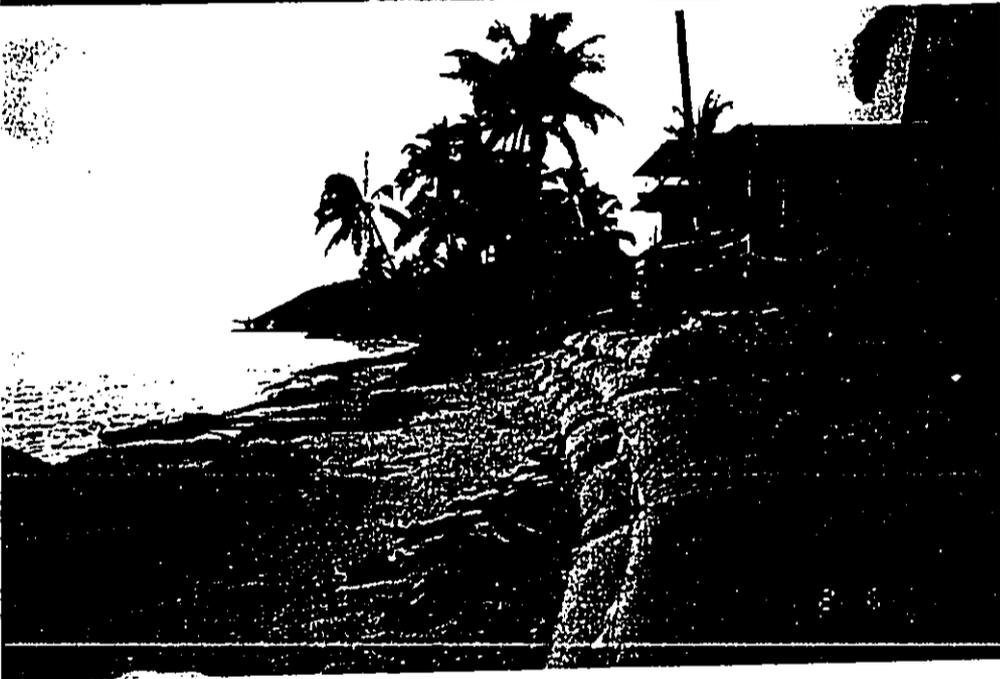
Photo 5: View southward showing sandbags fronting parcels 76 (Olds) and 77 (Davis).

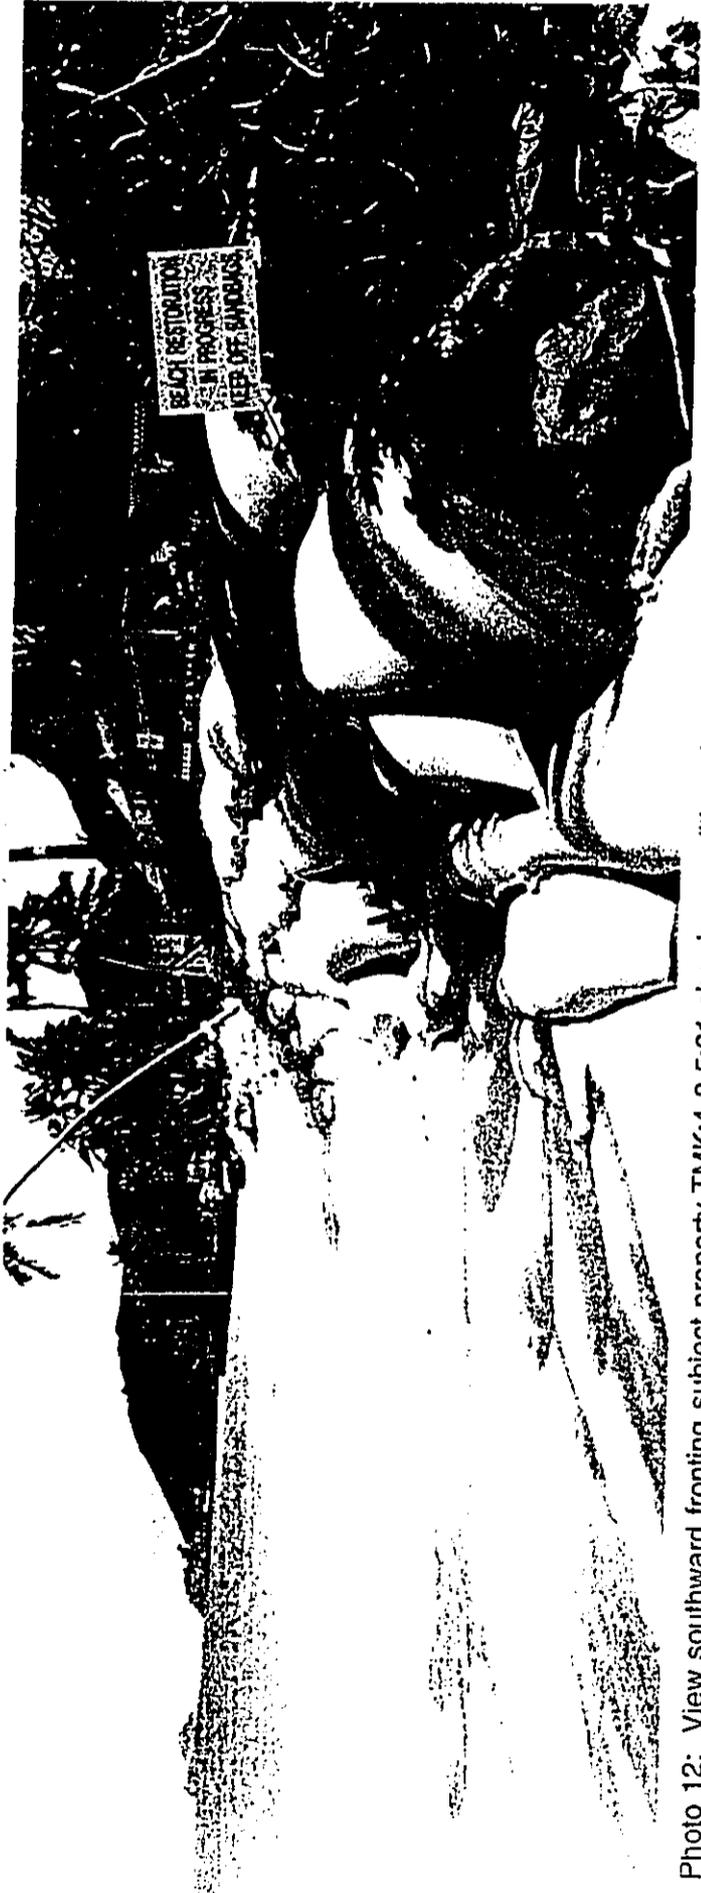
Photo 12: View southward fronting subject property TMK:4-3-5:61 showing condition of sand bag reveilment after repairs completed.

Photos 12 through 17, taken in May 1997, show the existing condition of the SEAbag revetment on the subject parcels and the condition of adjacent properties. Note that the shoreline fronting the adjacent properties to the south is continuing to be modified by placement of SEAbags, removal of prior SEAbags that were damaged, placement of additional beach sand obtained from offsite source(s), and possibly mechanical redistribution of sand in the nearshore area. While the details are unclear, apparently the work is being done as part of a demonstration pilot project for beach replenishment by the Lanikai Beach Management Committee.⁴ A Departmental Permit for use within the Conservation District was issued by the Board of Land and Natural Resources on June 3, 1996 for the demonstration beach replenishment project. A condition of the permit was the requirement to perform pre-, during-, and post-construction beach profile monitoring and topographic monitoring for at least a year. The first monitoring report for the "Pilot Research Project" was filed in September 1997 by David Lipp, the coastal engineer who is monitoring the project on a volunteer basis. The report
