DHHL EAST MAKA'ALA MIXED USE DEVELOPMENT

TMK (3) 2-2-47: 072

Hilo, Hawai'i

Draft Environmental Assessment

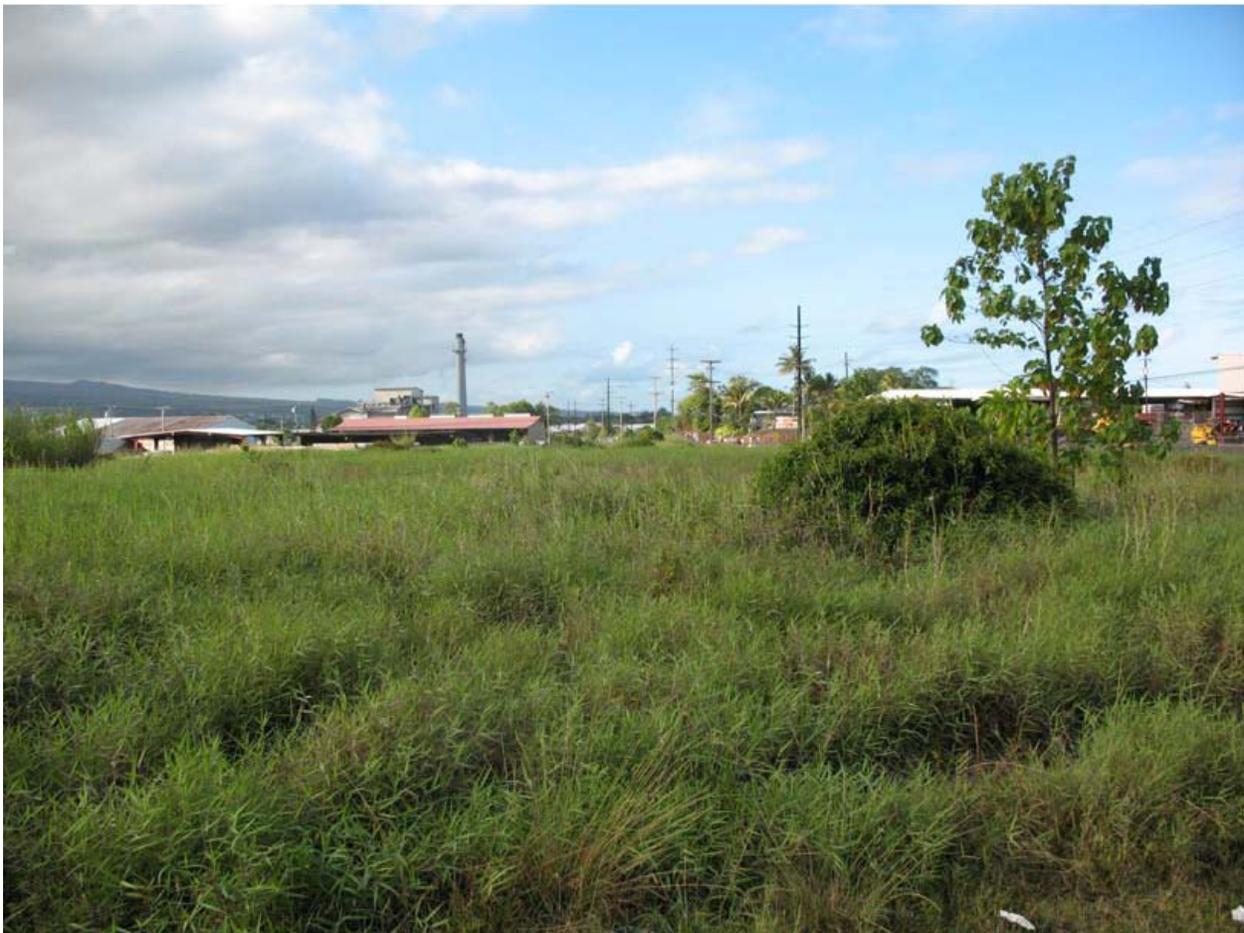
Figure 3.4 View to the North of the Undeveloped Eastern Portion of the Study Area

Currently, the project site includes a limited vegetation cover of exotic weeds and grasses (Figure 3.4). The vegetation of the site includes one observed and clearly planted 'ōhi'a tree (*Metrosideros polymorpha*), which is a native plant. Major trees include Polynesian introduction or "canoe plants" such as coconut and other palms, Norfolk pines, Macaranga, and gunpowder trees. Other Polynesian introduced plants observed are hau (*Hibiscus macrophyllus*), ornamental ti, and pandanus (*Pandanus odoratissimus*). The majority of the vegetation is comprised of alien (i.e. introduced to Hawai'i by humans) species including: common guava (*Psidium guajava*), koa

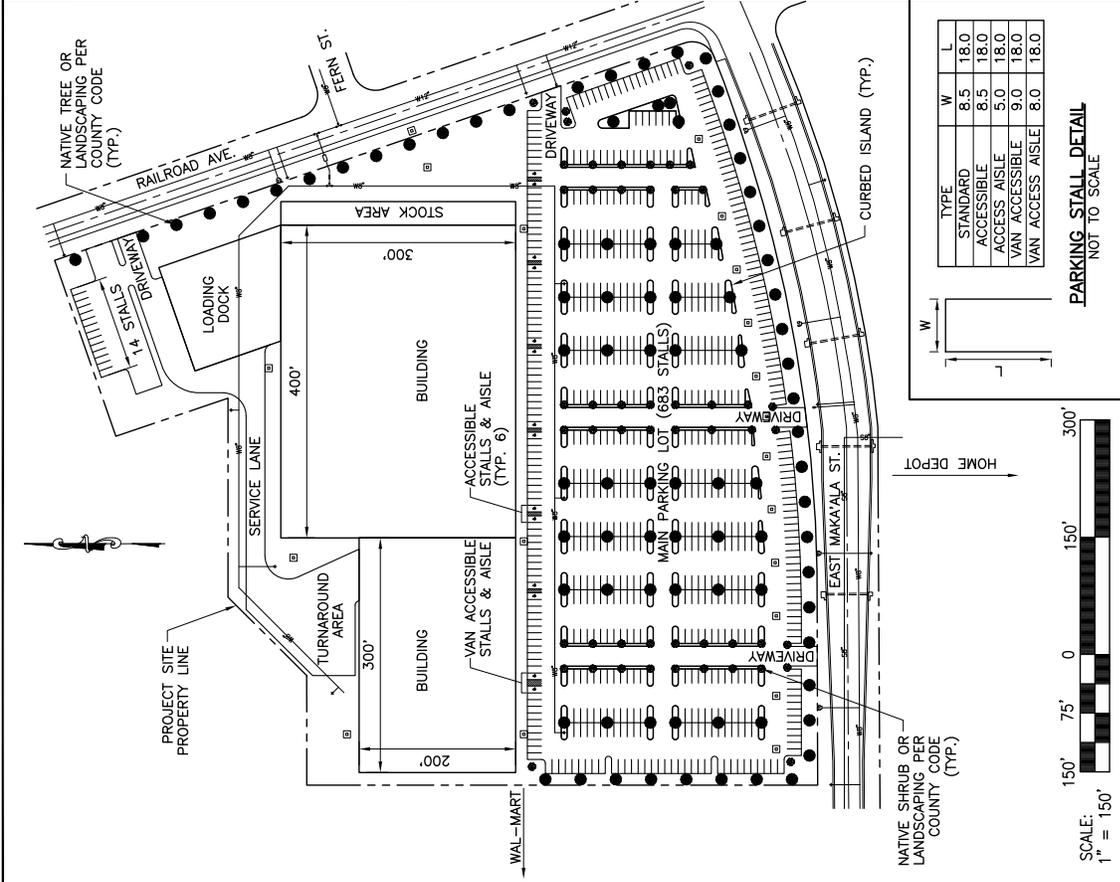
Department of Hawaiian Home Lands
 East Makala Mixed Use Development
 Hilo, South Hilo, Hawaii Island
 TM# (3) 2-2-047: 066, Lot 5-A-1
 Project Assessment Report
 Figure 8.1
 Overall Site Plan & Location
 Sheet 1/1, 10/15/08

PARKING STALL DETAIL
NOT TO SCALE

TYPE	W	L
STANDARD	8.5	18.0
ACCESSIBLE	8.5	18.0
ACCESS AISLE	5.0	18.0
VAN ACCESSIBLE	9.0	18.0
VAN ACCESS AISLE	8.0	18.0

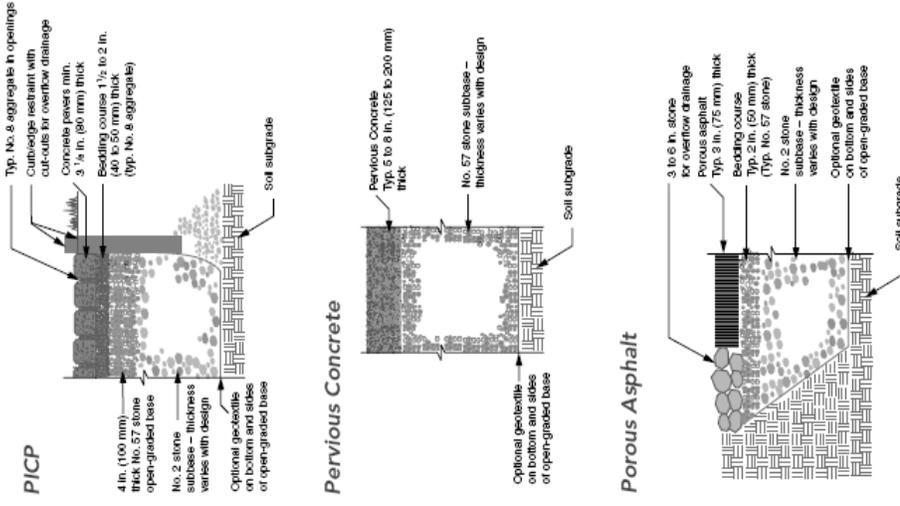
Figure 2. Typical PICP, pervious concrete and porous asphalt pavement sections. Surface and base thicknesses vary with traffic. Slower draining soils generally require thicker bases to store and infiltrate water. All can accommodate perforated drain pipes in the base for low infiltration soils.

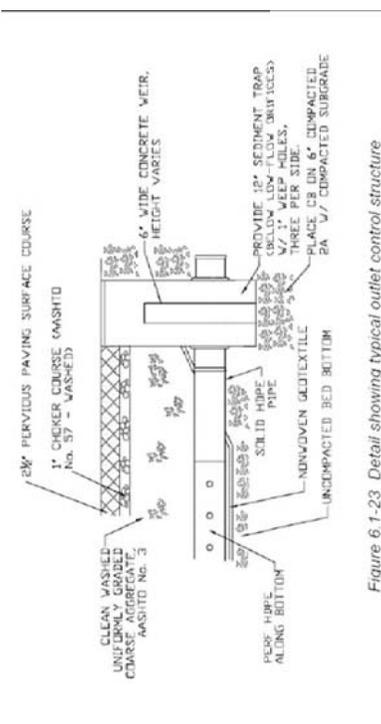
Figure 6.1-23 Detail showing typical outlet control structure

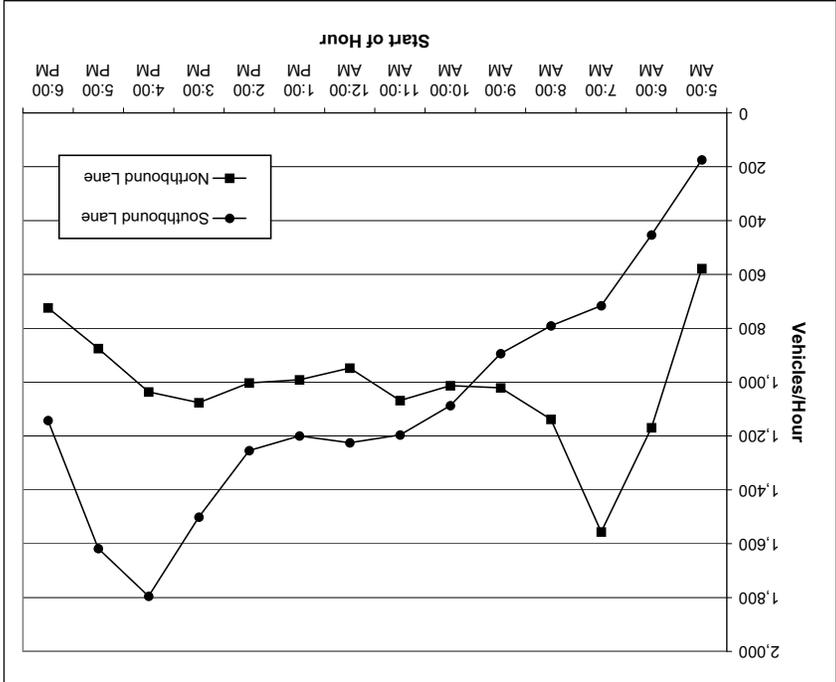
FIGURE 6
HOURLY TRAFFIC VOLUMES KANOELEHUA AVENUE NORTH OF PUAINAKO STREET

HOURLY TRAFFIC VOLUMES KANOELEHUA AVENUE NORTH OF PUAINAKO STREET (October 17-18, 2006)

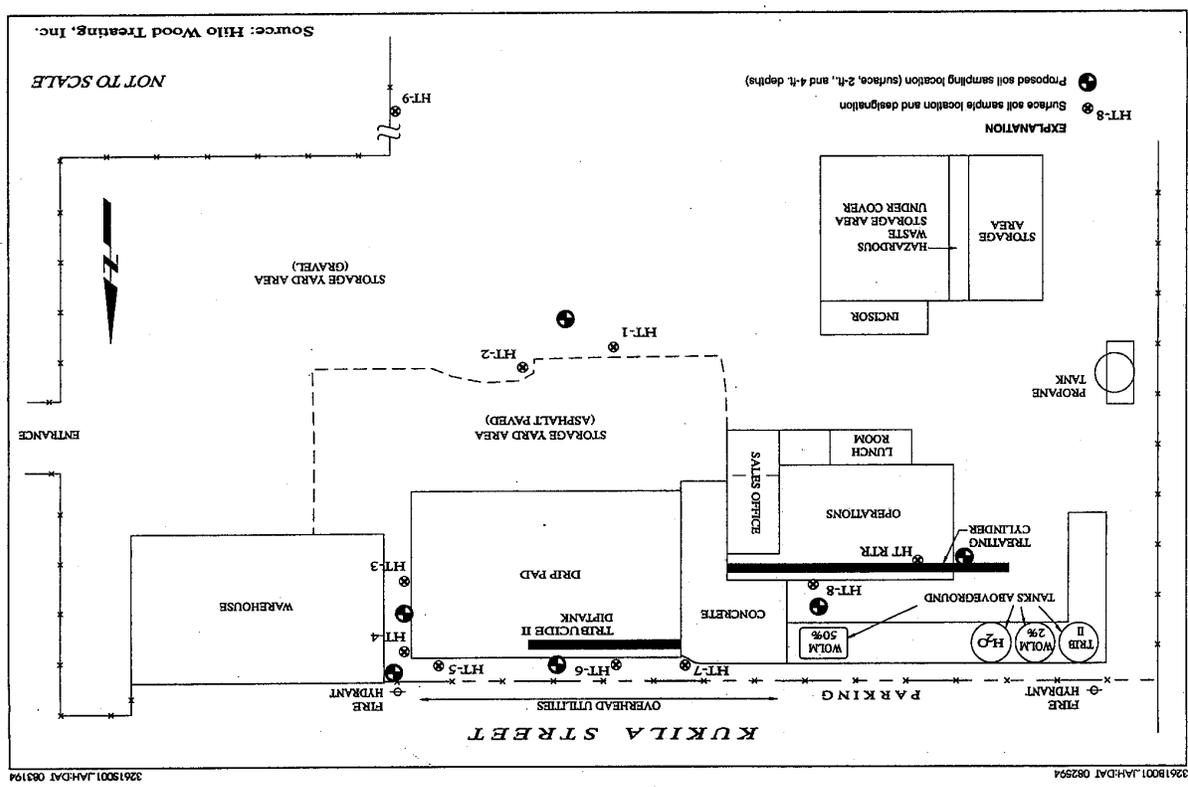
Figure 2 : LOCATIONS OF SURFACE SOIL SAMPLES COLLECTED ON AUGUST 8, 1994 AND RESULTS OF LABORATORY ANALYSIS

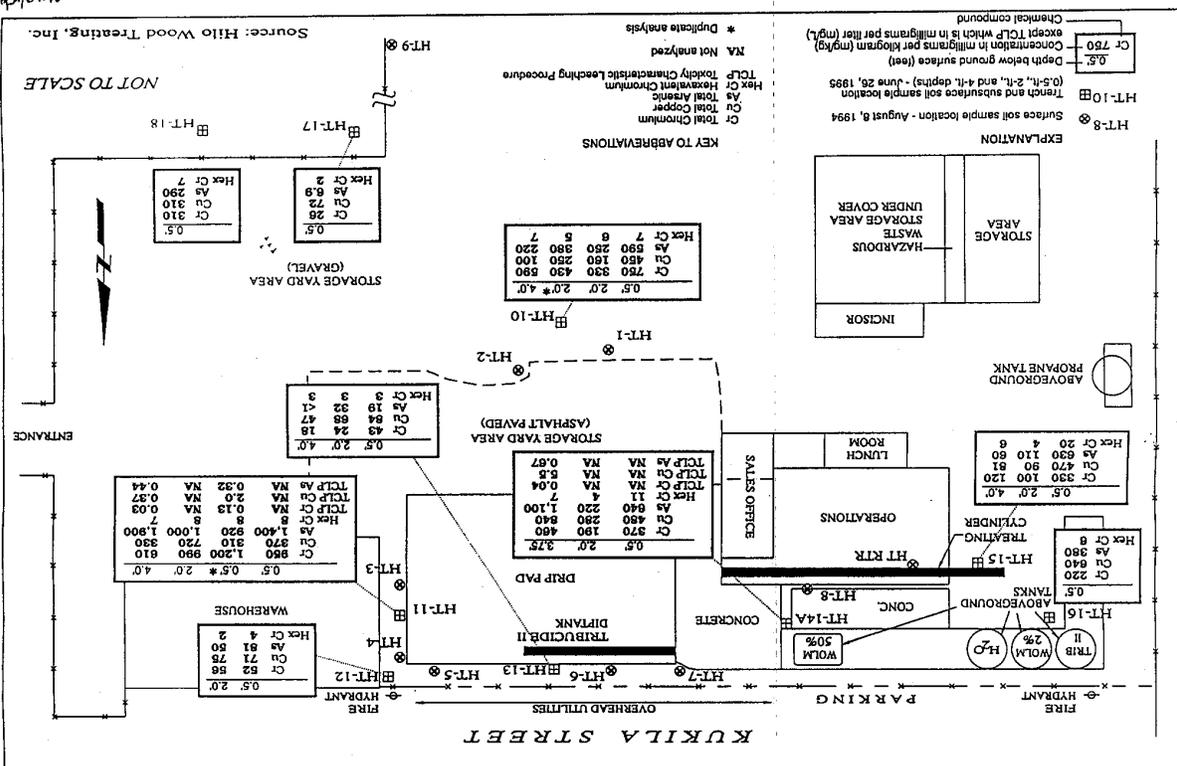
Figure 2 : SUBSURFACE SOIL SAMPLE ANALYTICAL RESULTS - JUNE 26, 1995

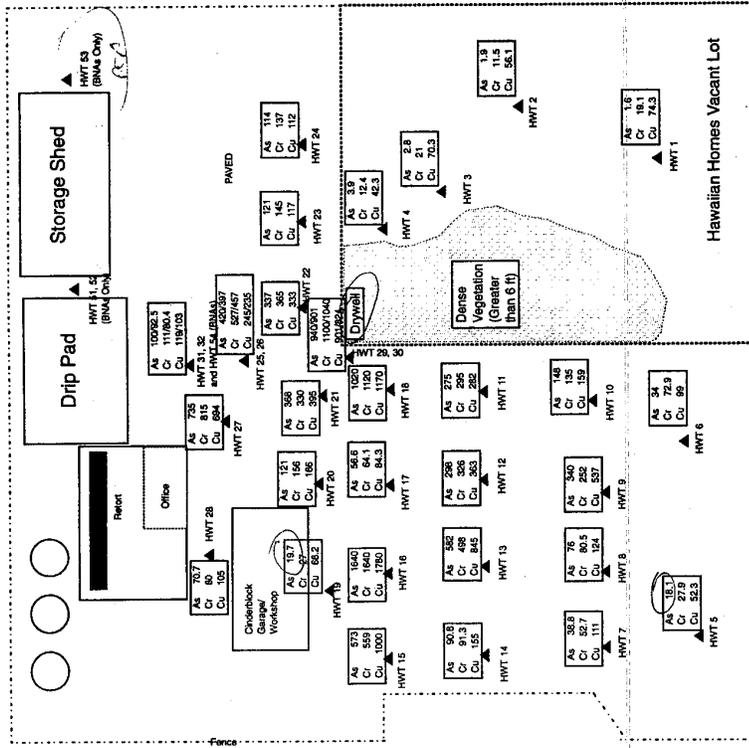
Figure 3. Soil Sampling Locations and analytical results

KEY
 As = Arsenic (mg/kg)
 Cr = Chromium (mg/kg)
 Cu = Copper (mg/kg)
 mg/kg = part per million (ppm)
 PRG Reference:
 As 22 mg/kg (non-cancer endpoint)
 Cr 450 mg/kg (industrial soil)
 Cu 63,000 mg/kg (industrial soil)
