SUBJECT: FINDING OF NO SIGNIFICANT IMPACT (FONSI) FOR
HAWAII BELT ROAD
REHABILITATION OF UMAUMA STREAM BRIDGE
FEDERAL AID PROJECT NO. BR-019-2(61)

**REHABILITATION OF UMAUMA STREAM BRIDGE
PROJECT**

**District of North Hilo, Island of Hawai'i
Federal Project No. BR-019-2(61)**

**State of Hawai'i
Department of Transportation, Highways Division**

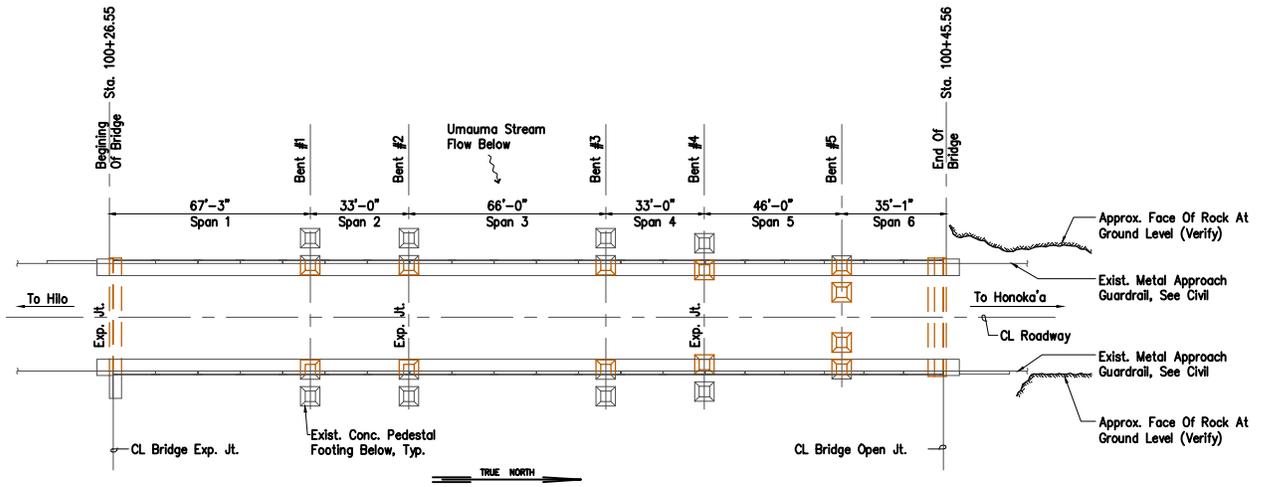
EXISTING BRIDGE PLAN

SCALE: 1" = 64'

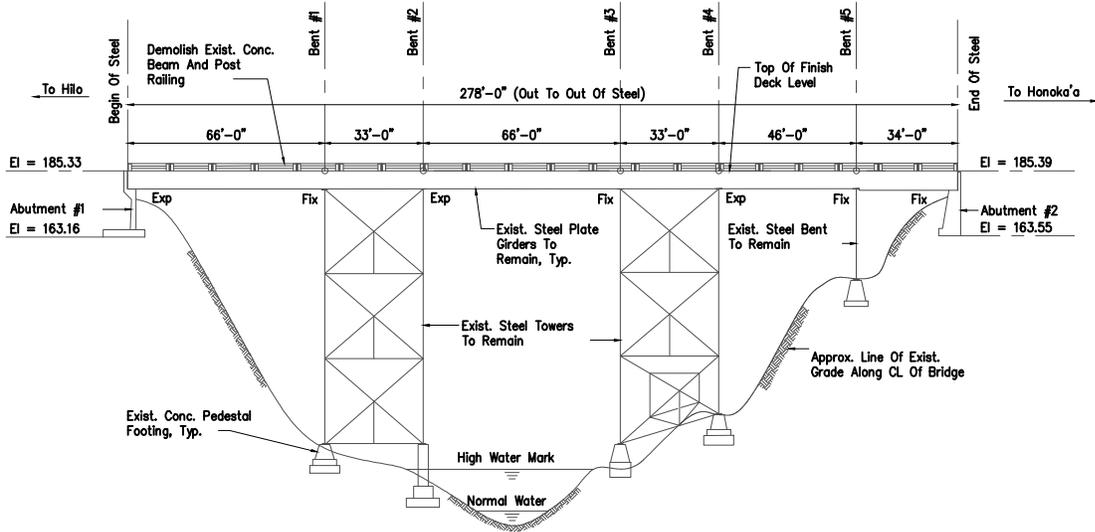
EXISTING BRIDGE PROFILE

SCALE: 1" = 64'

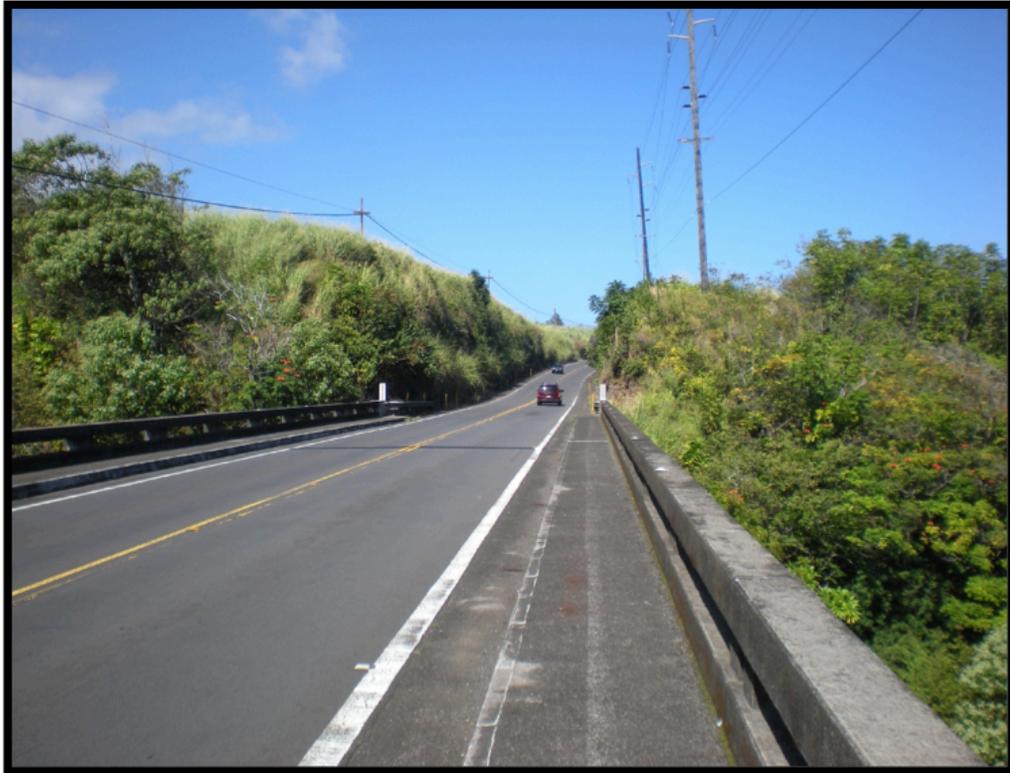
Photo 1: View of bridge along roadway

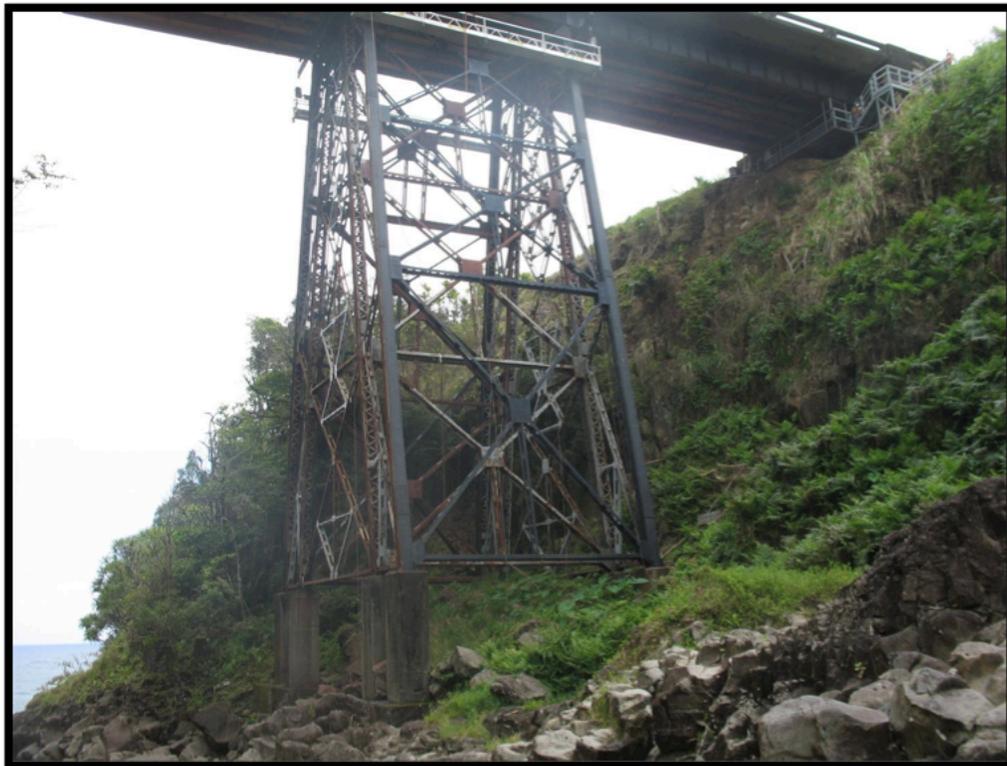
Photo 2: Steel girder and trestle

The existing Umauma Bridge was constructed in 1911. In the early 1950s, the bridge, including the trestles, was widened to support a two-lane highway for vehicular traffic. The bridge was retrofitted in the early 2000s to resist updated earthquake design loads. Umauma Bridge is a historic bridge and under the jurisdiction of the State Historic Preservation Division (SHPD). The steel framed Umauma Bridge is showing signs of steel deterioration. Repair and maintenance projects have been completed and are currently in progress to minimize steel deterioration. The proposed rehabilitation project would install new concrete towers that would support bridge loads, and existing steel towers would become non-structural, as the new concrete piers would be the primary load carrying elements.

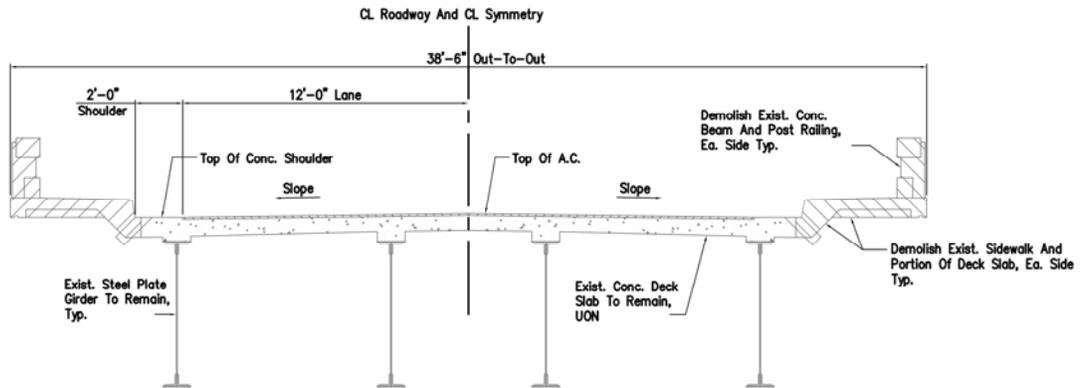
EXISTING CROSS SECTION

Note:
Section Symmetrical About BL, UON
(See Note 1)

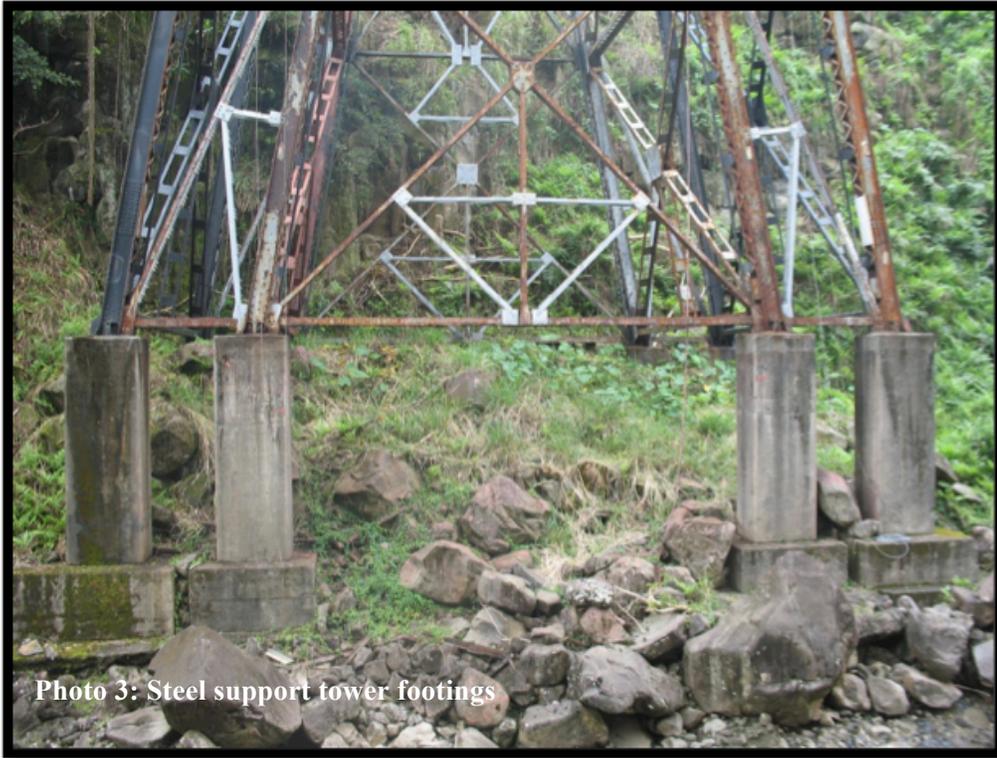
Photo 3: Steel support tower footings

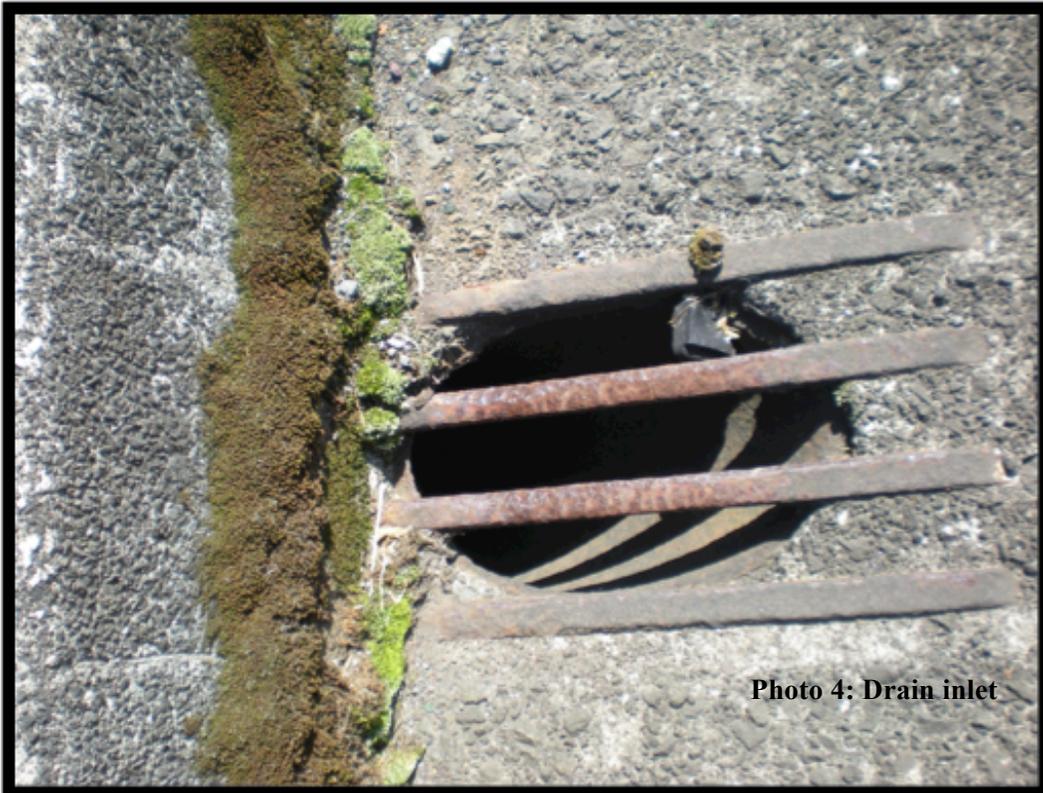
Photo 4: Drain inlet

4-inch pipe with an outlet approximately 4-feet below the bridge deck, allowing stormwater to discharge to the atmosphere and fall to the ground/stream below (see Photos 4 and 5). The proposed project would replace the drain inlets with deck drains placed at certain locations to prevent stormwater from falling directly into the stream. By doing so, storm runoff would be filtered through natural vegetation on the stream bank before entering into the stream.

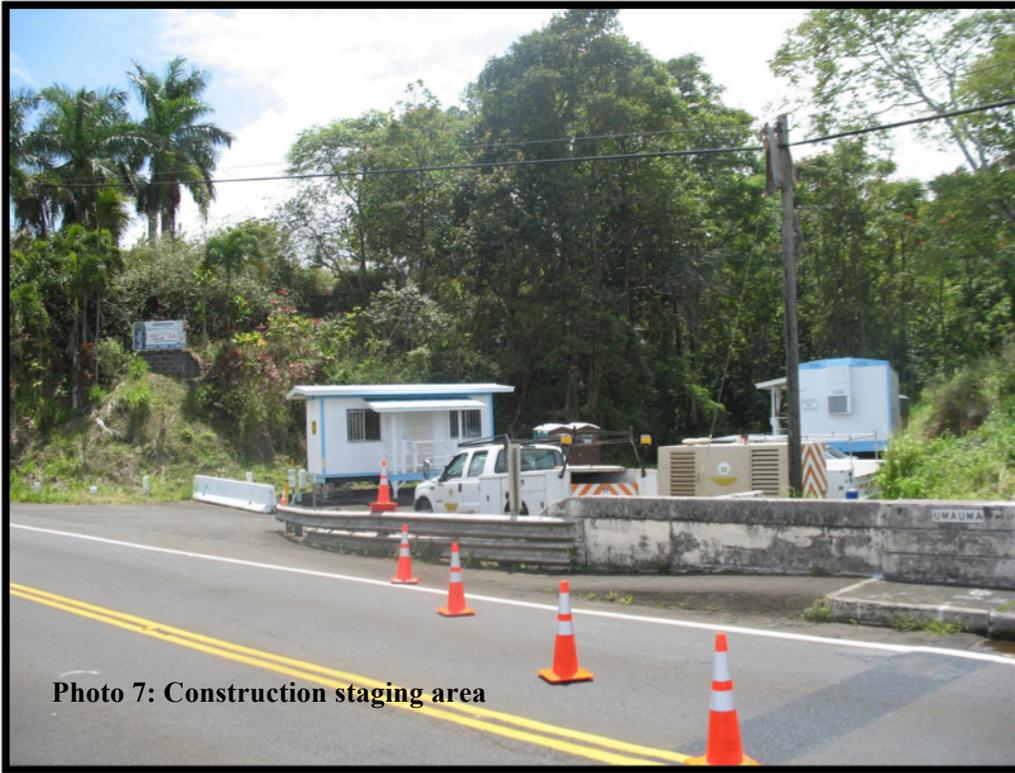
Photo 7: Construction staging area

The construction staging area is proposed to be located on the Hilo side of the bridge, *mauka*² of the roadway, on an adjacent property to the bridge (TMK (3) 3-1-01:15) (see Figure 6). The Department of Transportation (DOT) currently has several trailers in this staging area for bridge maintenance use (see Photo 7). Construction equipment would also be staged adjacent to the bridge footings and would be within State right-of-way.

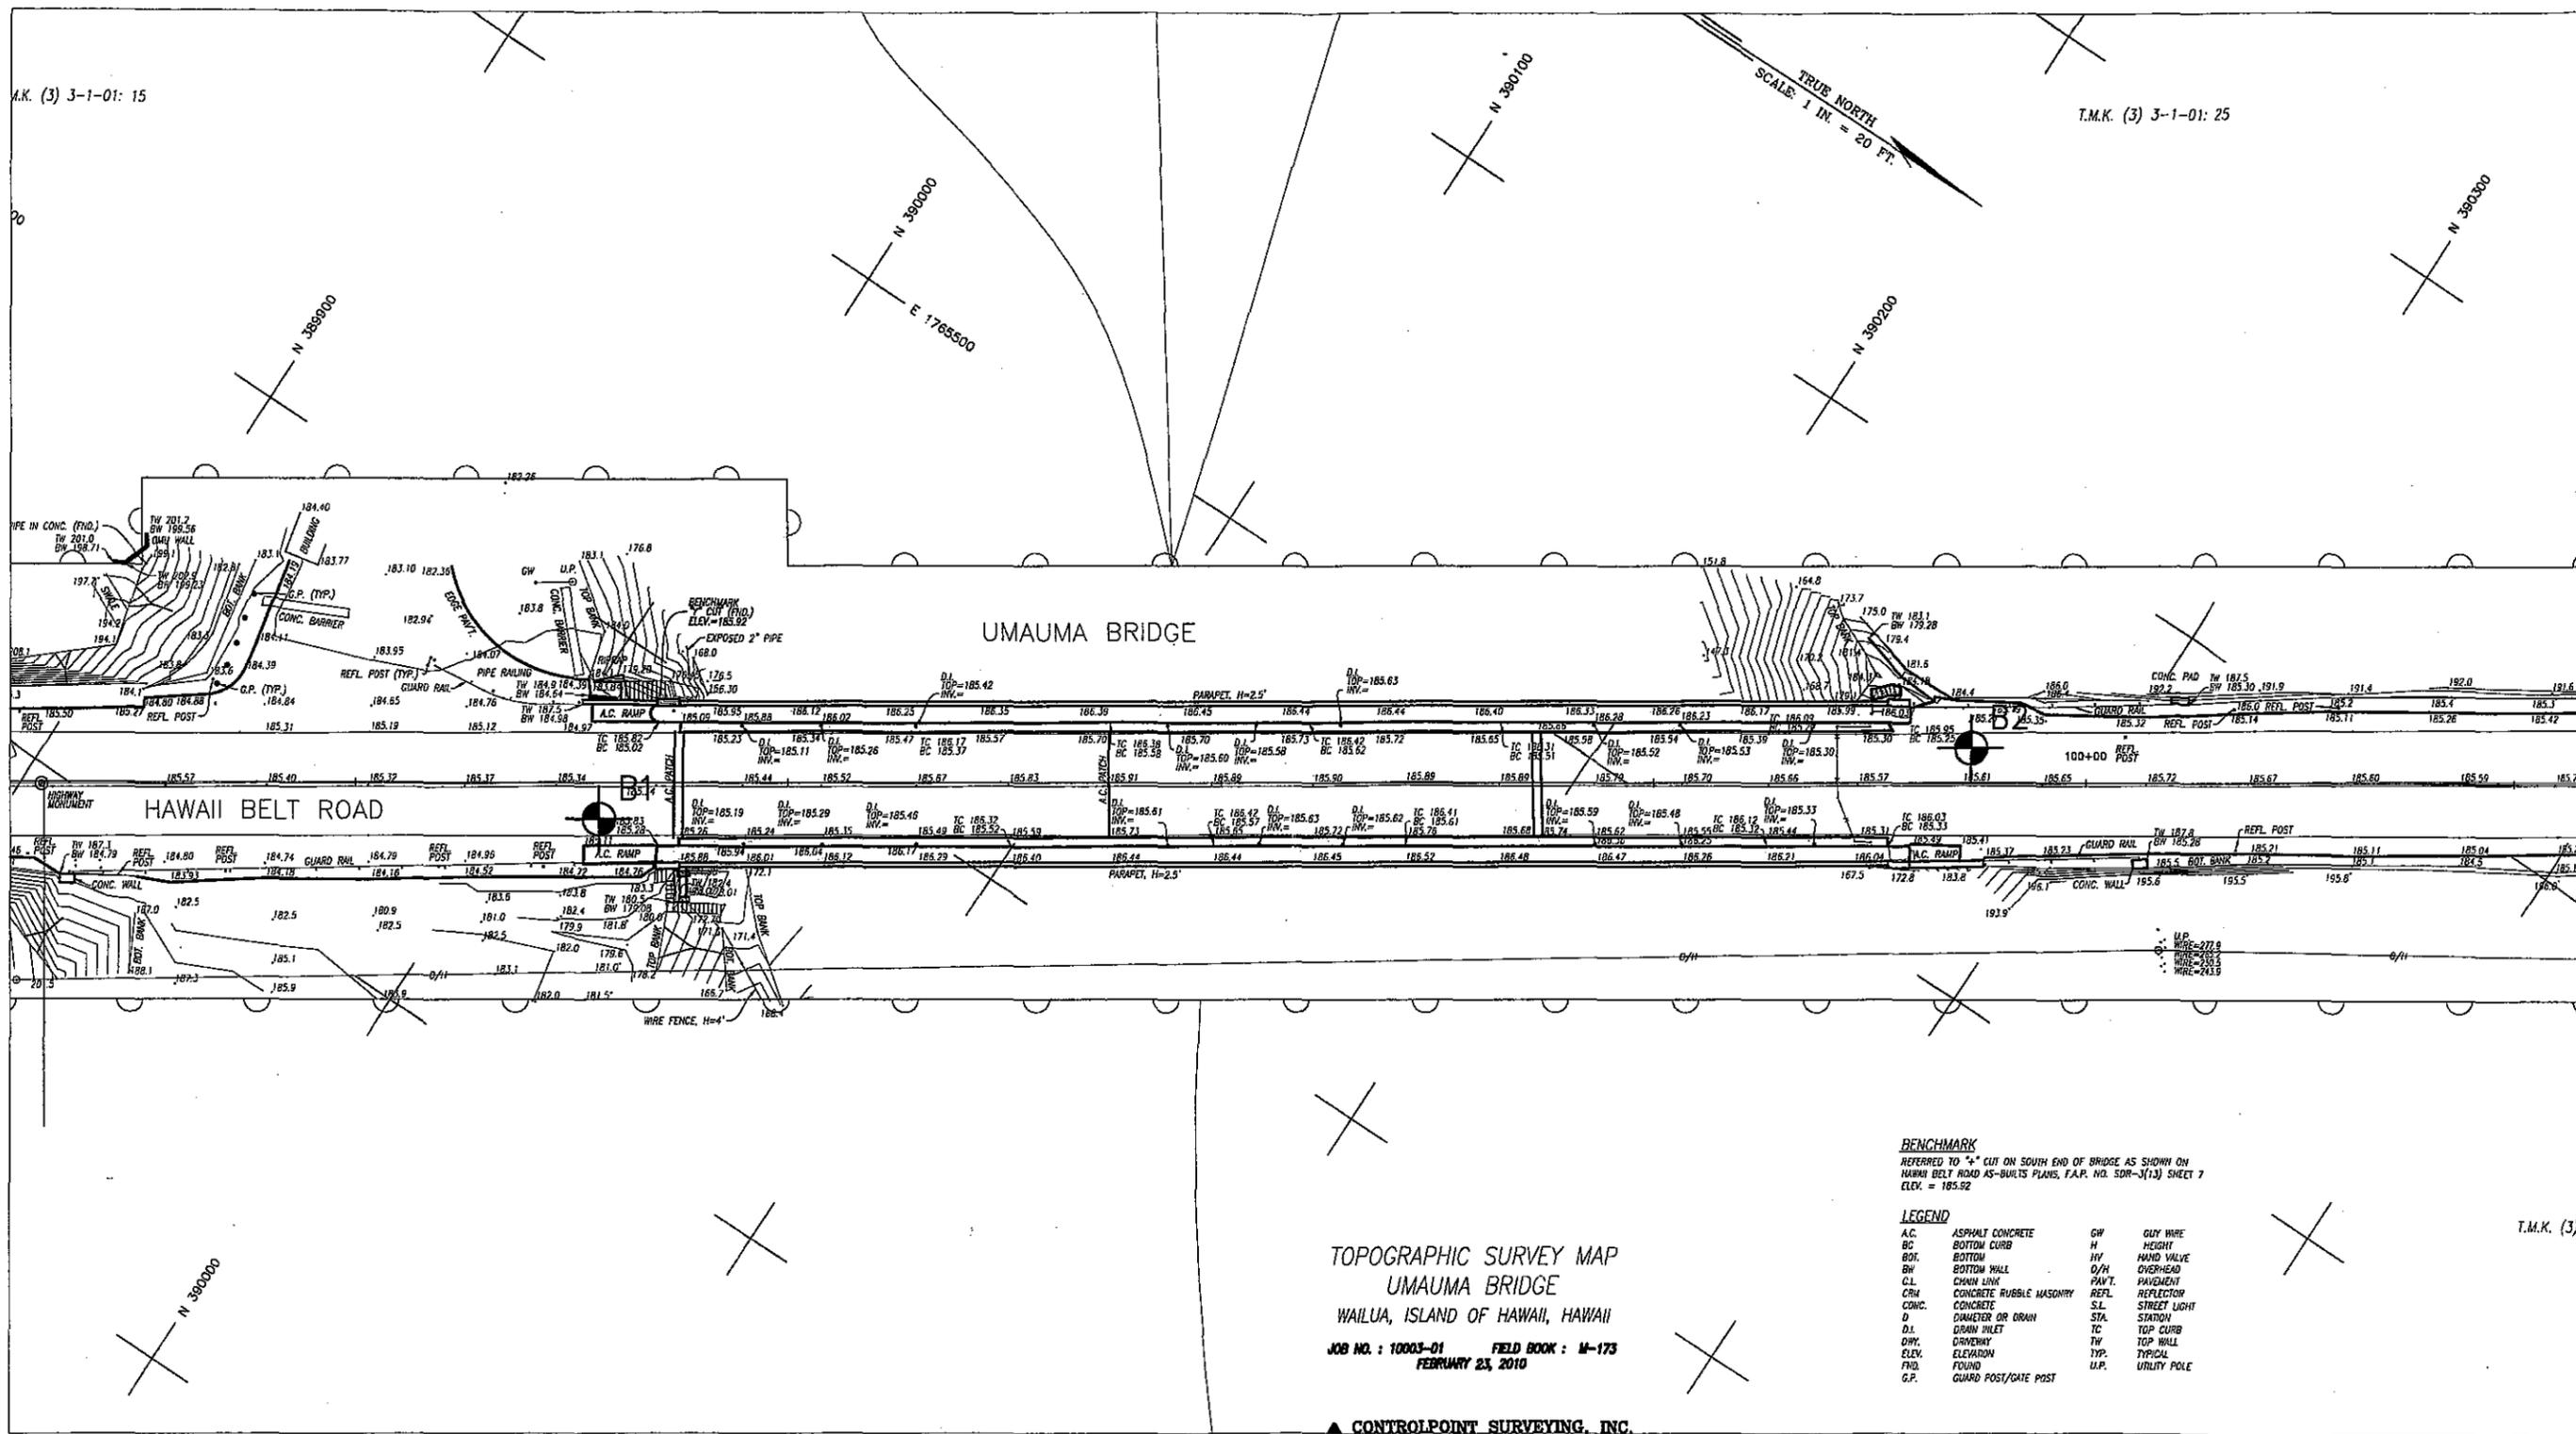
Plate A2.2

BORING LOCATION PLAN

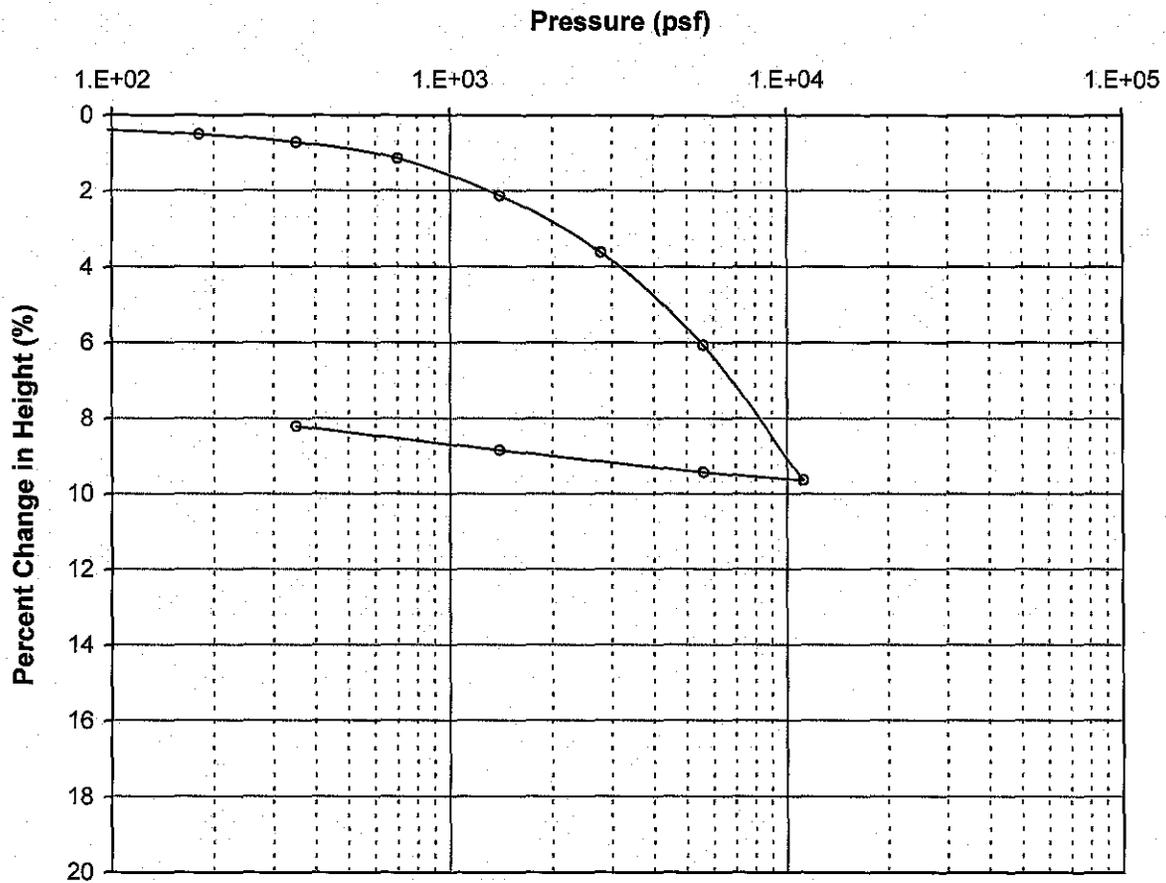
Consolidation Test Results

Boring No.: B1 Depth (ft): 28
 Soil Description: Mottled brown clayey silt

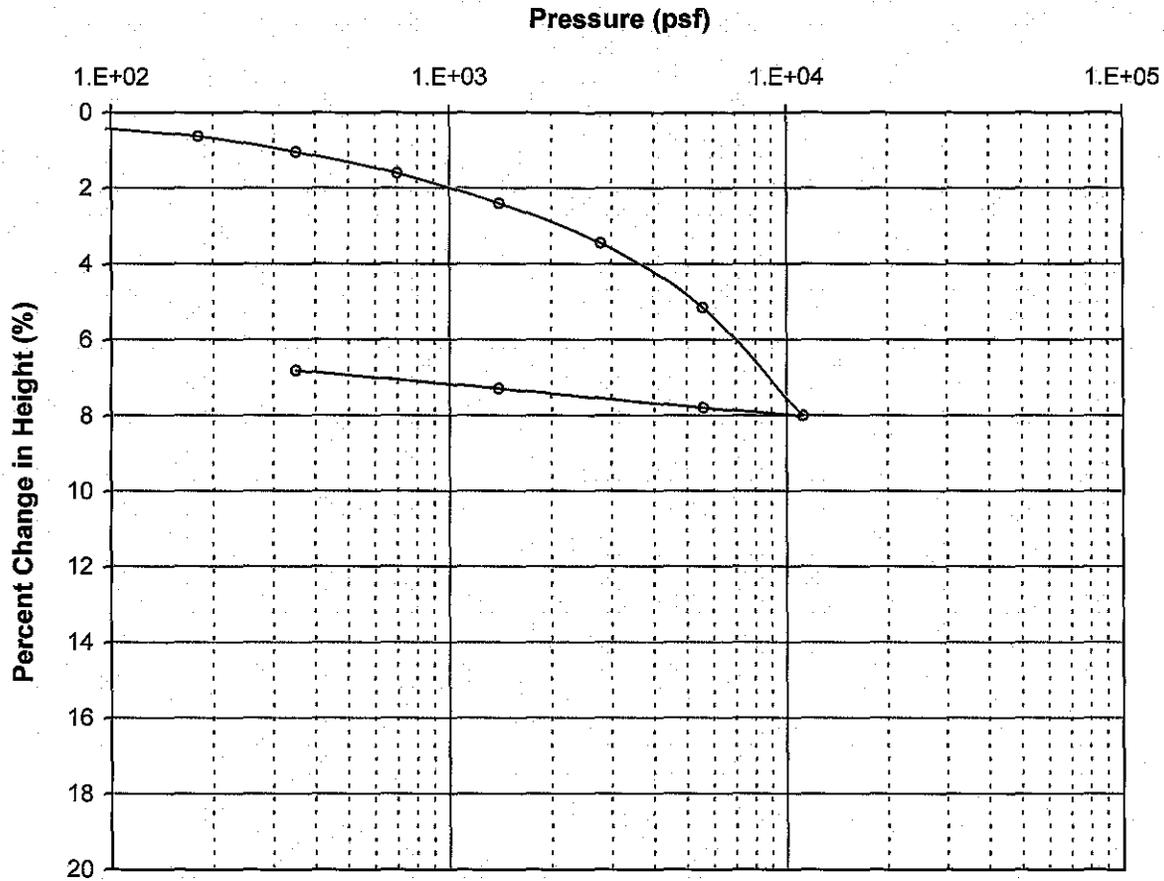
Consolidation Test Results

Boring No.: B2 Depth (ft): 13
 Soil Description: Mottled brown completely weathered rock

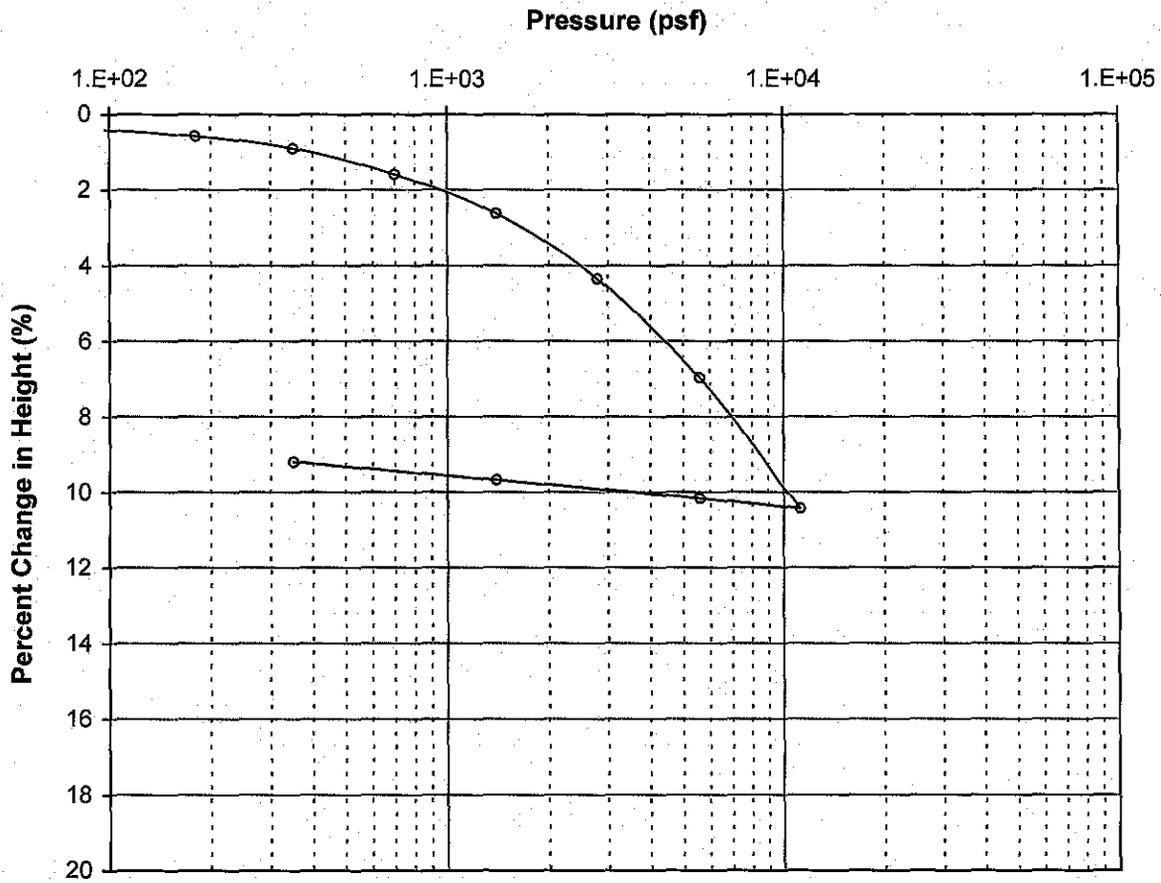
Consolidation Test Results

Boring No.: B4 Depth (ft): 4
 Soil Description: Brown clayey silt

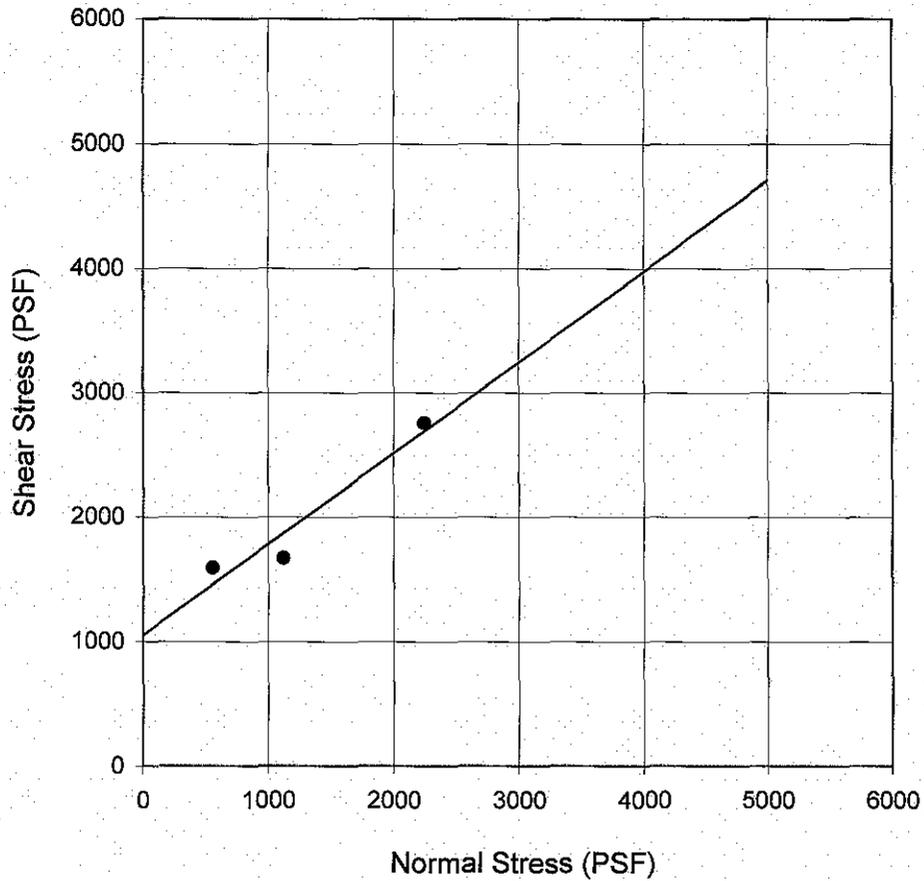
Direct Shear Test Results

Boring No.: B1 Depth (ft): 13
 Soil Description: Mottled brown clayey silt with sand and gravel
 Strength Intercept (C): 1052.4 PSF
 Friction Angle (ϕ): 36.2 DEG

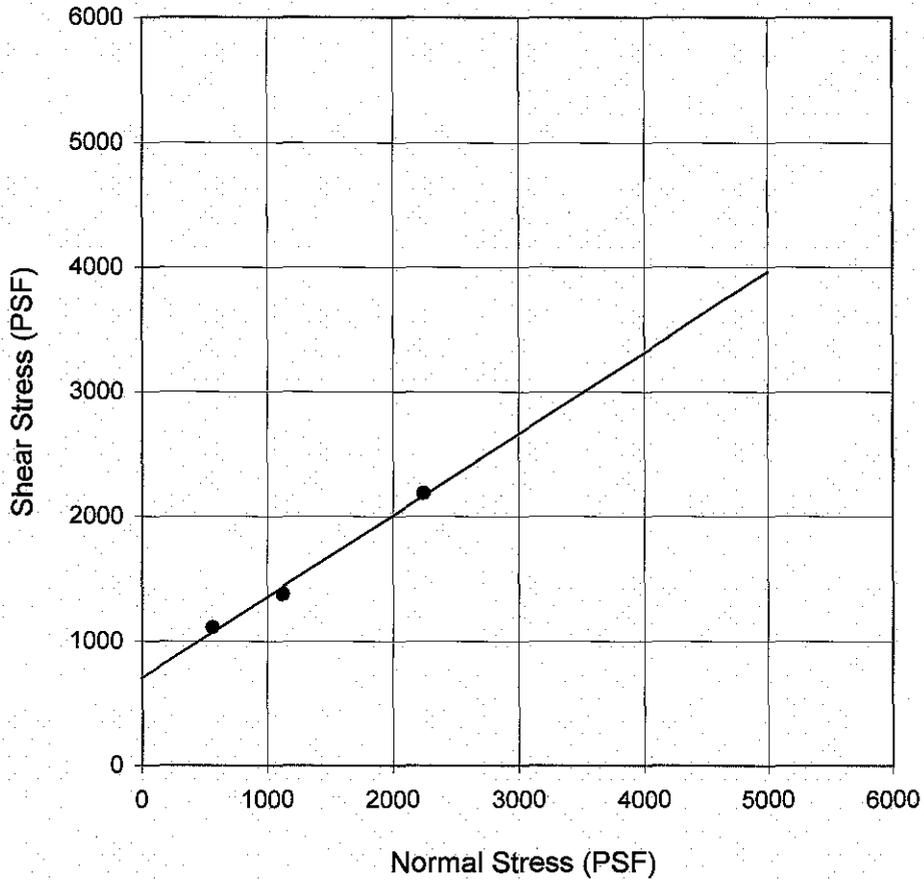
Direct Shear Test Results

Boring No.: B1 Depth (ft): 33
 Soil Description: Mottled brown clay silt
 Strength Intercept (C): 705.0 PSF
 Friction Angle (ϕ): 33.1 DEG

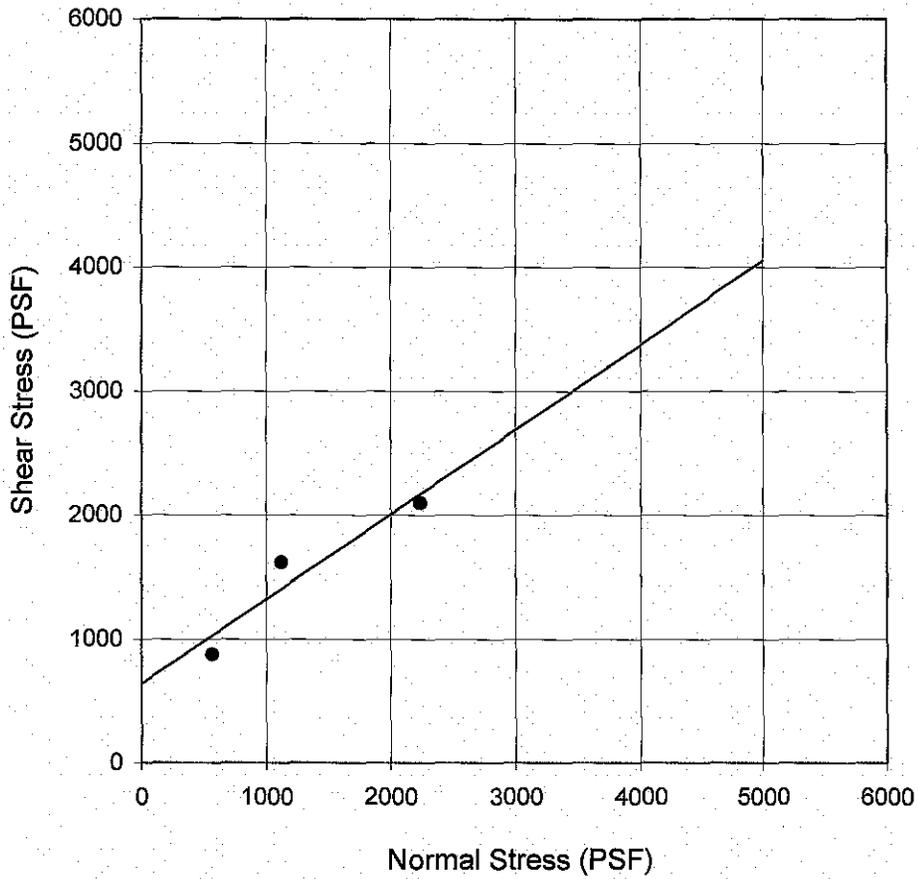
Direct Shear Test Results

Boring No.: B2 Depth (ft): 4
 Soil Description: Mottled brown clayey silt with gravel
 Strength Intercept (C): 643.1 PSF
 Friction Angle (ϕ): 34.3 DEG

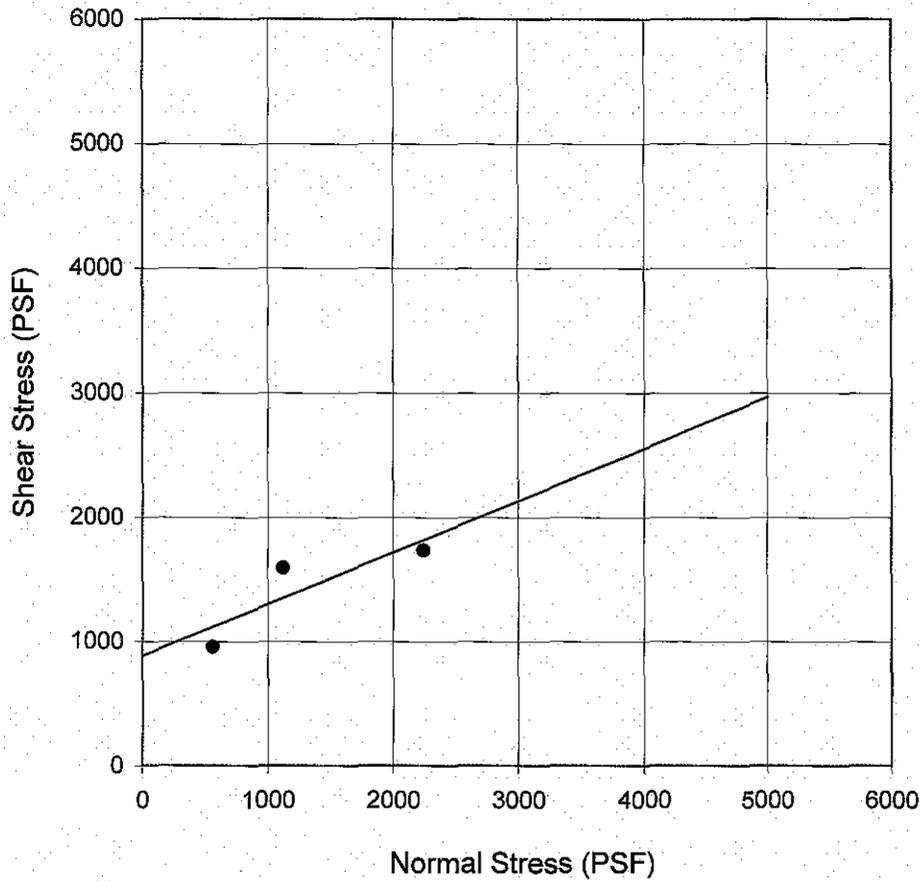
Direct Shear Test Results

Boring No.: B2 Depth (ft): 28
 Soil Description: Mottled brown completely weathered rock
 Strength Intercept (C): 885.8 PSF
 Friction Angle (ϕ): 22.6 DEG

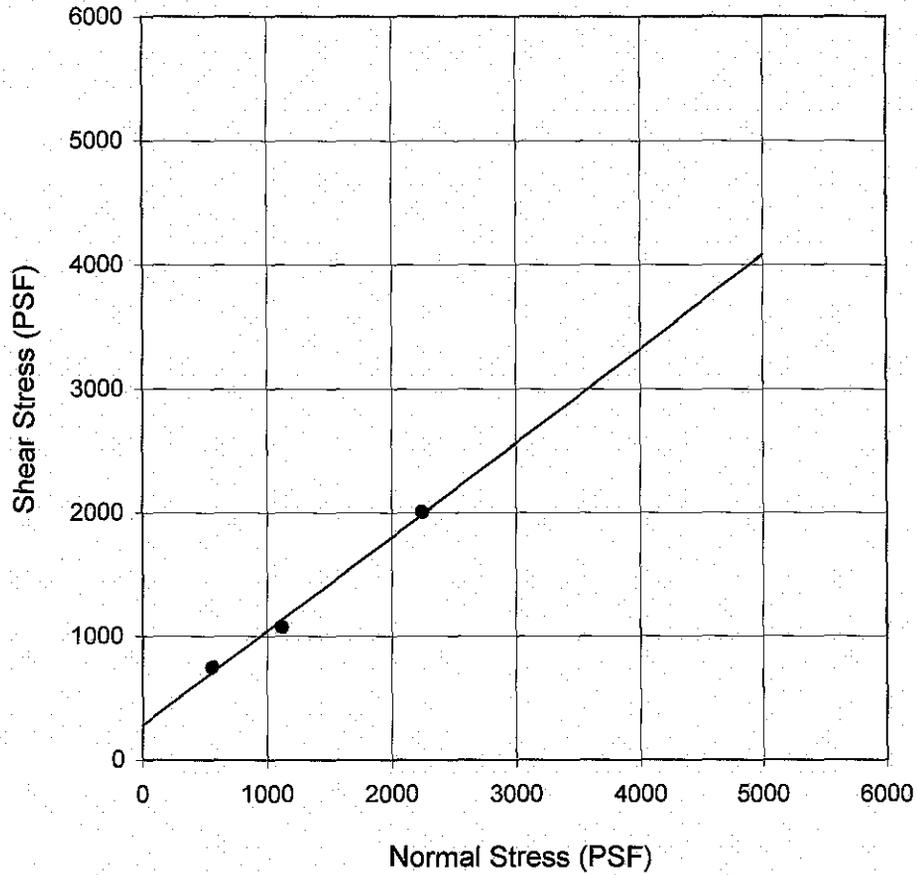
Plate B3.5

Direct Shear Test Results

Boring No.: B4 Depth (ft): 2
 Soil Description: Brown clayey silt with gravel
 Strength Intercept (C): 281.4 PSF
 Friction Angle (ϕ): 37.2 DEG

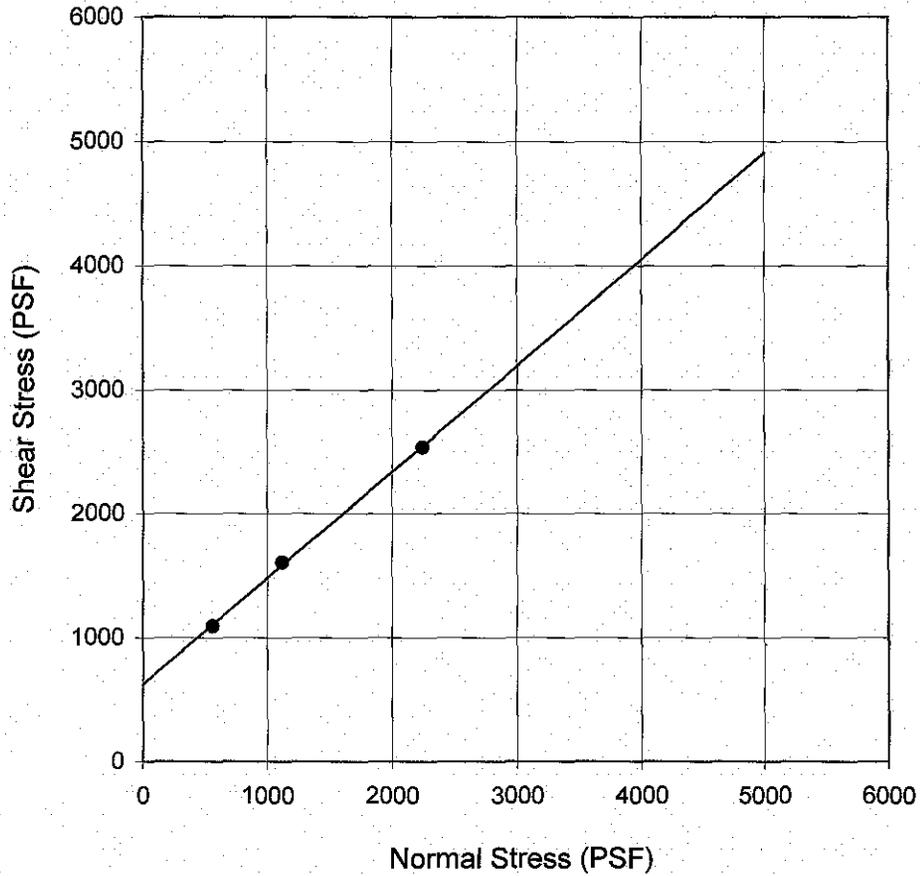
Direct Shear Test Results

Boring No.: B5 Depth (ft): 2
 Soil Description: Mottled brown clayey silt with gravel
 Strength Intercept (C): 624.1 PSF
 Friction Angle (ϕ): 40.6 DEG

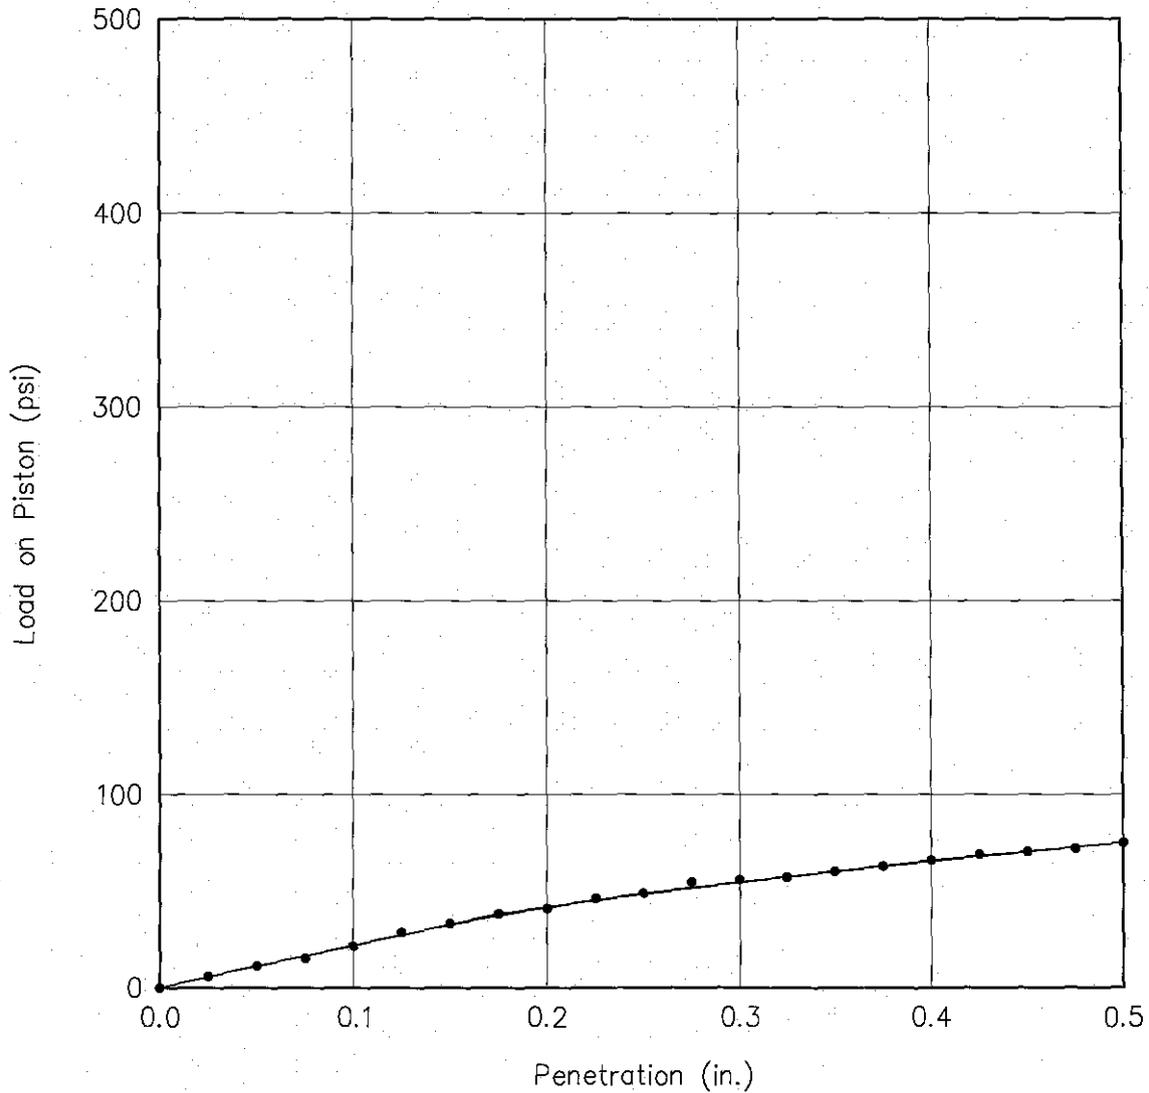
Location: Boring B1 at 2 to 4 ft
 Description: Brown clayey silt
 Sample Dry Density: 74 pcf
 Sample Moisture Content: 45%

W.O. 10-4890	Umauma Stream Bridge Rehabilitation, North Hilo
Hirata & Associates, Inc.	CBR STRESS PENETRATION CURVE Plate B5.1

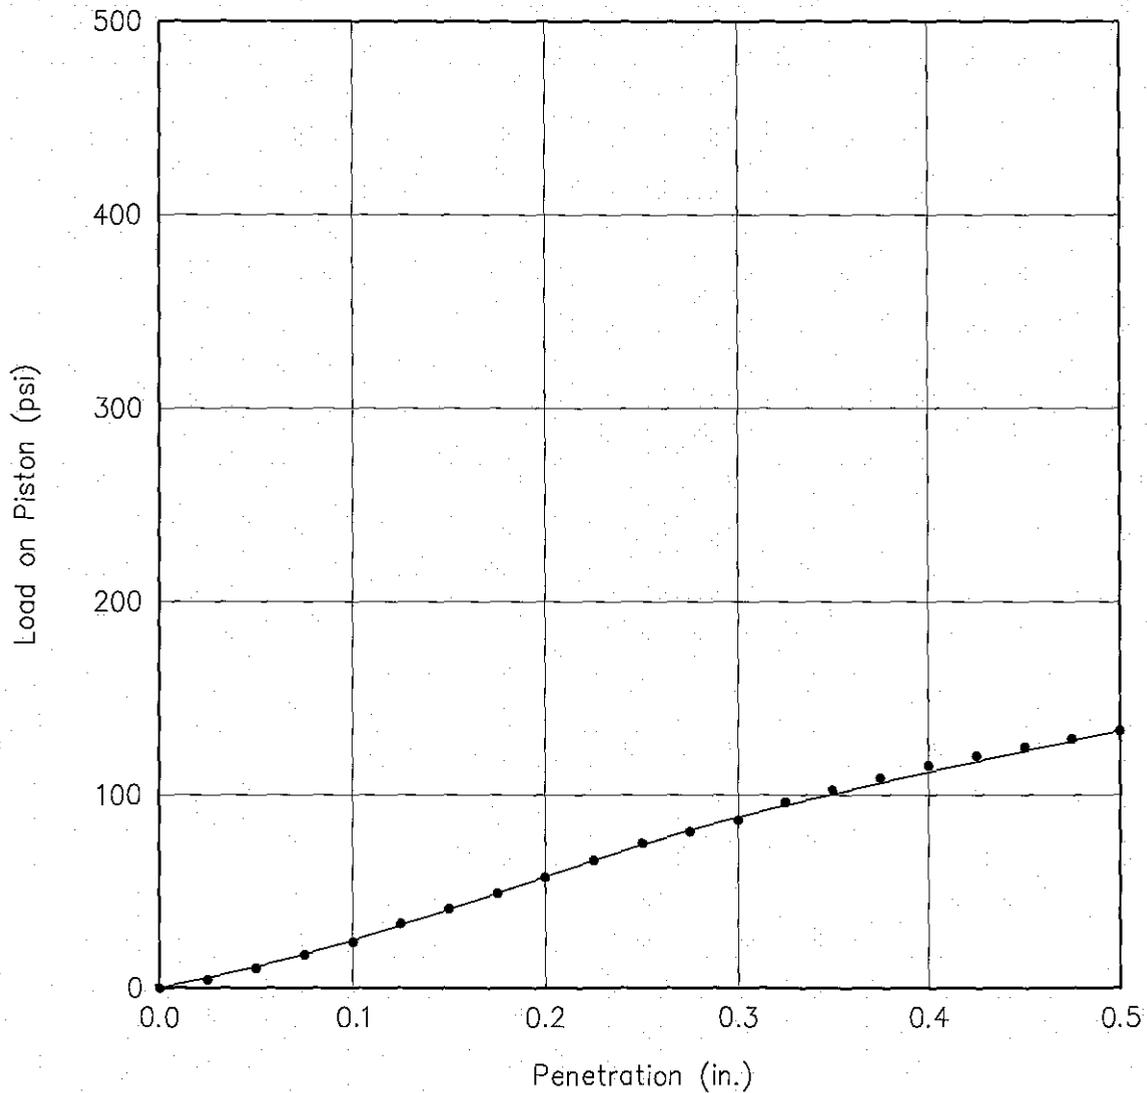
Location: Boring B2 at 2 to 4 ft
 Description: Brown clayey silt
 Sample Dry Density: 74 pcf
 Sample Moisture Content: 43%

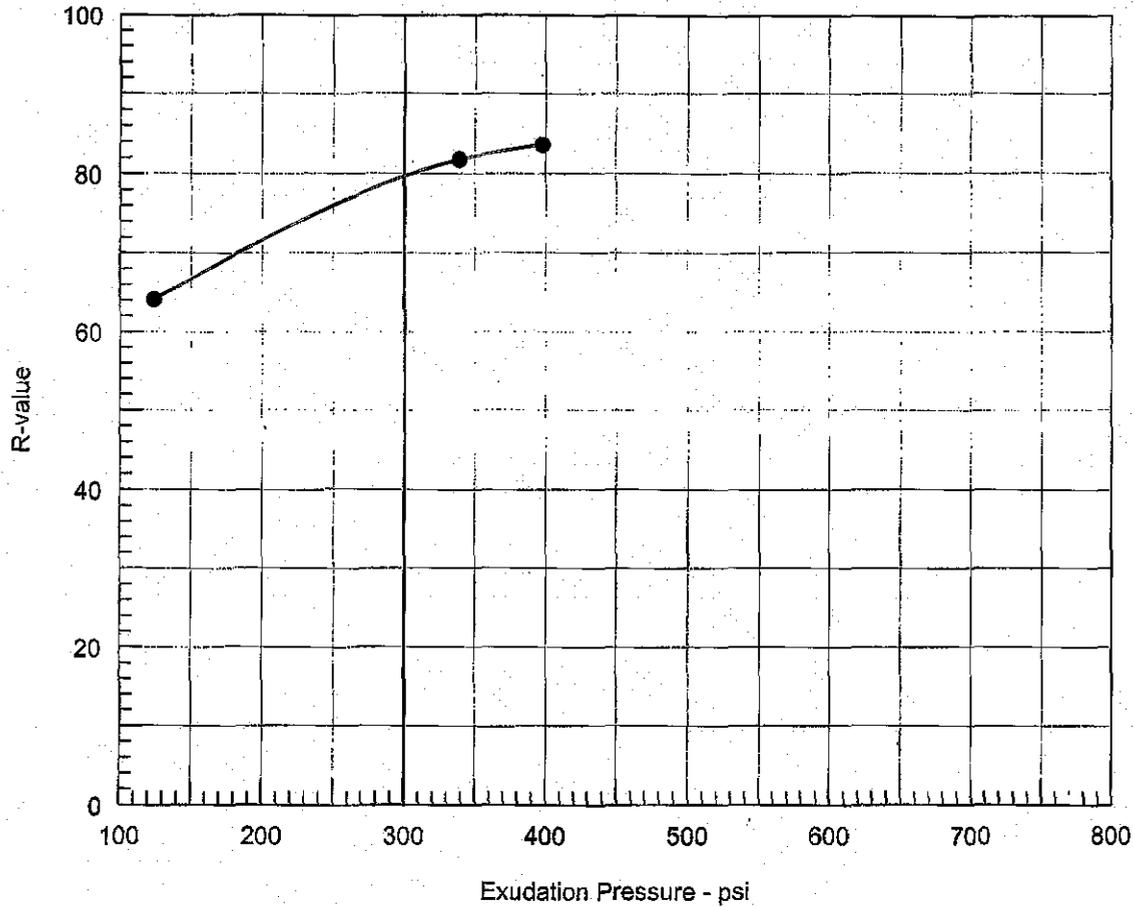
Resistance R-Value and Expansion Pressure - ASTM D 2844

No.	Compact. Pressure psi	Density pcf	Moist. %	Expansion Pressure psi	Horizontal Press. psi @ 160 psi	Sample Height in.	Exud. Pressure psi	R Value	R Value Corr.
1	250	117.9	17.2	0.00	42	2.50	124	64	64
2	350	118.2	16.4	0.00	17	2.44	398	84	84
3	325	118.1	16.7	0.00	20	2.48	339	82	82

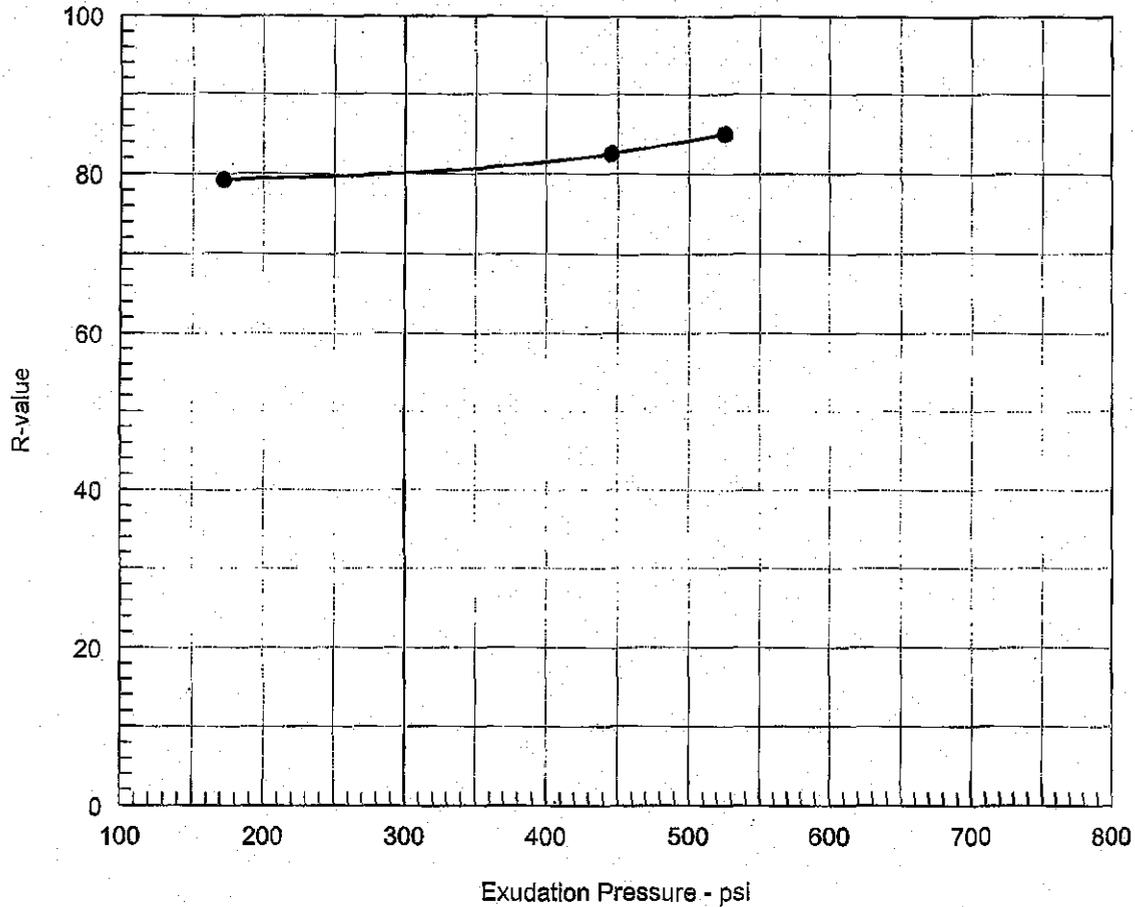
Resistance R-Value and Expansion Pressure - ASTM D 2844

No.	Compact. Pressure psi	Density pcf	Moist. %	Expansion Pressure psi	Horizontal Press. psi @ 160 psi	Sample Height in.	Exud. Pressure psi	R Value	R Value Corr.
1	350	113.0	18.0	0.21	17	2.44	525	86	85
2	350	113.5	18.9	0.00	24	2.46	172	79	79
3	350	113.9	18.4	0.00	19	2.42	446	83	83

Test Results	Material Description
<p>R-value at 300 psi exudation pressure = 80</p>	<p>Reddish brown gravelly sandy silt, B2, sample received 4/22/2010</p>
<p>Project No.: 0020078 Project: Location: Umauma Stream Bridge Rehab, WO #10-4890 Sample Number: 2110-2 (SL397) Depth: 2'-4' Date: 4/28/2010</p>	<p>Tested by: DTN Checked by: LKL Remarks: B2</p>
<p>R-VALUE TEST REPORT SIGNET TESTING LABS, INC.</p>
