SUBJECT: FINDING OF NO SIGNIFICANT IMPACT (FONSI) FOR
HAWAII BELT ROAD
REHABILITATION OF UMAUMA STREAM BRIDGE
FEDERAL AID PROJECT NO. BR-019-2(61)

**REHABILITATION OF UMAUMA STREAM BRIDGE
PROJECT**

**District of North Hilo, Island of Hawai'i
Federal Project No. BR-019-2(61)**

**State of Hawai'i
Department of Transportation, Highways Division**

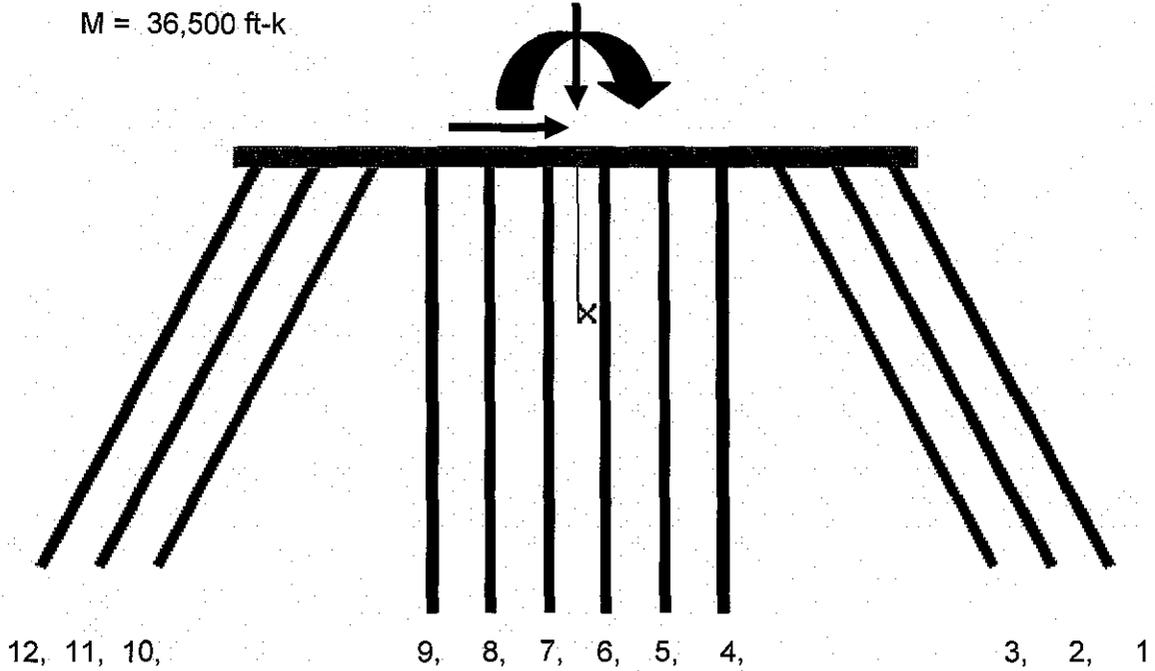
Applied Load at Pile cap in transverse direction
 $P = 2300 \text{ k}$
 $V = 1400 \text{ k}$
 $M = 36,500 \text{ ft-k}$

Note: each row has 4 (7-in diameter) micropiles

Row No.	Verical Load (kips)	Lateral Load (kips)	Axial Load (kips)	Shear (kips)	Bending Moment (ft-kips)
1	157	80.9	176.6	2.2	3.37
2	144.7	75	163	2.4	3.83
3	132.5	69.1	149.4	2.5	4.28
4	91.1	4	91.1	4	8.04
5	75.9	4	75.9	4	8.04
6	60.7	4	60.7	4	8.05
7	45.5	4	45.5	4	8.05
8	30.3	4	30.3	4	8.05
9	15.2	4	15.2	4	7.97
10	-47	27.8	-54.5	3.8	7.28
11	-59.3	33.7	-68.1	3.7	6.86
12	-71.5	39.7	-81.7	3.5	6.44

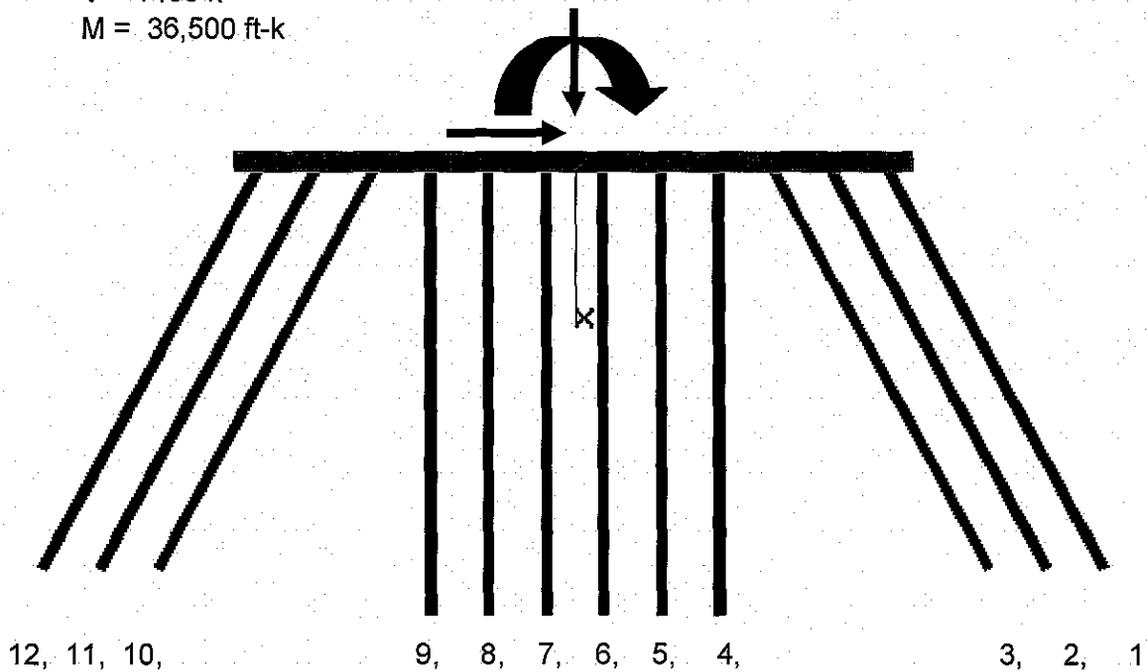
Note: each row has 4 (7-in diameter) micropiles

Row No.	Vertical Load (kips)	Lateral Load (kips)	Axial Load (kips)	Shear (kips)	Bending Moment (ft-kips)
1	142.1	73.7	160.0	2.4	3.90
2	129.8	67.8	146.4	2.6	4.35
3	117.6	61.8	132.8	2.7	4.79
4	72.7	4	72.7	4	8.02
5	57.5	4	57.5	4	8.02
6	42.3	4	42.3	4	8.02
7	27	4	27	4	8.02
8	11.8	4	11.8	4	8.02
9	-3.3	4	-3.3	4	8.03
10	-61.9	35	-71	3.6	6.74
11	-74.1	40.9	-84.6	3.5	6.32
12	-86.4	46.9	-98.2	3.3	5.89

Pile Cap Deflection = 0.06 inch

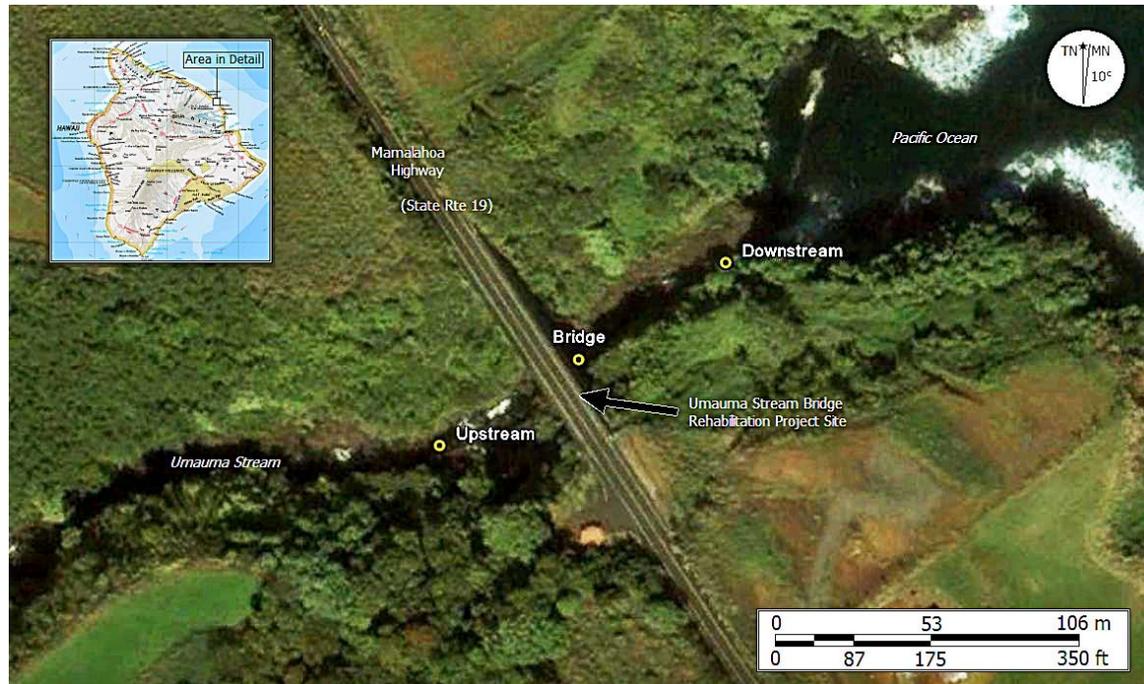
Figure 2. Location of water quality stations (yellow circles) sampled on July 21, 2010.

Station “Upstream” was located in a large pool approximately 175 ft (53 m) upstream of the Māmalahoa Highway bridge, upstream from the Umauma-Hanapueo confluence. Station “Bridge” was located a few meters downstream from the bridge. Station “Downstream” was located in a pool just above the waterfall near the ocean shore, about 200 ft (60 m) downstream from the bridge. All water samples were collected on July 21, 2010 and delivered to AECOS, Inc. in Kane’ohe, O’ahu for laboratory analyses (AECOS Log No 26469).

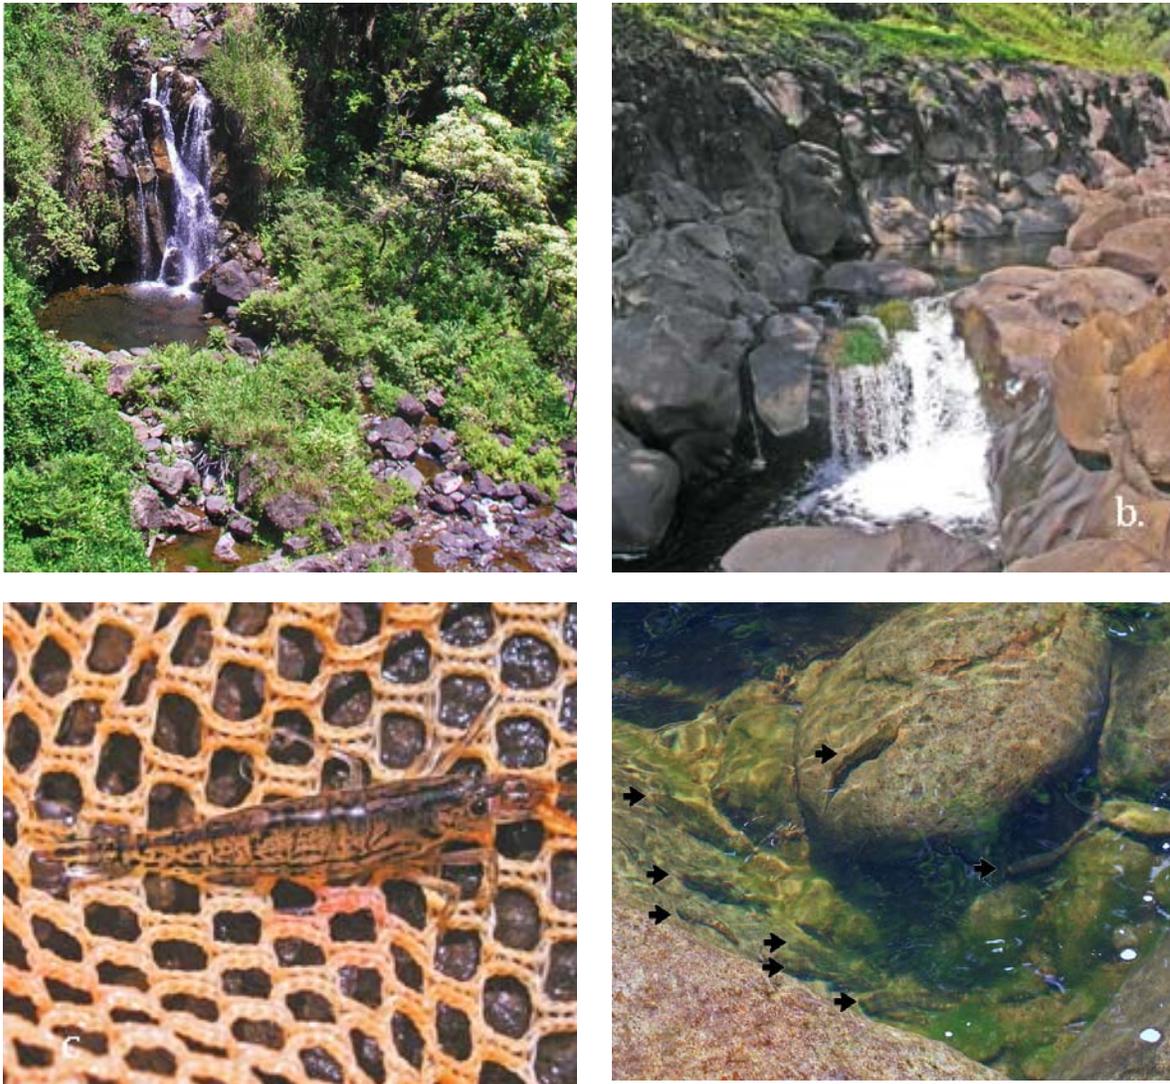
Figure 3. (Clockwise from top left) Hanapueo confluence with Umauma Stream just upslope from highway bridge; Stream flow and chlorophyte growth downstream from project site; Endemic *‘ōpae kālā’ole* from Umauma stream; Numerous *‘o’opu nakea* and *‘o’opu ‘alamo’o* in a large pool upstream from the project site.
