SUBJECT: DRAFT ENVIRONMENTAL ASSESSMENT (EA) FOR THE PROPOSED MILOWAI MA'ALAEA SEAWALL REPAIR PROJECT, LOCATED AT 50 HAUOLI STREET, WAILUKU, MAUI, HAWAII; TMK: (2) 3-8-014:022 (SM1 2012/0008) (EA 2012/0006) (SSV 2012/0004)

Project Name: Milowai Ma'alaewa Seawall Repair Draft EA

On behalf of the Owner, Sandhills Gang Partners, the Applicant, Milowai Ma'alaea AOO is seeking a Special Management Area (SMA) Permit, and a Shoreline Setback Variance (SSV) as part of this Environmental Assessment (EA) to repair an existing seawall at the Milowai Ma'alaea Residential Condominium project.

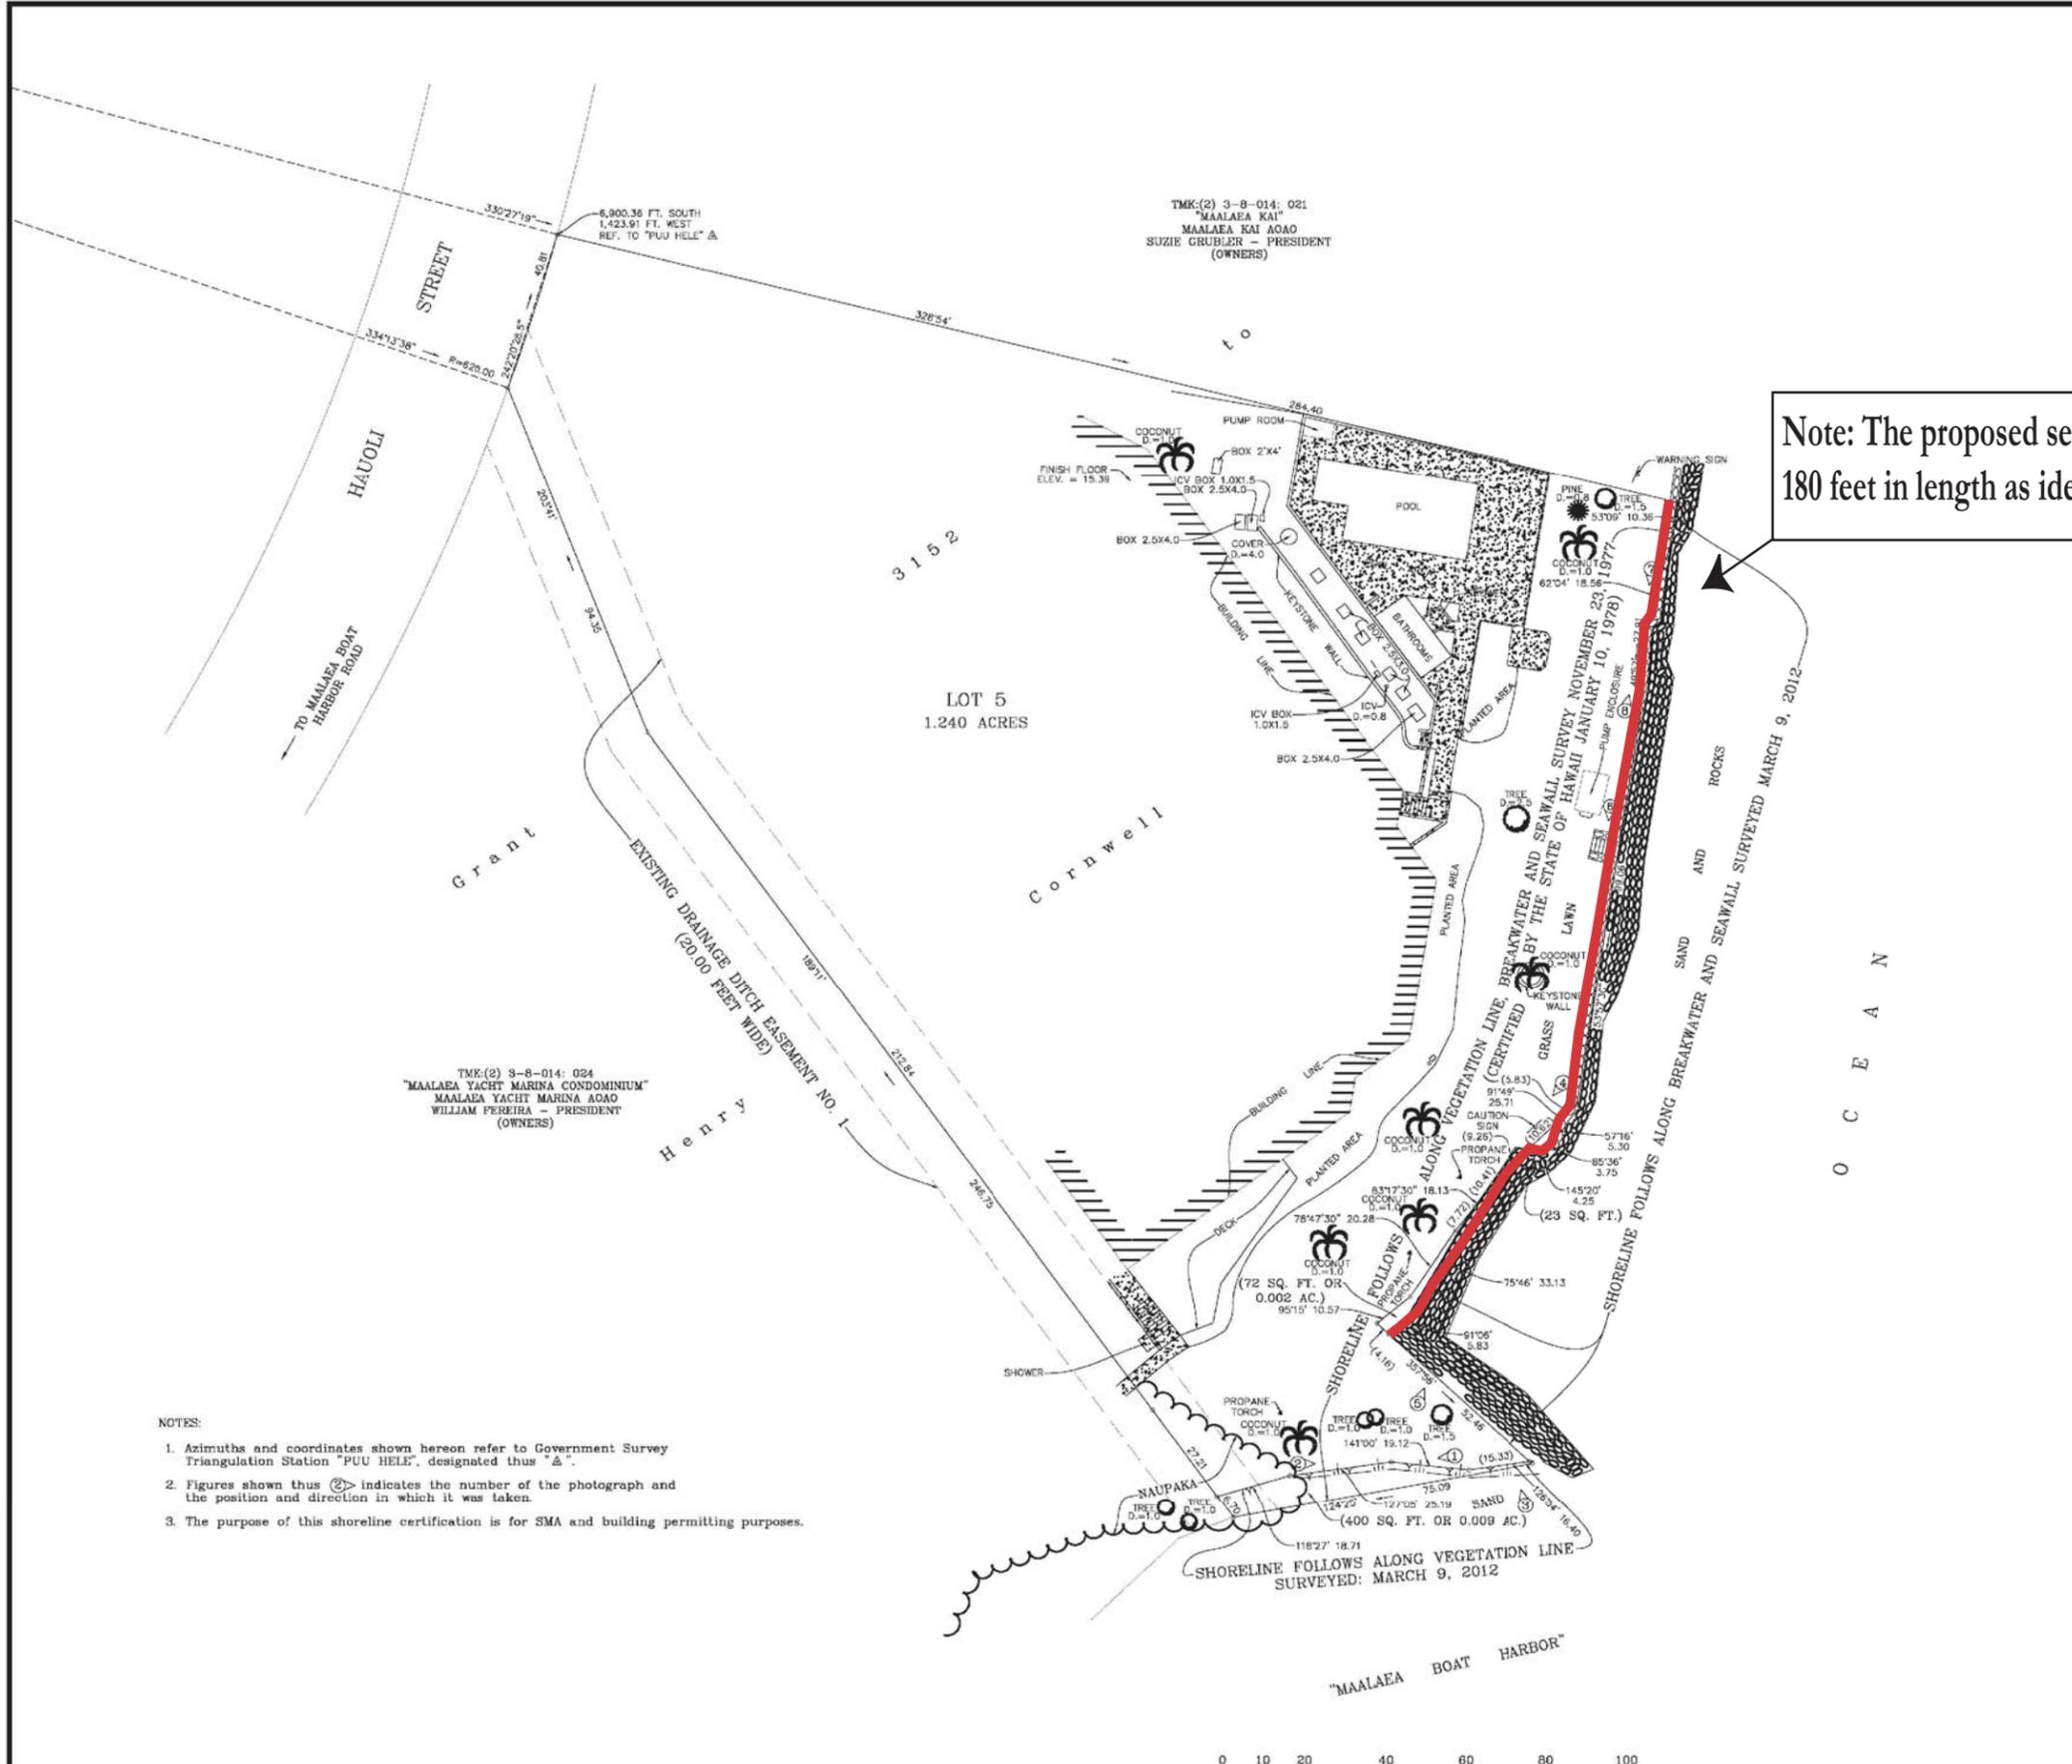
Figure 3
Survey
Milowai Ma'alaea

Note: The proposed seawall repair work is approximately 180 feet in length as identified by the Red Line.

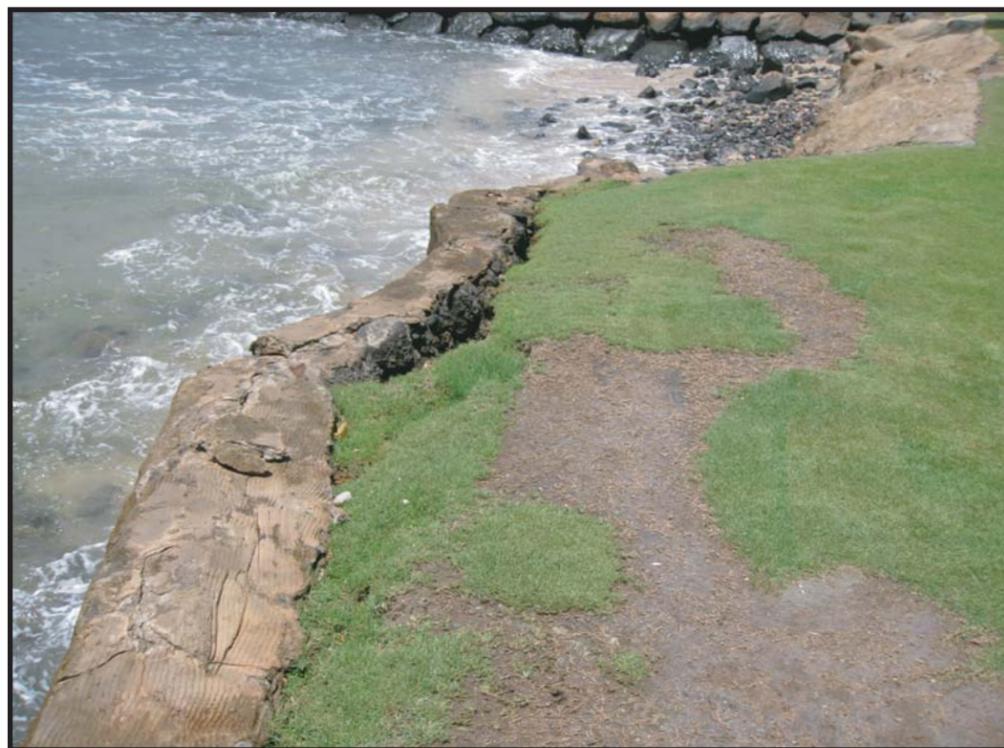
View of the sink hole behind the top of the existing seawall. Note small sand beach and base of Ma'alaea breakwall in the background.

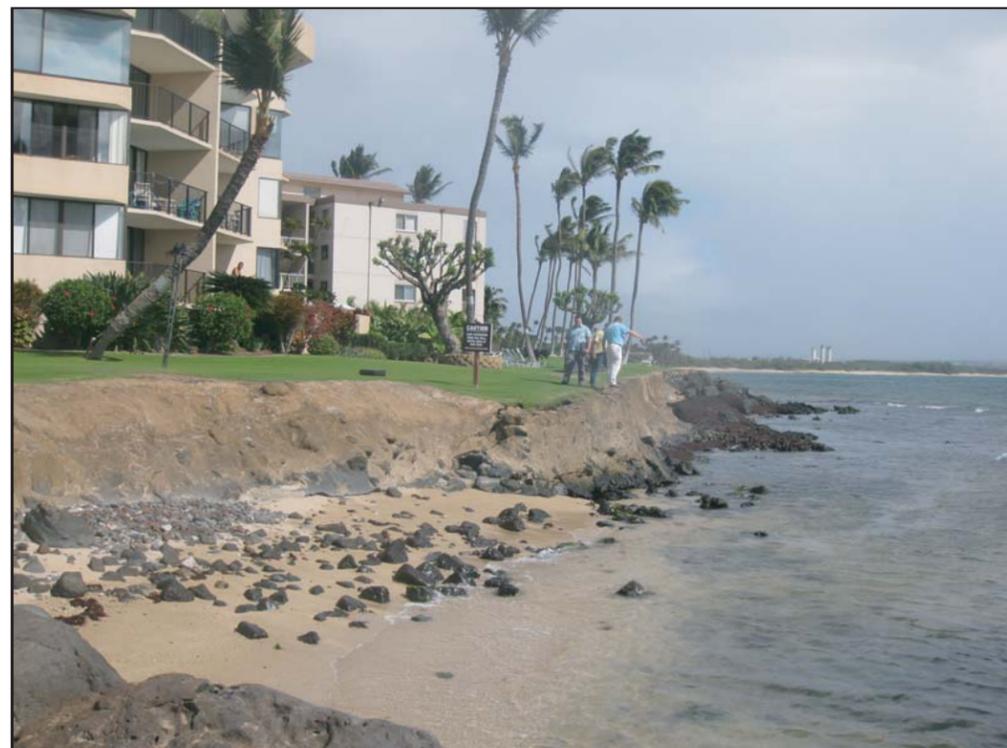
View of the sink hole behind the top of the existing seawall. Note small sand beach and base of Ma'alaea breakwall in the background.

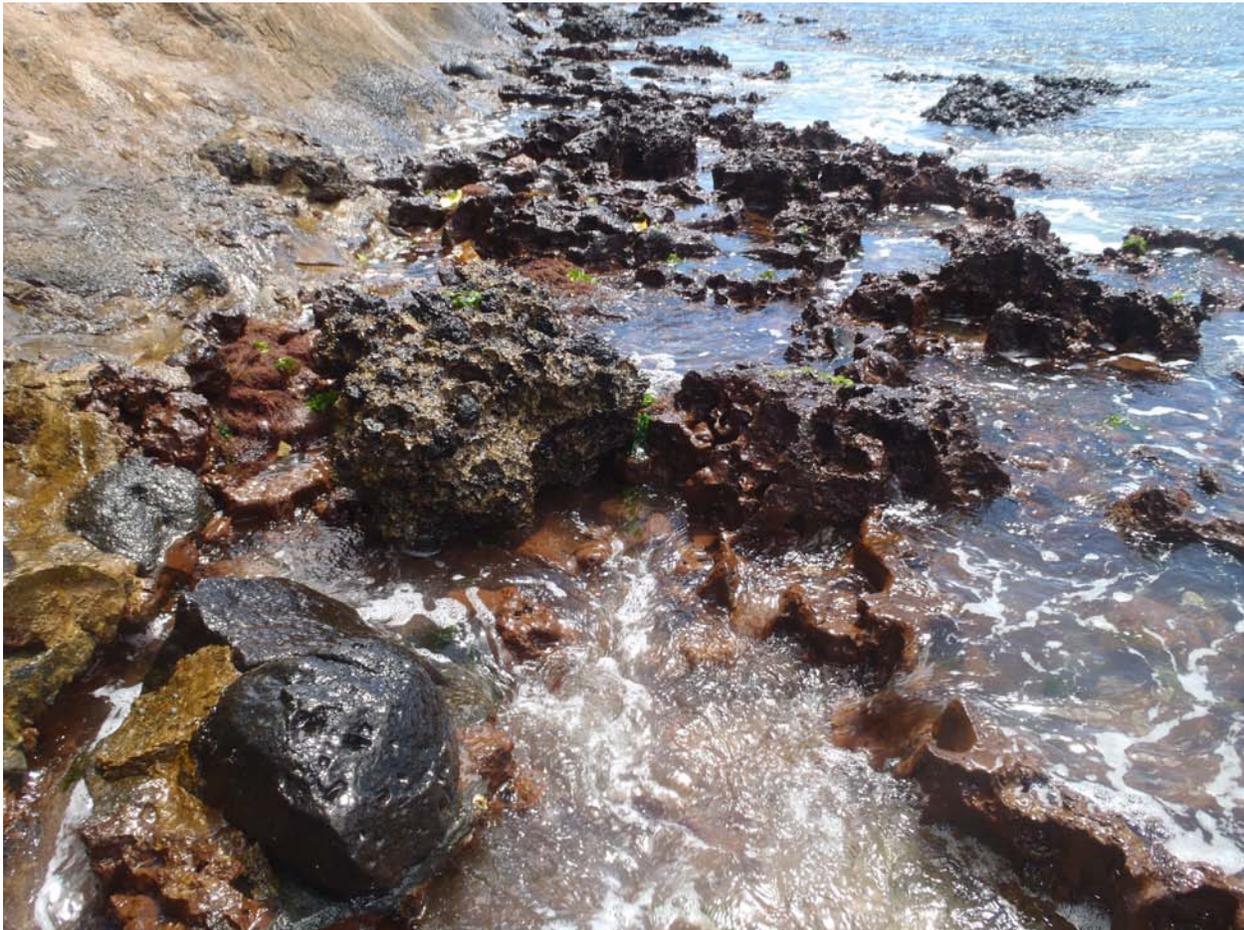
Figure 2-2. Milowai seawall footing on weathered rock foundation

The weathered material is solution pitted due to the chemical and mechanical forces of wave action. As illustrated by Figure 2-2, this process may also be responsible for the undermining found along portions of the wall's footing, leaving the wall unsupported at a number of locations. Saltwater damage to vegetation and sink holes directly behind the wall, are evidence of both wave overtopping and wall undermining.

The Milowai property's oceanfront shoreline is hardened with a vertical to nearly vertical seawall from the Maalaea jetty to the eastern property boundary, where it ties into the neighboring property's rock revetment. In a number of locations, the seawall exhibits considerable evidence of instability and partial failure likely due to wave overtopping, supportive sediment undermining, and subsequent wall cracking. Based on visual observations of exposed portions of the wall's foundation, the seawall appears to be constructed on substrate consisting of a weathered volcanic material composed of tuffaceous rock with clasts of basalt cobbles, as shown in Figure 2-2 and Figure 2-3.

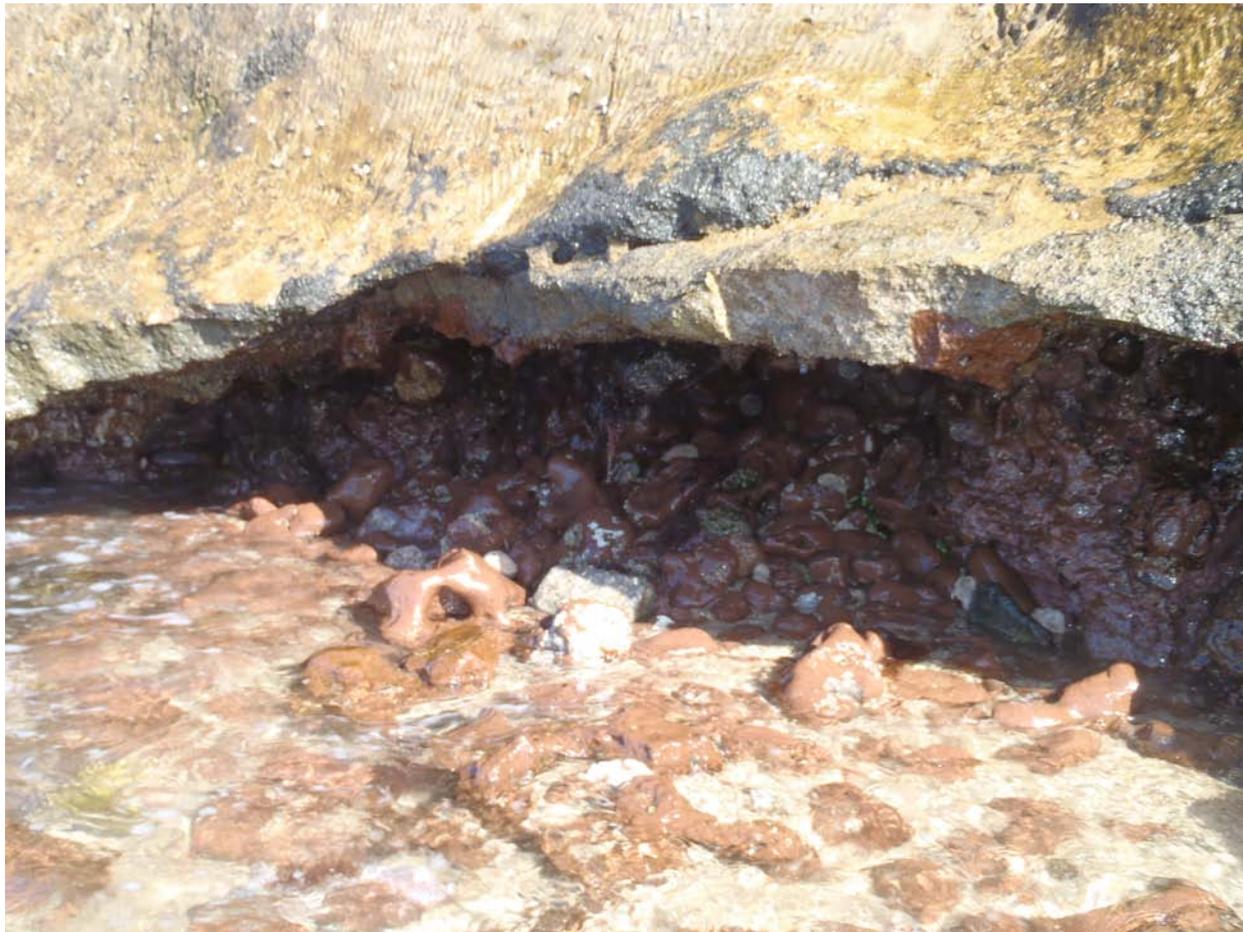
Figure 2-3. Undermined section of seawall footing, revealing weathered volcanic rock as the foundation material

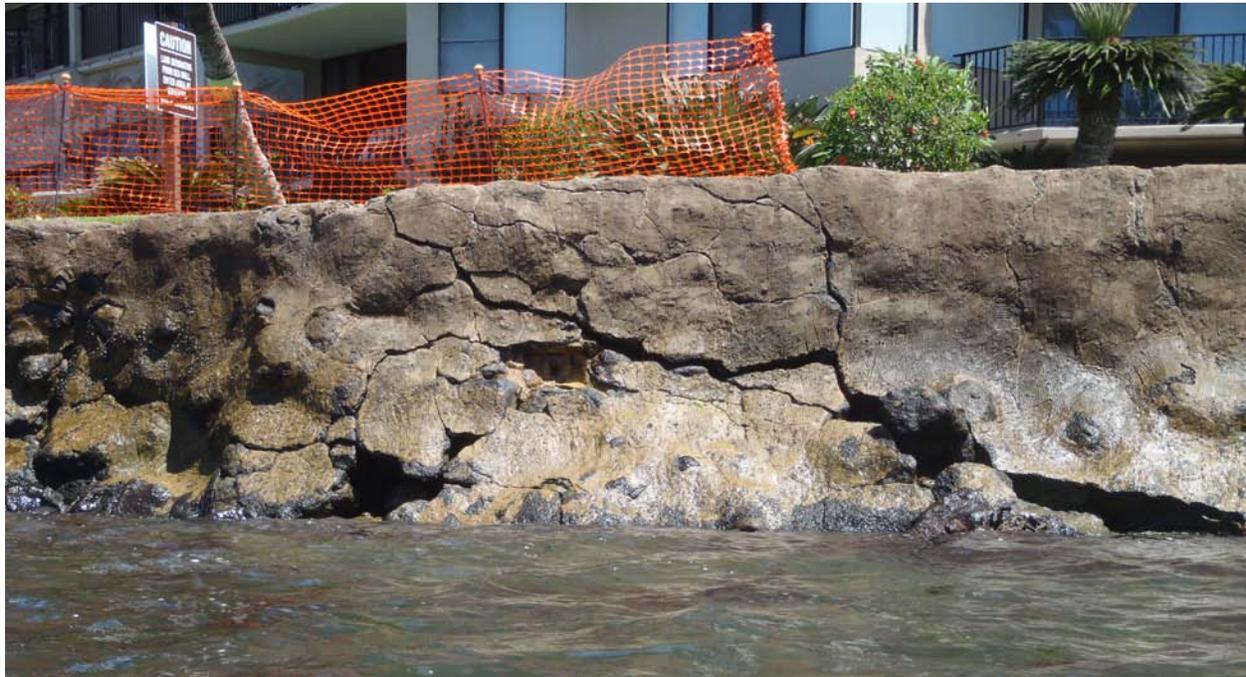
Figure 2-4. Extensive cracking and settlement along western reach of seawall

General layout and existing conditions of the shoreline and CRM seawall are illustrated by the site photographs in Figure 2-4 through Figure 2-7.

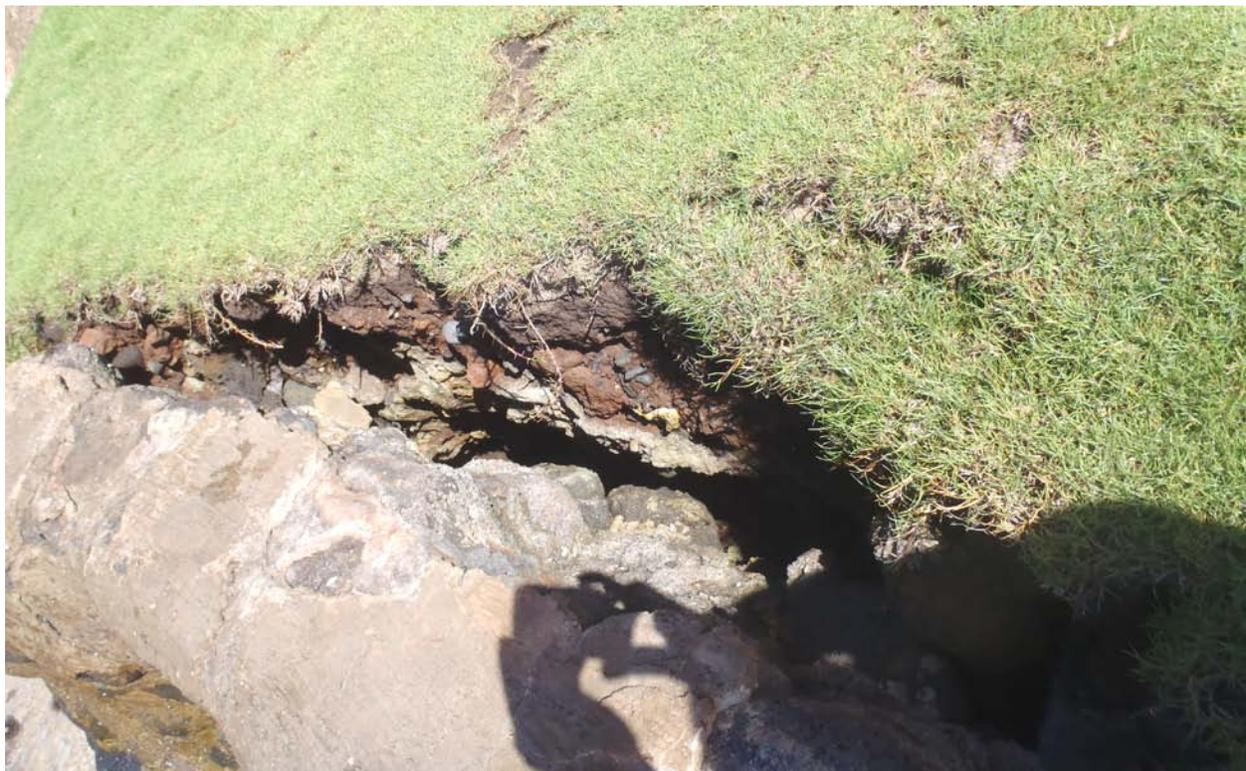
Figure 2-5. Wall displacement away from supportive soil along with significant void space behind wall, indicative of structural instability and failure

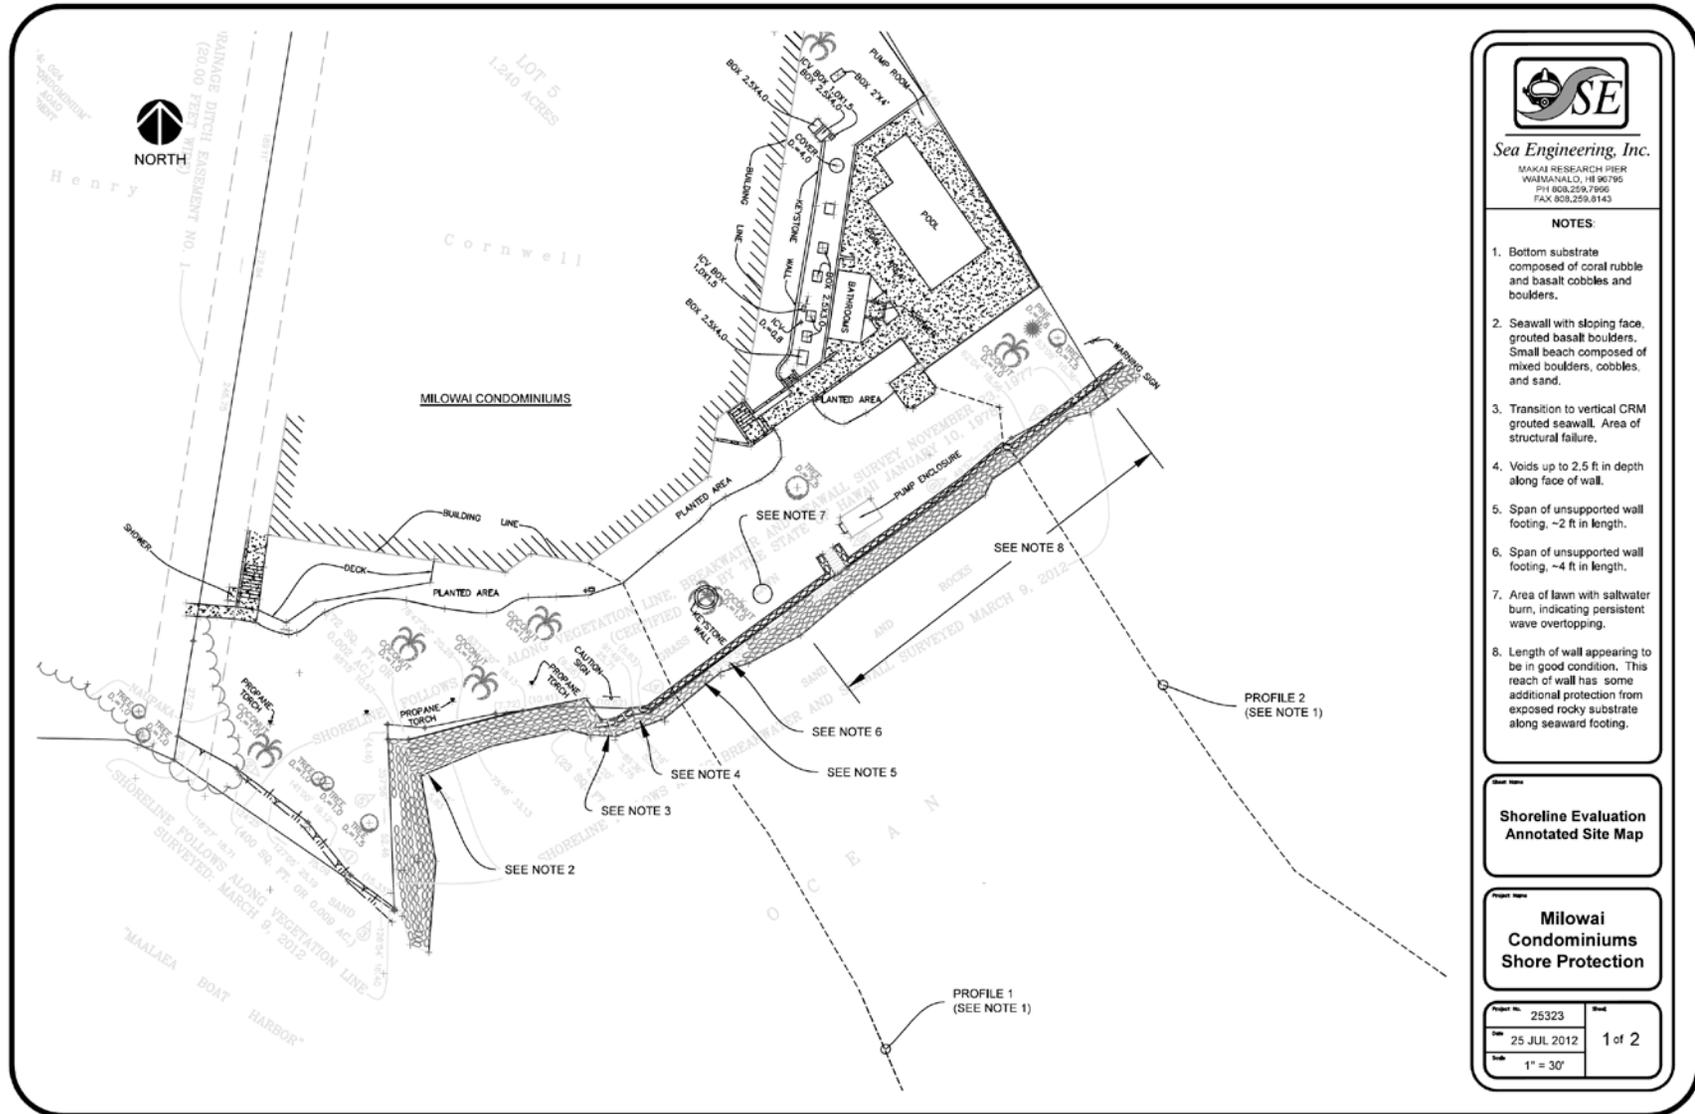
Figure 2-8. Milowai Condominiums site map (topographic survey by Newcomer-Lee Land Surveyors, Inc.)

Sea Engineering measured typical shoreline profiles at the property, running offshore for approximately 200 feet, to identify any significant nearshore features. It was found that nearshore bathymetry was relatively flat and shallow. Profile locations and results are presented on the site map (Figure 2-8) and profiles (Figure 2-9).

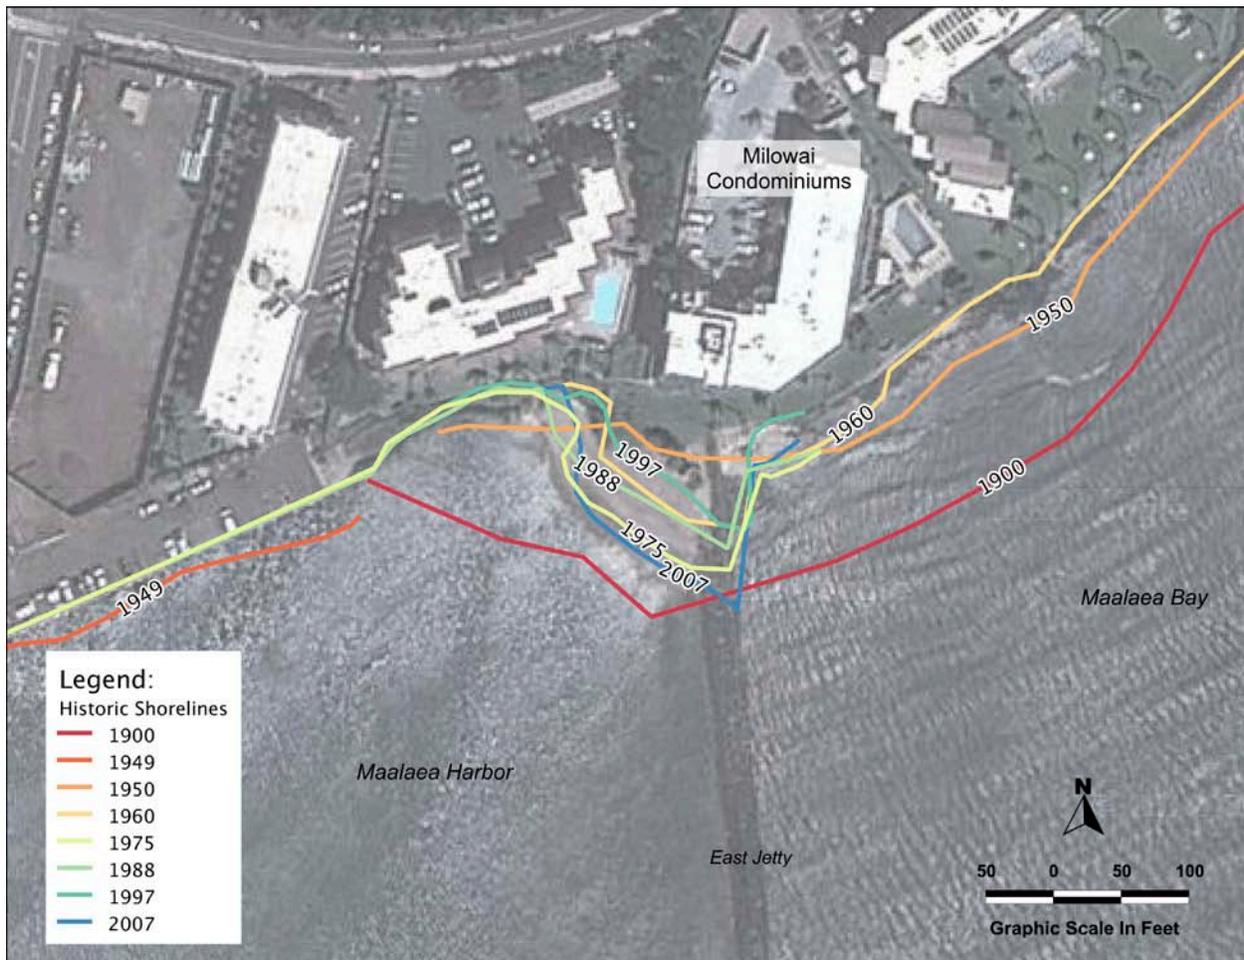
Figure 2-10. Historic shorelines at Maalaea, digitized from aerial photographs. Background image date is March 2011, from Google Maps (Shoreline data source: University of Hawaii Coastal Geology Group)

Coastal erosion trends along the south Maui shoreline have been documented by researchers at the University of Hawaii's Coastal Geology Group (CGG). The CGG analyzed historical aerial photographs dating from 1900 to 2007 to quantify the relative shoreline change over time. During this process, the aerial images were digitally orthorectified (i.e., corrected for distortion and scale) and georeferenced, where points in the image are registered to known ground control points, in order to create accurate photographic maps. The maps were then used to digitize the low water marks in order to develop a quantitative record of historic shoreline change. This historic shoreline data was acquired from the university and used to develop the map presented in Figure 2-8. Interpretation of the historical shorelines suggests that a beach has been absent from the condominium's Maalaea Bay shoreline since at least 1960, except for a small, fluctuating pocket of beach material next to the jetty. The isolated beach on Milowai's protected harbor-front shoreline appears relatively stable, with a net accretion since construction of the jetty.

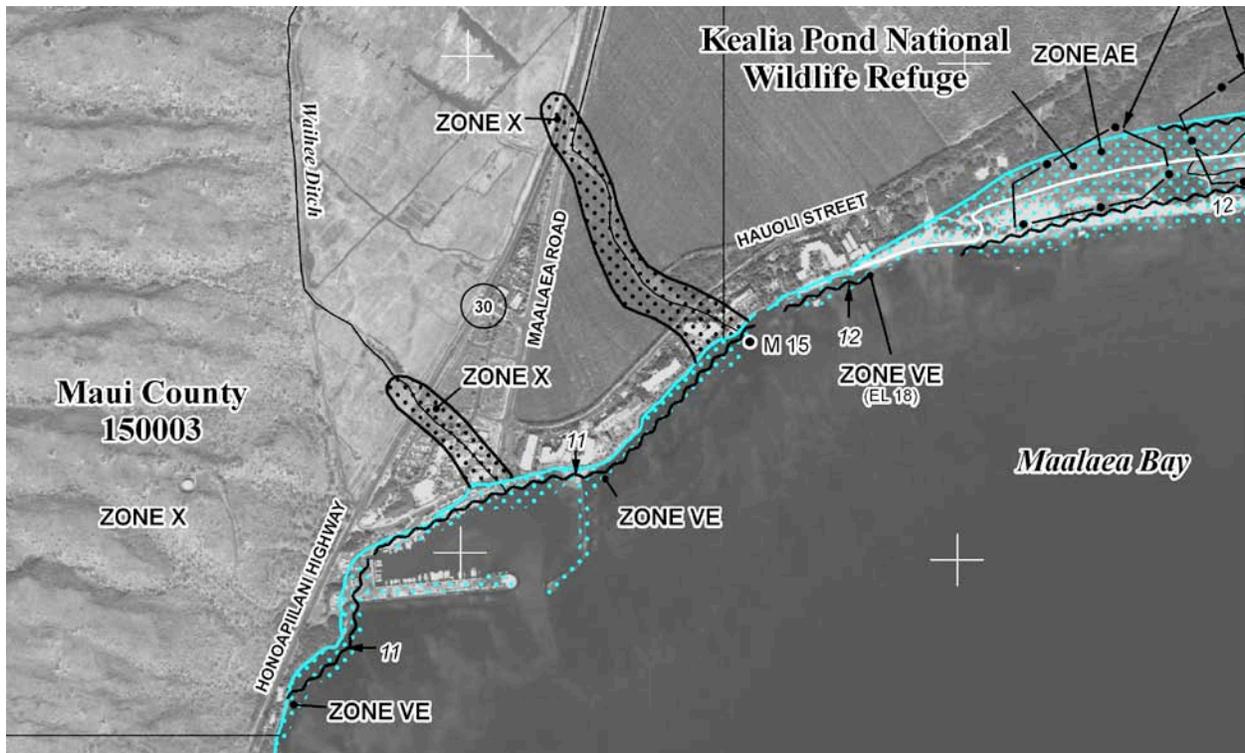
Figure 2-11. Cropped area of the Maalaea FIRM, showing Milowai's flood hazard as Zone VE, with a Base Flood Elevation of 11 feet (MSL)

The coastal Base Flood Elevation (BFE) for the Milowai property in this zone is given as 11 feet above mean sea level (see Figure 2-9), where the BFE is defined as the maximum computed water surface elevation for the 1% annual flood event. In contrast to inland BFEs along rivers and streams which contain only one component, coastal BFEs may be based on many additive components such as storm surge, wave height, wave setup, and wave runup. These components are discussed in more detail in Section 3.

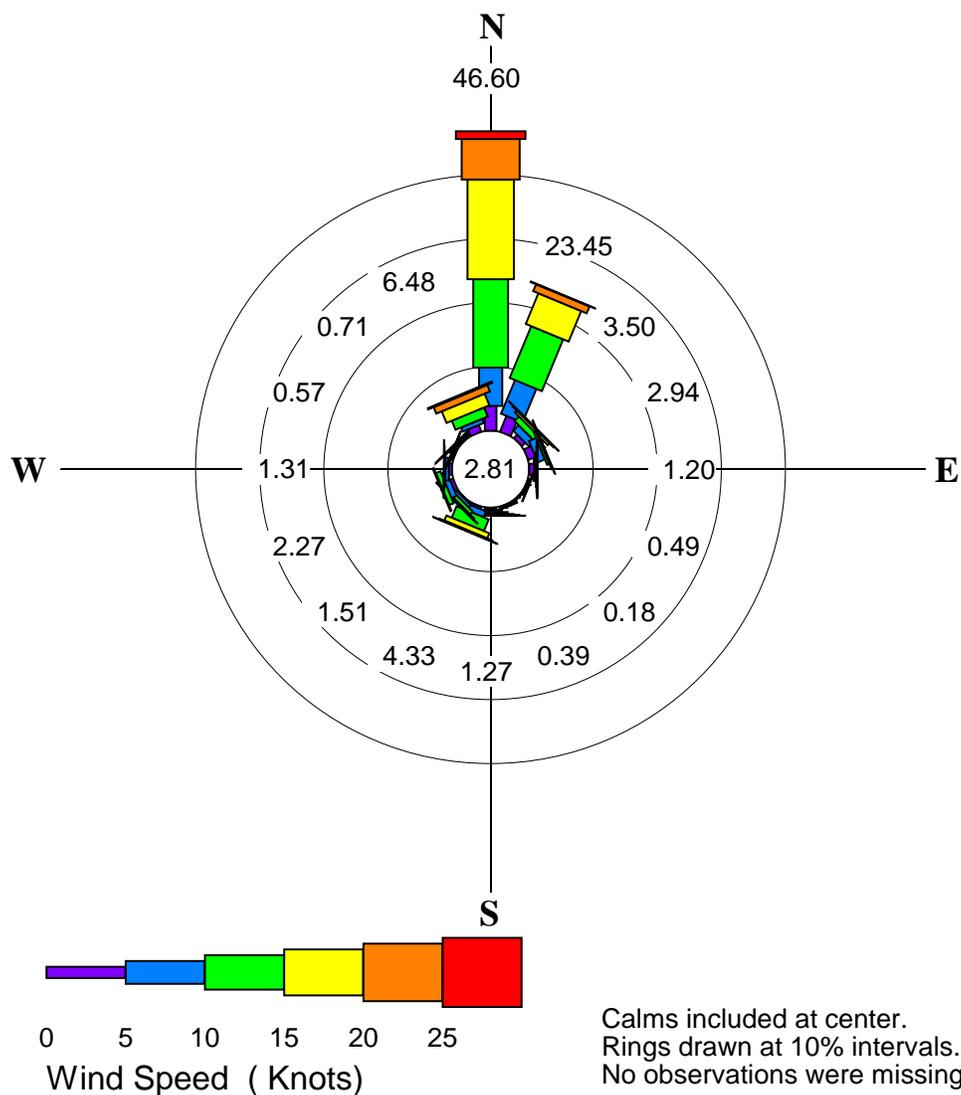
PERCENT OCCURRENCE: Wind Speed (Knots)							PERCENT OCCURRENCE: Wind Speed (Knots)						
DIR	LOWER BOUND OF CATEGORY						DIR	LOWER BOUND OF CATEGORY					
	0	5	10	15	20	25		0	5	10	15	20	25
N	3.85	5.95	13.77	15.52	6.31	1.20	S	0.32	0.36	0.30	0.14	0.12	0.04
NNE	2.65	5.65	8.72	5.16	1.16	0.10	SSW	0.37	1.00	1.93	0.84	0.13	0.05
NE	0.73	1.18	0.99	0.39	0.17	0.04	SW	0.15	0.49	0.62	0.22	0.03	0.00
ENE	1.21	1.18	0.33	0.18	0.03	0.00	WSW	0.49	0.86	0.73	0.18	0.00	0.00
E	0.70	0.28	0.12	0.08	0.03	0.00	W	0.52	0.57	0.17	0.03	0.03	0.01
ESE	0.31	0.13	0.04	0.01	0.00	0.00	WNW	0.28	0.19	0.03	0.04	0.01	0.01
SE	0.09	0.08	0.01	0.00	0.00	0.00	NW	0.21	0.19	0.15	0.09	0.04	0.03
SSE	0.26	0.13	0.00	0.00	0.00	0.00	NNW	1.08	0.70	1.49	1.93	1.09	0.18
TOTAL OBS = 7764 MISSING OBS = 0							CALM OBS = 218 PERCENT CALM = 2.81

Figure 3-1. Wind rose plot, Maalaea Harbor (July 2003 – October 2004)

for a total duration of 12 months was obtained from the National Weather Service office. The dataset covers the periods of July through December of 2003, February through March of 2004, and July through October of 2004. The hourly data was provided in the form of 2-minute sustained wind speeds at 10 meters (33 feet) elevation above ground, and directions given in meteorological convention. Figure 3-1 presents a wind rose diagram of the Maalaea wind data, where the statistical occurrence of a particular wind speed and direction are expressed as a histogram wrapped around the compass directions. The wind rose clearly shows that winds at Maalaea Harbor come from a narrow directional sector between north and northwest more than 75 percent of the time. Although southerly winds occur only a small percentage of the time, they are occasionally strong. The strongest wind in this record is 39.96 knots from 350° true north (TN), while the strongest southerly wind was 29.97 knots from 210° TN.

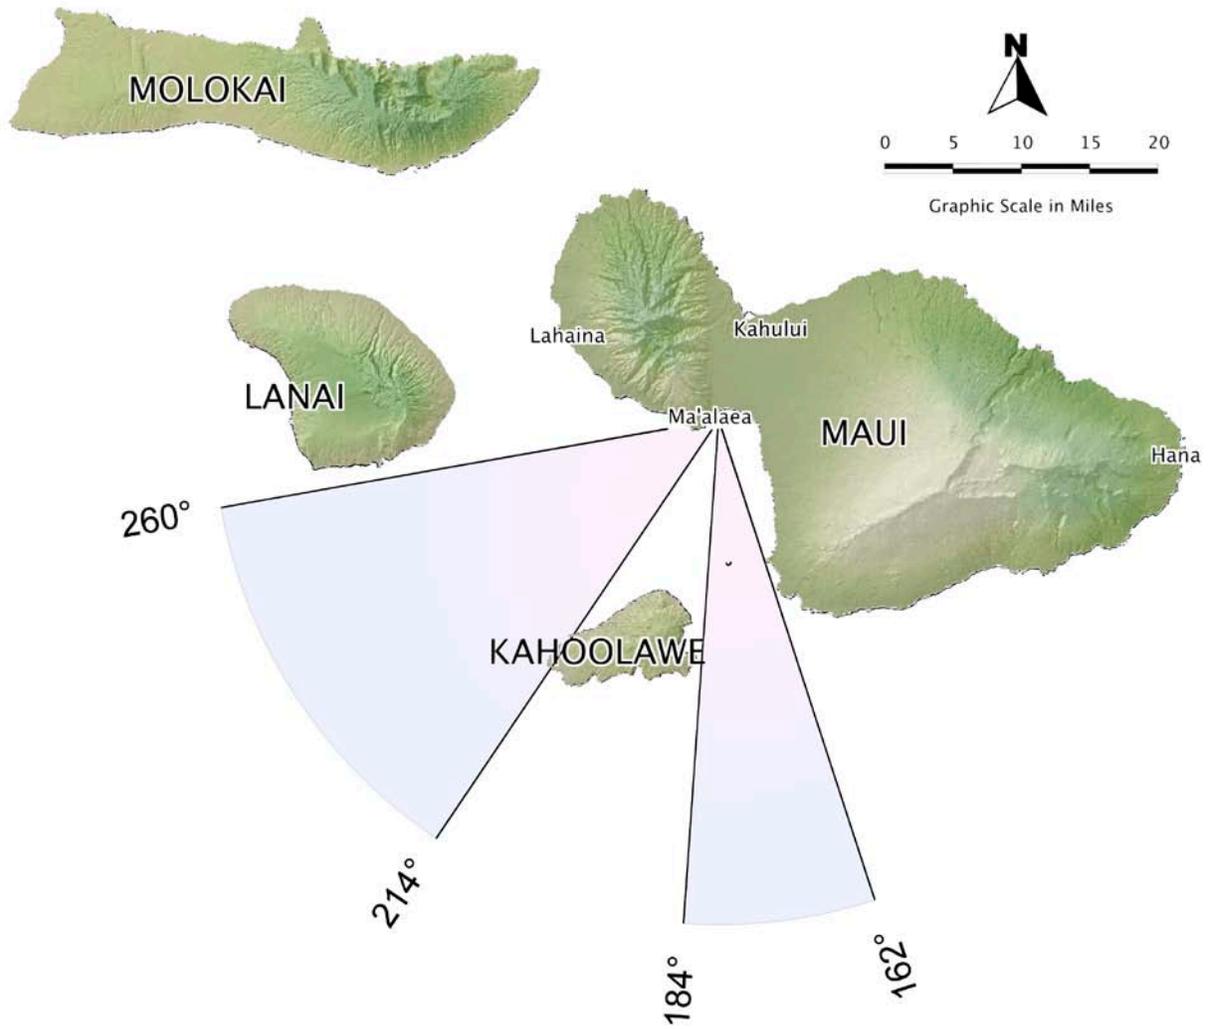
Figure 3-2. Wave exposure windows for Maalaea Bay

A wave refraction analysis was completed by Sea Engineering (1994) for compass points centered on 135° (SE), 157.5° (SSE), 180° (S), 202.5° (SSW), 225° (SW), 247.5° (WSW), and 270° (W). This analysis revealed that, because of the sheltering effects of Kahoolawe, Lanai, Molokai, and West Maui, waves coming from 247.5, 225, 202.5, and 180 degrees produce the most wave energy in the vicinity of Maalaea. Waves from 247.5, 225, and 180 degrees travel in nearly straight paths toward Maalaea Bay, while waves from 202.5 degrees are refracted around Kahoolawe toward Maalaea Bay. The occurrence of waves from these directions is shown in Table 3-1. The data show peak wave occurrence from the south-southwest, with typical heights and periods of 2 to 6 feet and 12 to 18 seconds, respectively.

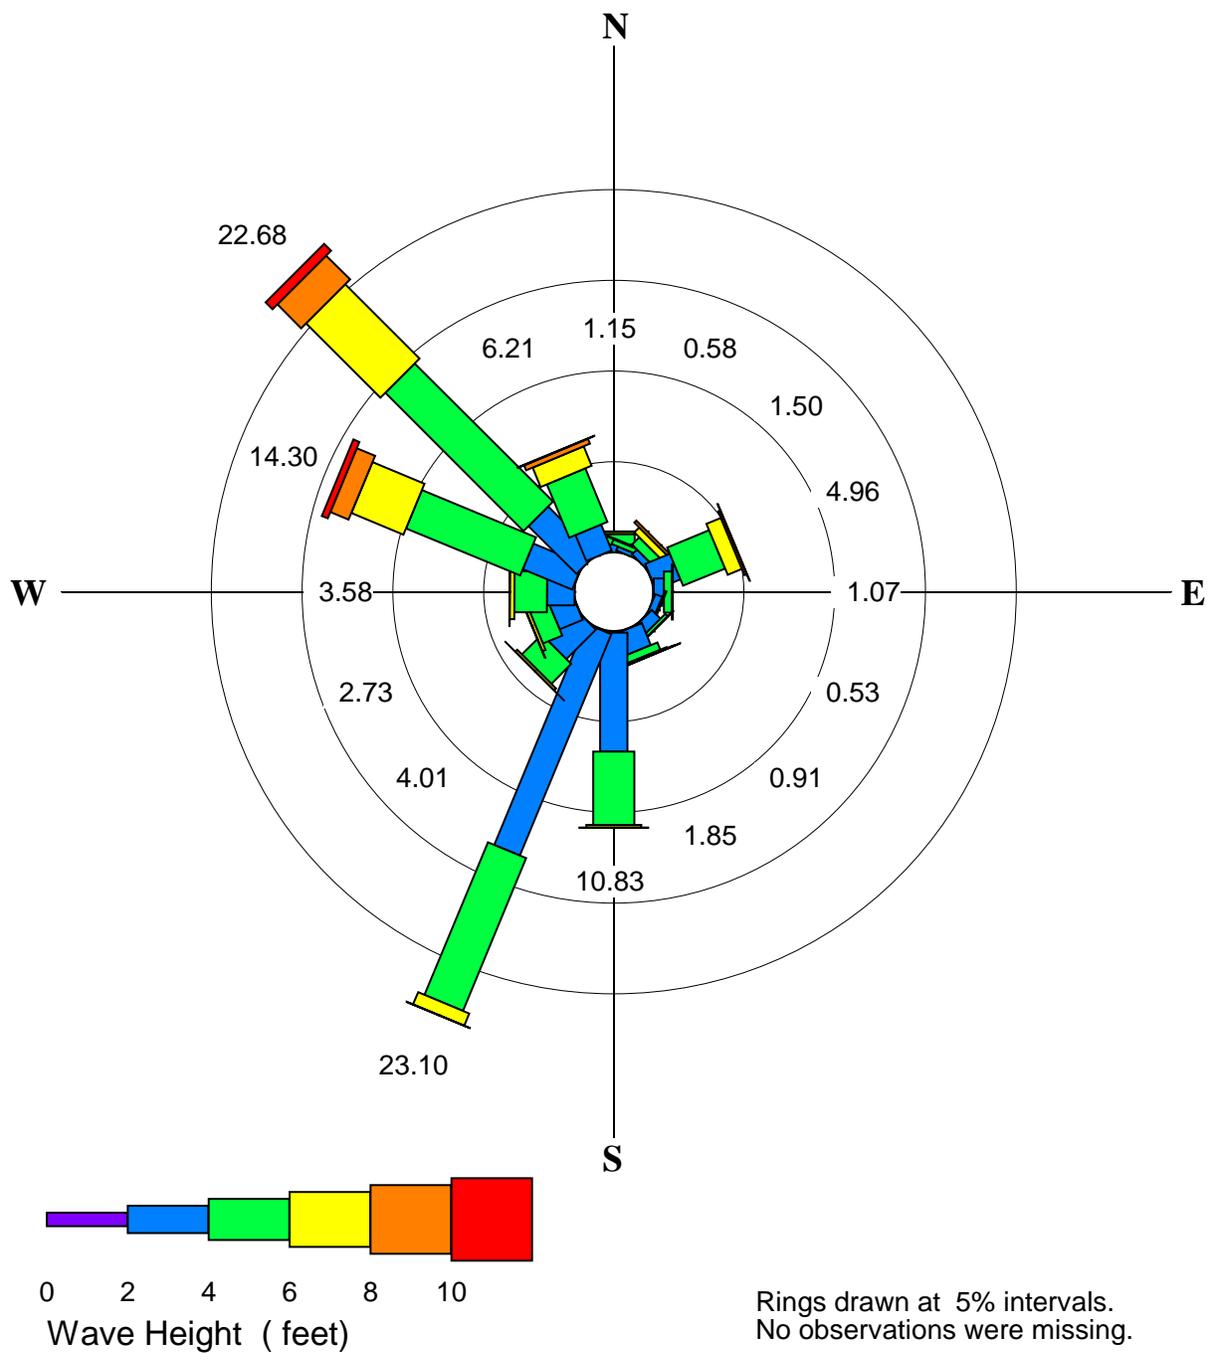
Figure 3-3. Wave Height Rose Plot for WIS Station 114

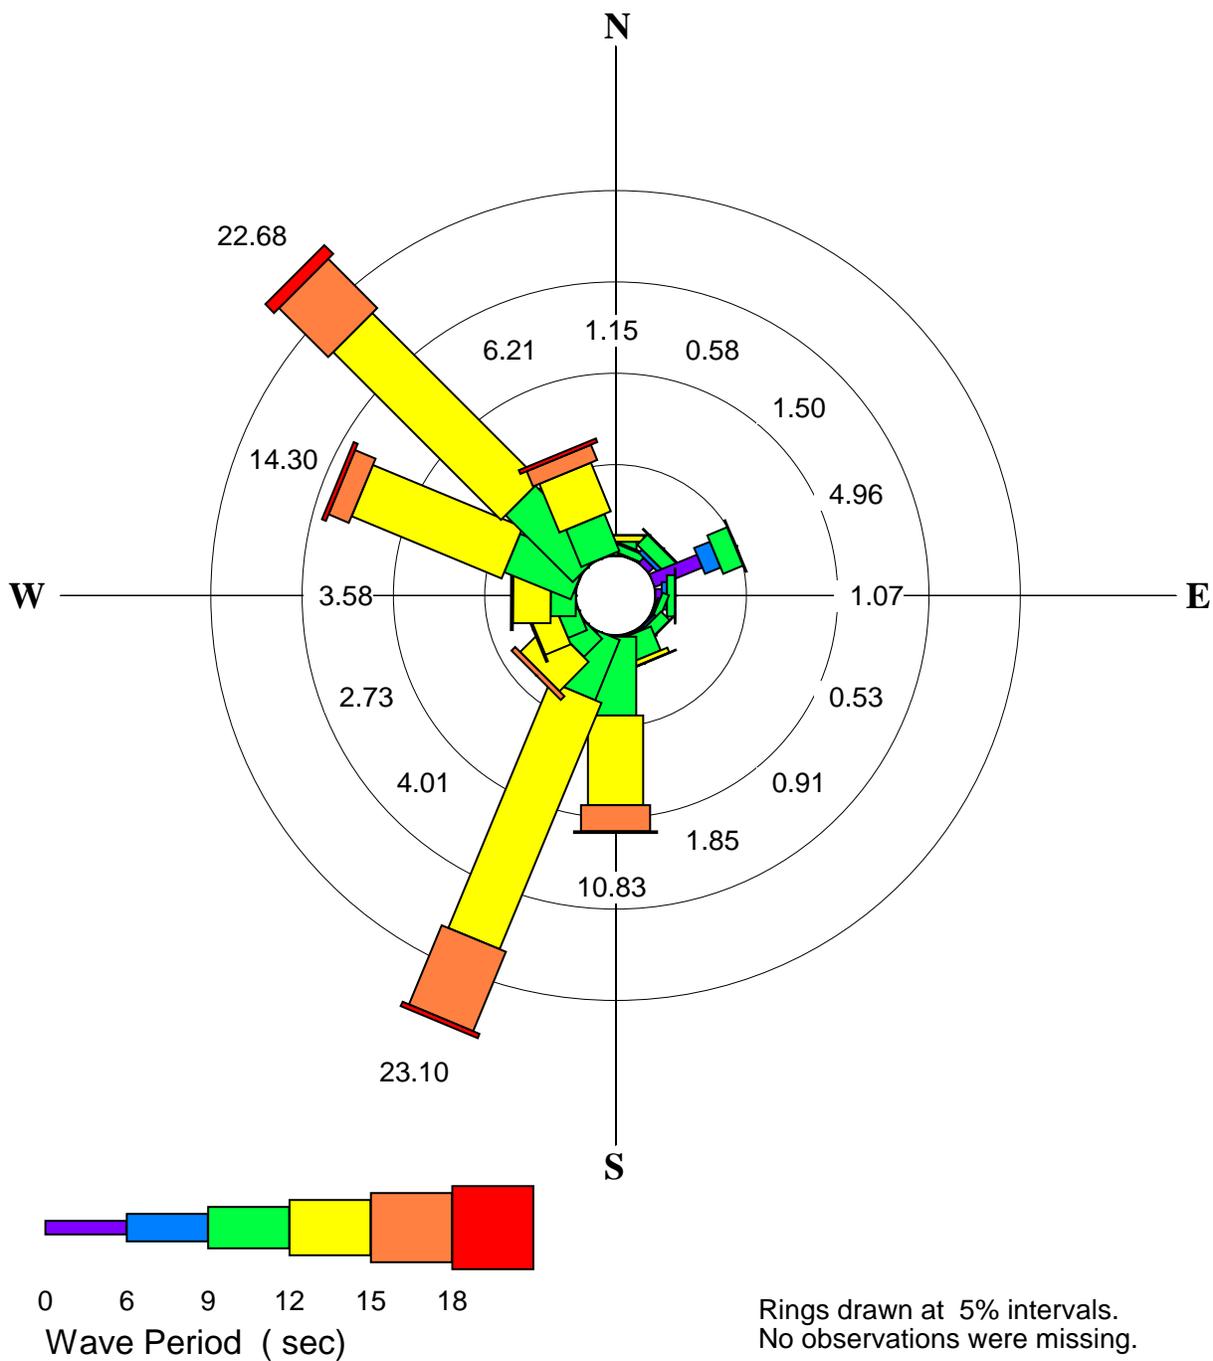
Figure 3-4. Wave Period Rose Plot for WIS Station 114

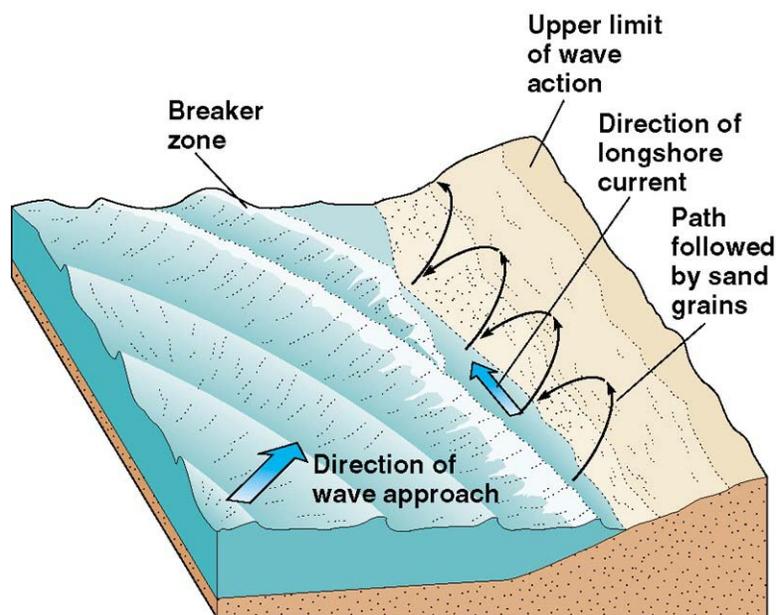
Figure 3-5. Diagram of longshore transport and swash zone

often influences the direction of the resultant longshore current. Longshore currents are typically found along broad, uninterrupted beaches where bottom topography is gradual and constant across the beach, features which are more commonly associated with the U.S. Mainland. When the wave crests approach at an angle to the shoreline, a longshore current will generally develop in the direction of the breaking wave front, as illustrated in Figure 3-5. The breaking wave itself can suspend sediment which can then be transported both in the swash zone (area between the upper and lower wash of waves on the beach) and by longshore currents

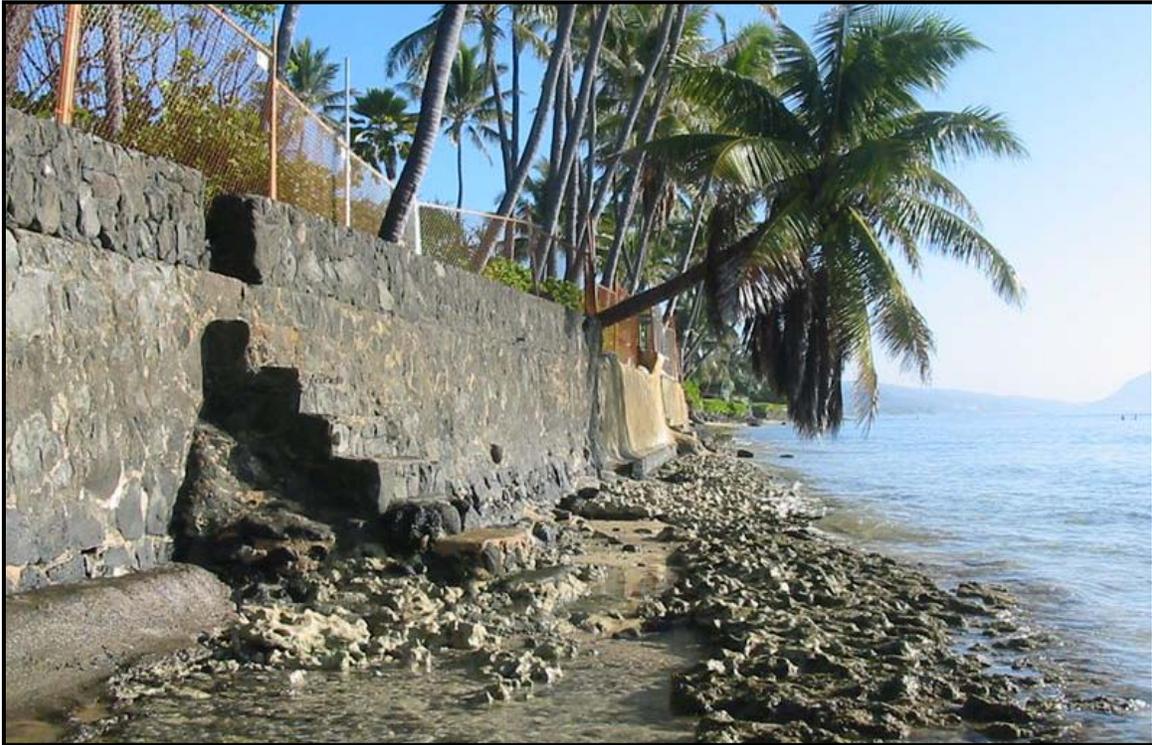
Figure 4-1. CRM seawall in Kahala, Oahu

foundation of a seawall is critical for its stability, particularly on a sandy and eroding shoreline. Ideally, a seawall should be constructed on solid, non-erodible substrate. Seawalls are not flexible structures, and their structural integrity is dependent upon the stability of their foundations.
