SUBJECT: DRAFT ENVIRONMENTAL ASSESSMENT (EA) FOR THE PROPOSED MILOWAI MA'ALAEA SEAWALL REPAIR PROJECT, LOCATED AT 50 HAUOLI STREET, WAILUKU, MAUI, HAWAII; TMK: (2) 3-8-014:022 (SM1 2012/0008) (EA 2012/0006) (SSV 2012/0004)

Project Name: Milowai Ma'alaewa Seawall Repair Draft EA

On behalf of the Owner, Sandhills Gang Partners, the Applicant, Milowai Ma'alaea AOO is seeking a Special Management Area (SMA) Permit, and a Shoreline Setback Variance (SSV) as part of this Environmental Assessment (EA) to repair an existing seawall at the Milowai Ma'alaea Residential Condominium project.

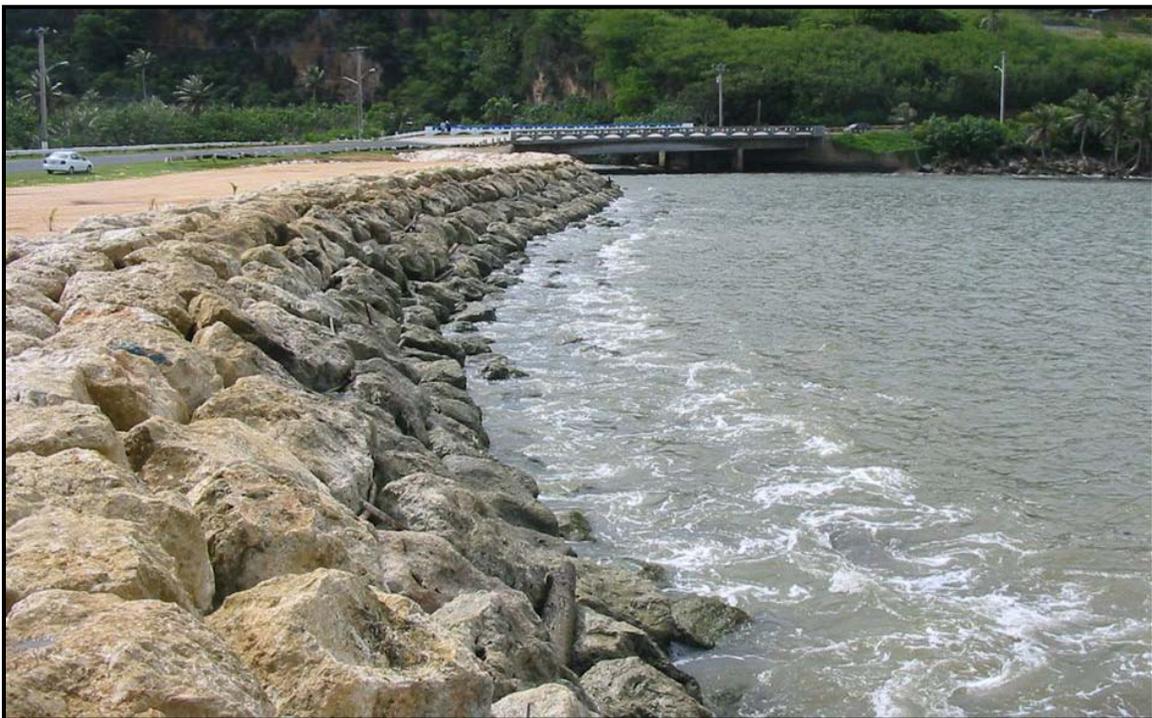
Figure 4-2. Example of typical rock revetment structure (Talofofo, Guam)

Because both seawalls and revetments fix the shoreline at the position of the structure, on chronically eroding coasts, they will eventually lead to loss of the beach.

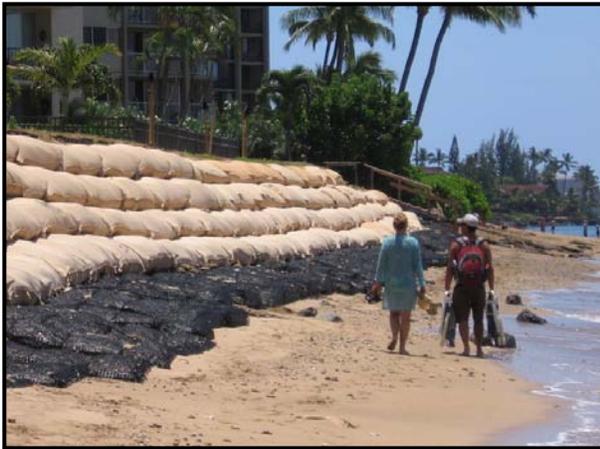
Figure 4-3. Geotextile Sand Bags

Small, hand-filled sand bags are an ancient flood control and shore protection remedy, and they are still frequently used. However, they tend to degrade quickly and loose bags in the water can be an environmental nuisance. Geotextile materials are a more recent development, with large, 5 feet x 10 feet geotextile sand bags and custom sized large diameter geotextile tubes that have been used for temporary emergency shore protection in Hawaii in recent years (Figure 4-3 and Figure 4-4). The bags or tubes are filled with beach quality sand with the understanding that should the fabric become damaged or otherwise fail, the sand will be released and become part of the beach system.

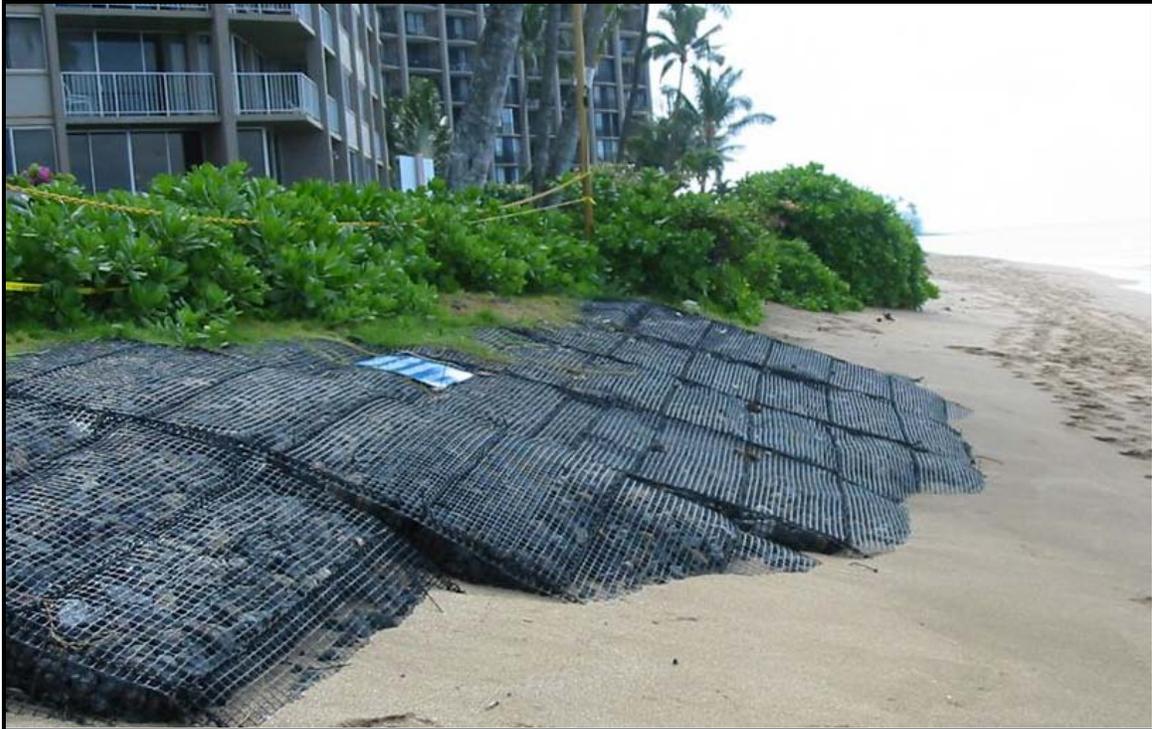
Figure 4-5. Tensar™ Marine Mattresses Used for Articulating Protection

Triton Marine Mattresses are fabricated by the Tensar Corp., and consist of rock filled HDPE (high density polyethylene) grids. The typical width is 5 ft and the recommended maximum length is 35 ft. However, the length can vary and design length is dependent on the desired handling characteristics of the mattress. A 12-inch by 35-ft mattress weighs about 9 tons. Figure 4-5 is a photograph of the Triton marine mattresses used as an articulating revetment. The marine mattresses have also been effectively used as a foundation for a geotextile sand bag revetment.

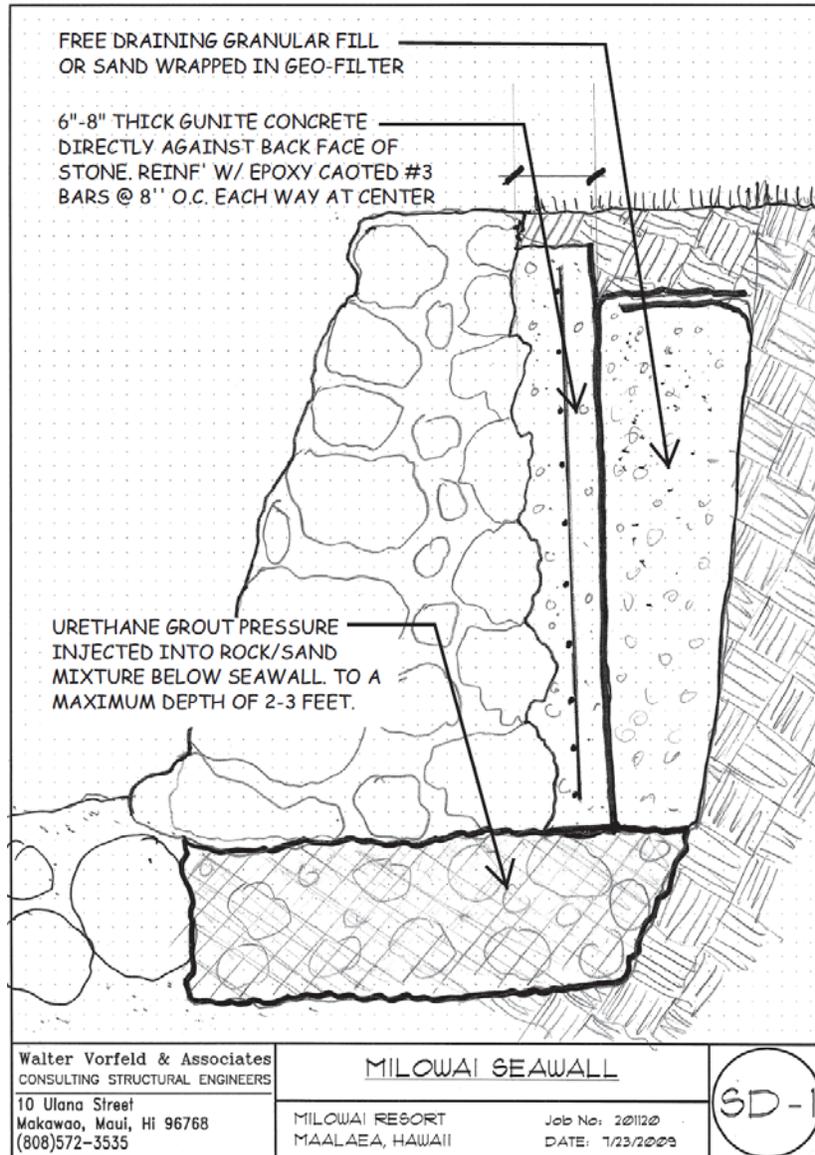
Figure 4-6. Wall repair schematic by Walter Vorfeld & Associates

- If felt necessary a system of corrosion protection utilizing sacrificial anodes or some other effective system may be included in the reinforcing to extend its life in the highly corrosive conditions.

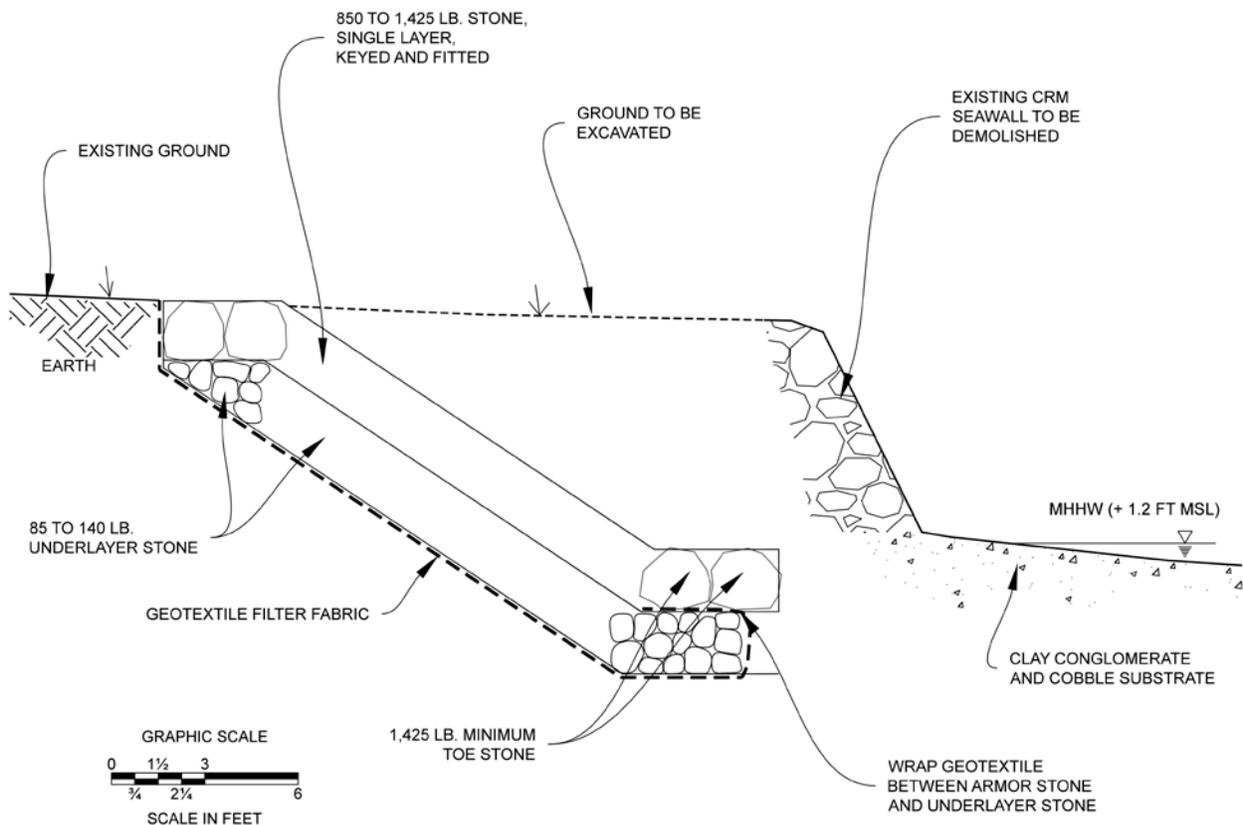
Figure 4-7. Conceptual revetment section (typical), shown at Profile 2

The parameters necessary for the design and construction of a rock revetment at Milowai Condominiums are discussed in Section 5, along with a typical section.

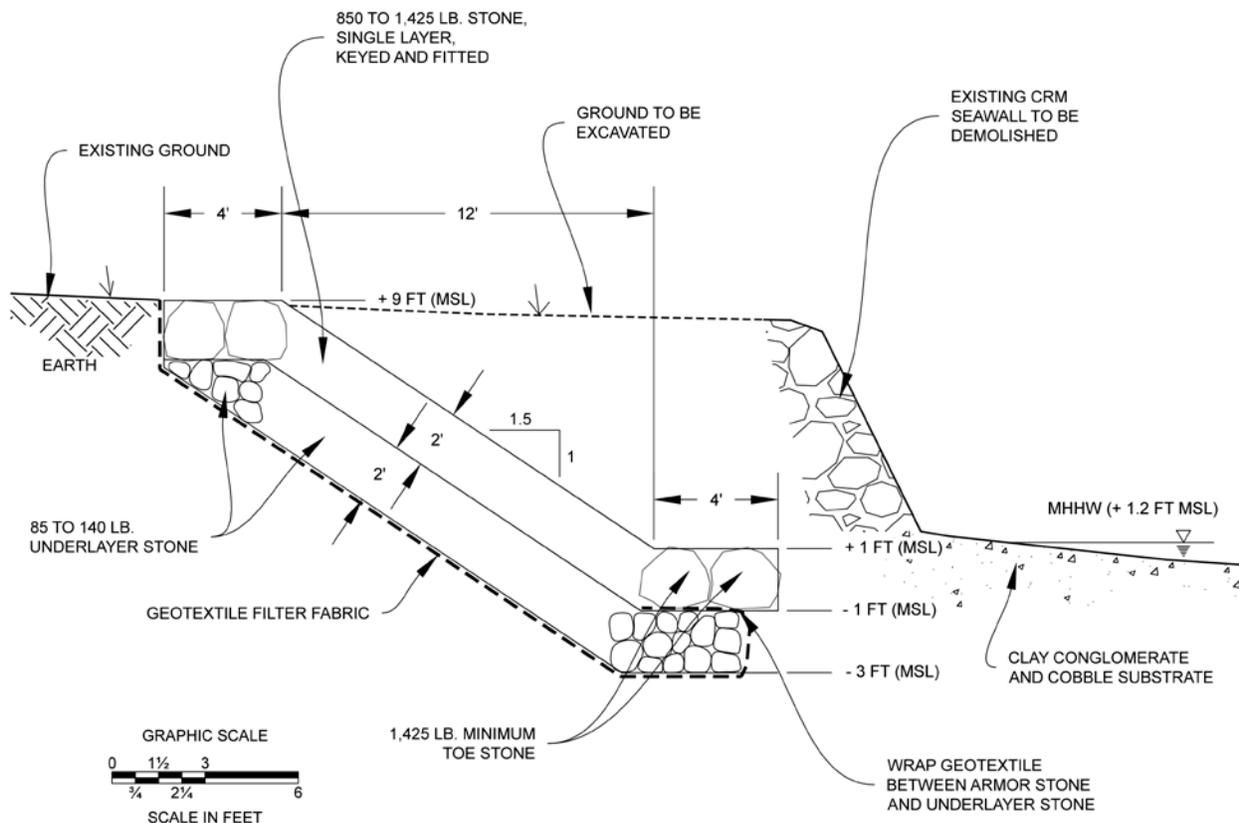
Figure 5-1. Typical armor stone revetment section

The revetment design cross-section is presented in Figure 5-1. The revetment crest and face consist of armor stone with a median stone size of 1.9 feet based on the design wave conditions calculated in Section 5.1. Crest elevation is designed at + 9.0 ft MSL, which is the approximate elevation of existing grade immediately landward of the revetment, as well as the computed runup elevation for the annual event. The revetment crest is two stones wide, or approximately 4 ft.

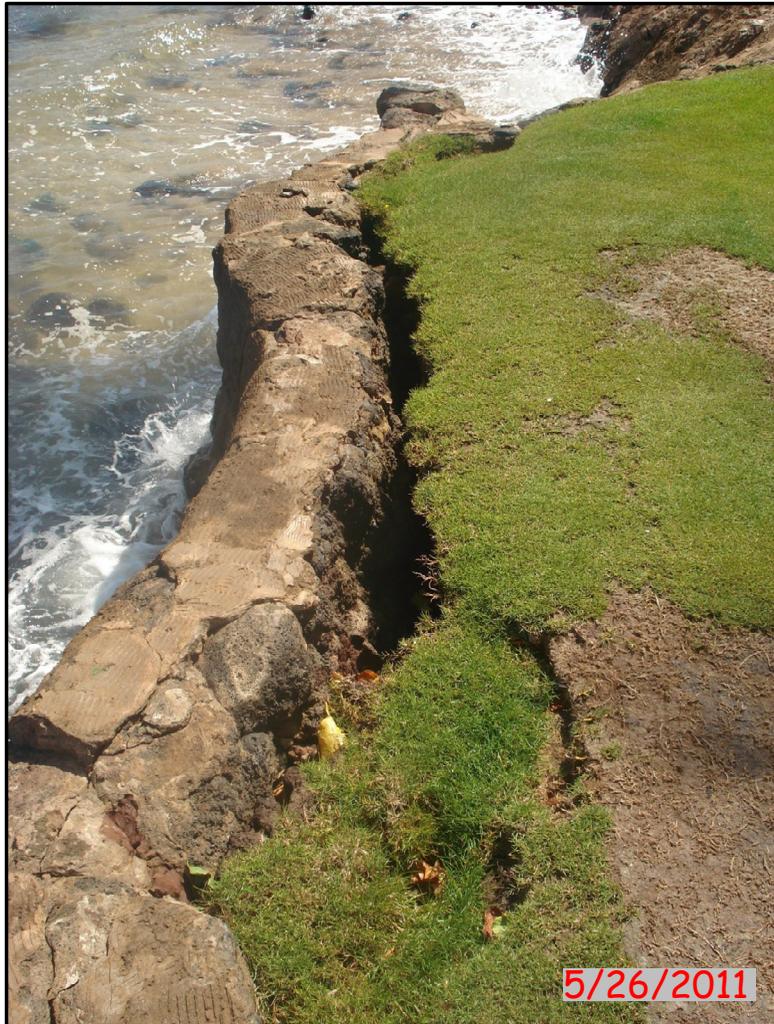
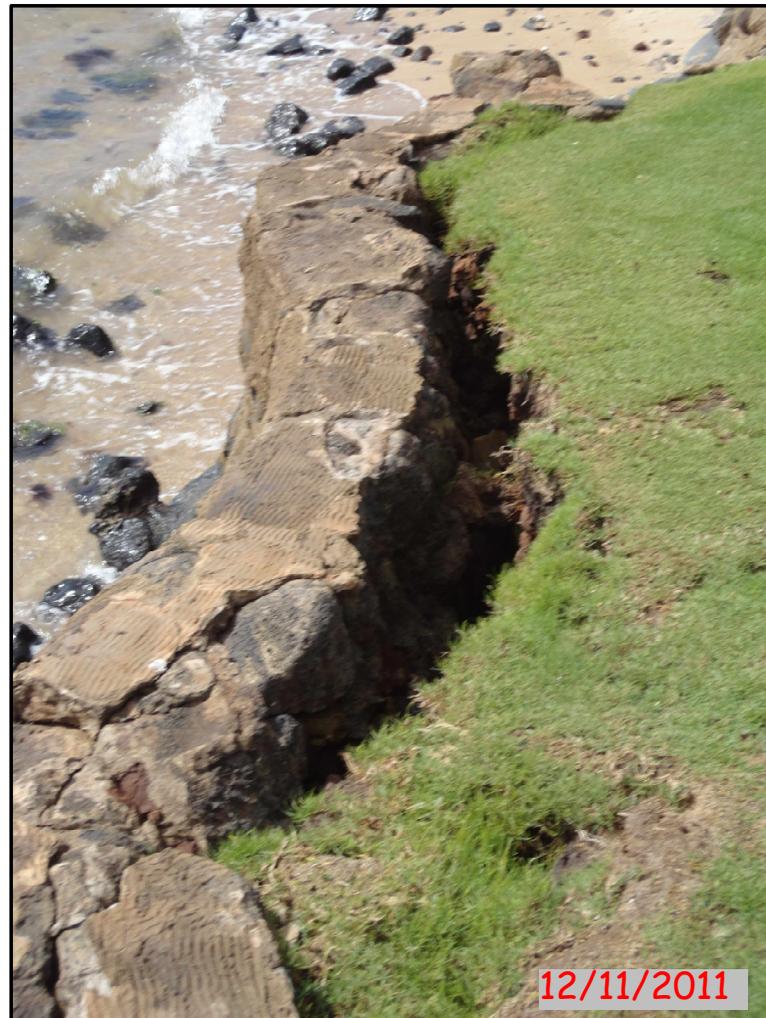
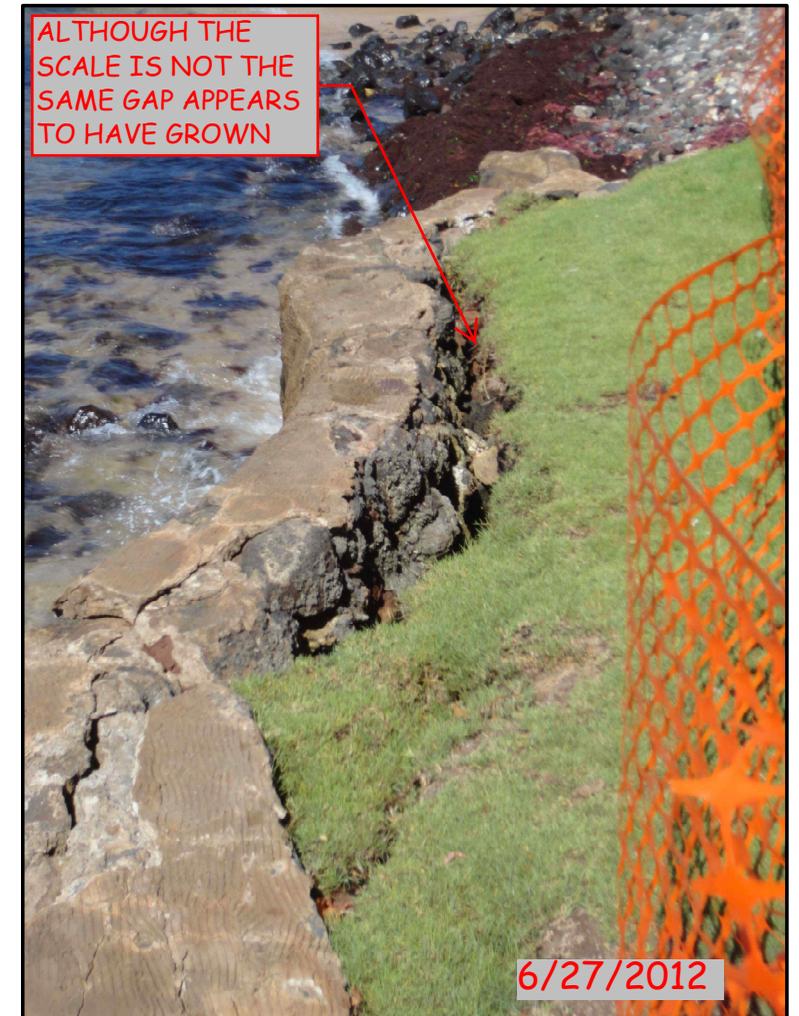
TOP VIEW OF SEAWALL NEAR CORNER
(APPROXIMATELY 6 MONTHS BETWEEN EACH PHOTO)

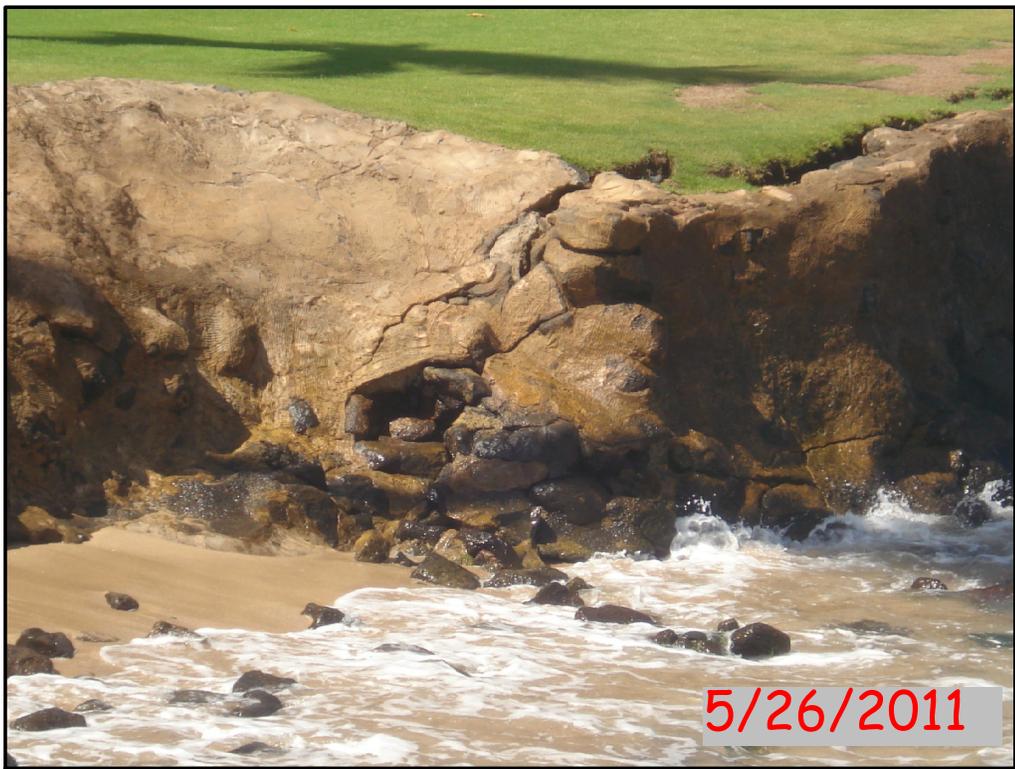
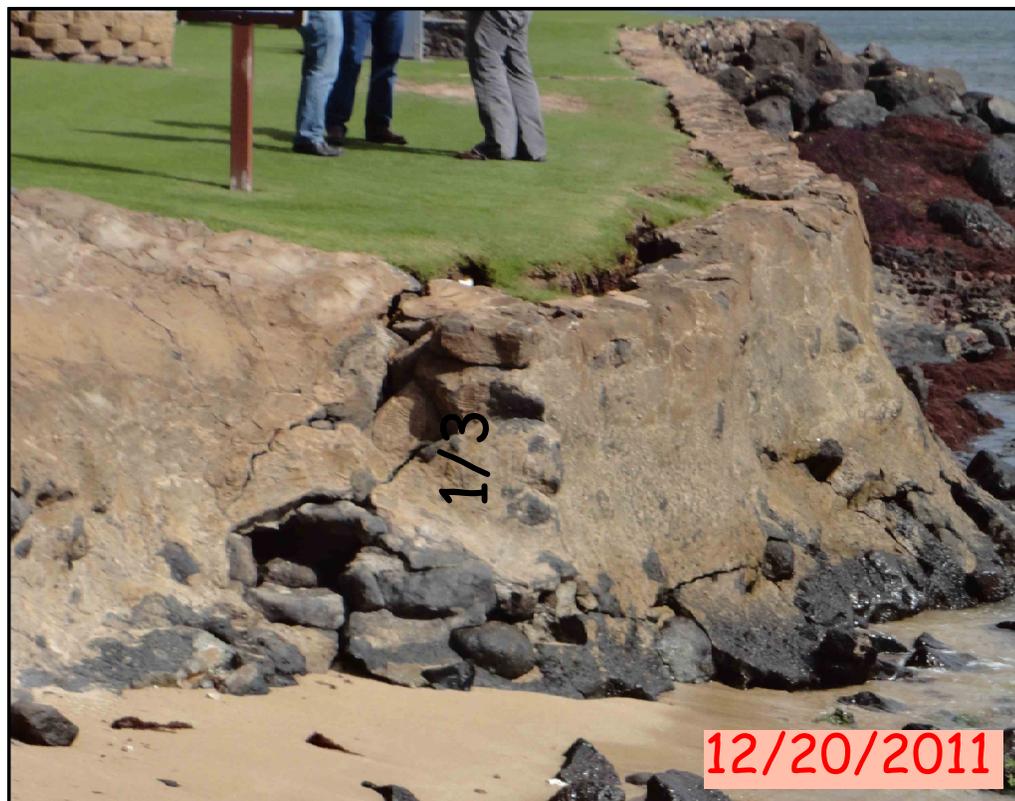
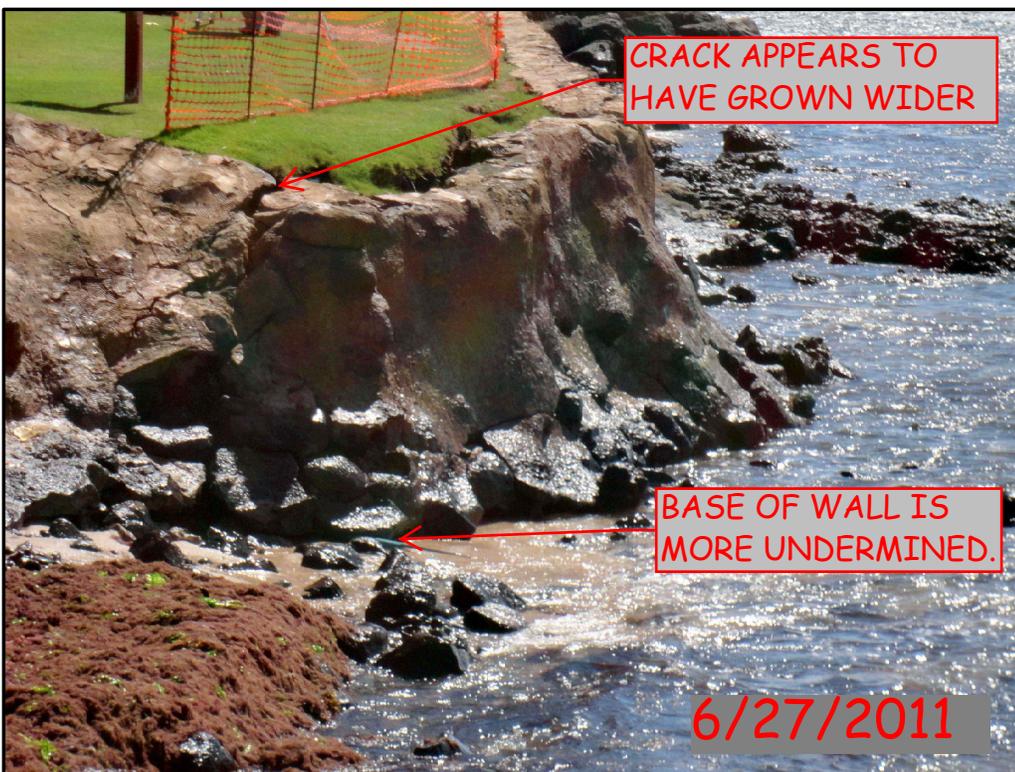
SEAWALL CORNER IMAGE

URETHANE GROUT PRESSURE
INJECTED INTO ROCK/SAND
MIXTURE BELOW SEAWALL. TO A
MAXIMUM DEPTH OF 2-3 FEET.

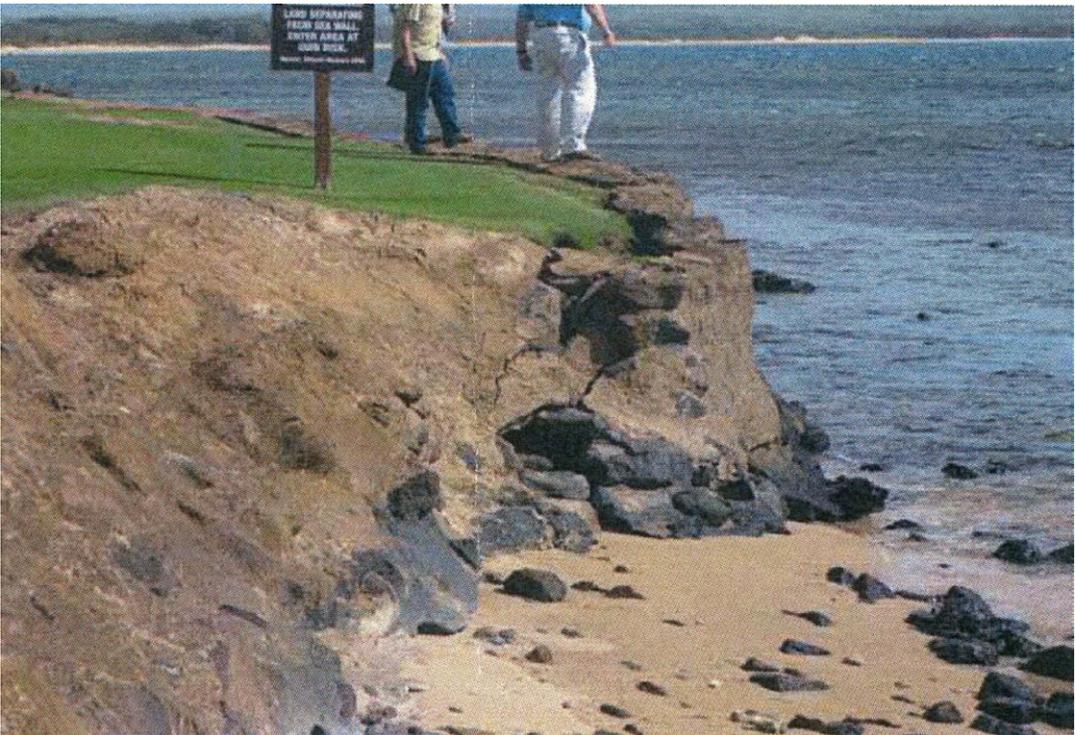
Figure 6. Close-up view of seawall

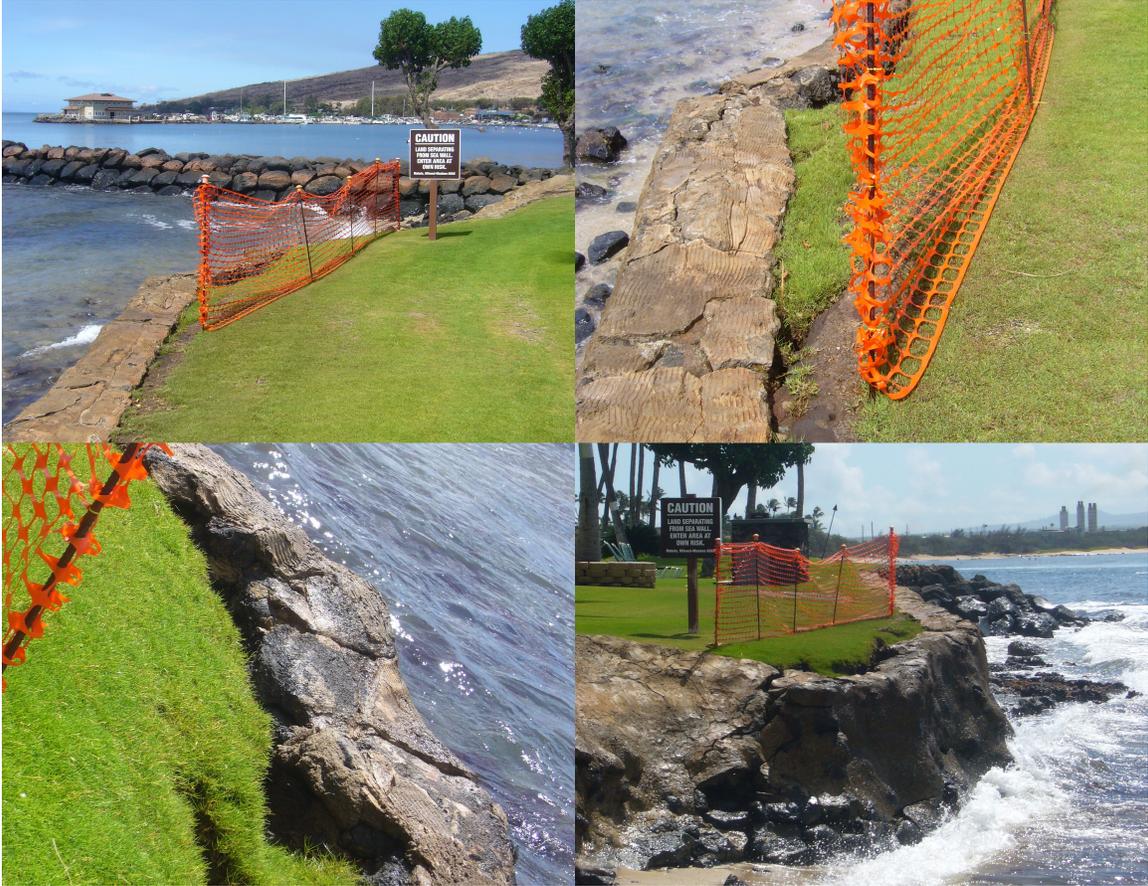
Figure 3. Site of erosion undermining Milowai property. Engledow photos 6/12
