Subject: Draft Environmental Assessment (DEA) for Conservation District Use Application (CDUA) OA-3589 for the Repair and Reconstruction of a Seawall at Kaluahole, Waikiki, Oahu, TMK (1) 3-1-003:001

**Environmental Assessment**

**Conservation District Use Application  
Kainalu Seawall, Diamond Head  
Honolulu, Hawaii**

TMK (1) 3-1-003: 001

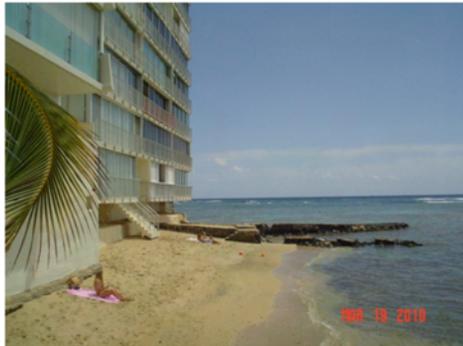
Shoreline and public beach.

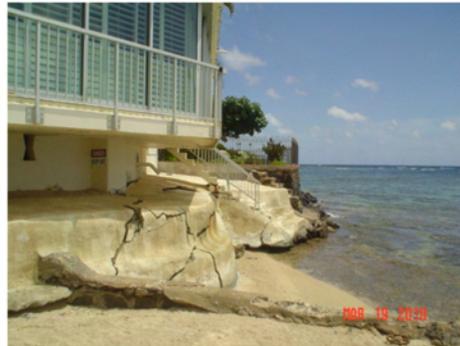
Shoreline and eroded section of beach.

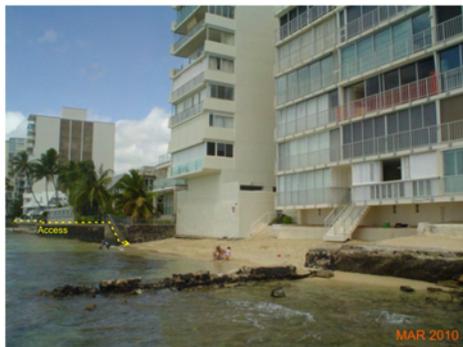
Public beach and beach access.

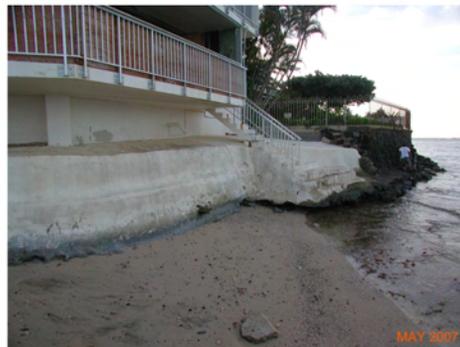
Eroded section in 2007. People accessing shoreline to the East along rocks.

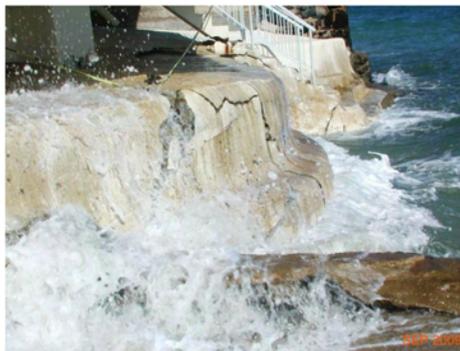
Eroded section in 2009 during high tide wave action.

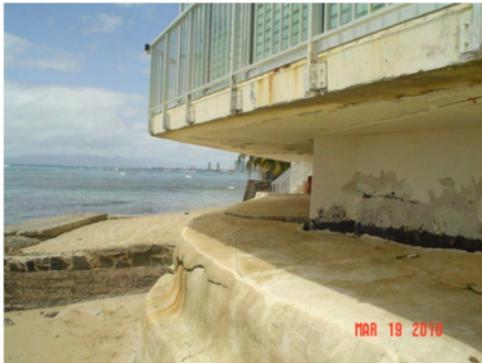
View West

The continued erosion of sand appears to be causing differential settling, which in turn, is causing the wall and gunite to crack and pull away from the apartment building. It is feared that if erosion continues, the wall will collapse and seawater inundation of the Kainalu support pilings may cause the building to become unstable and collapse.

Crack on top surface. Wall is hollow under surface.

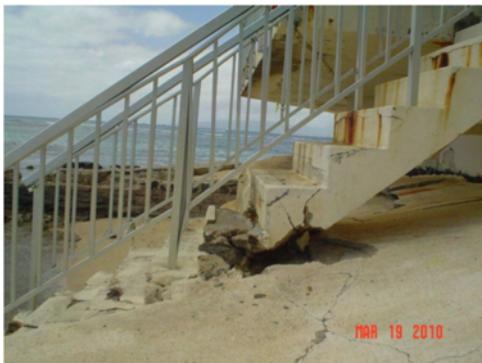
Crumbling stairs to be removed.

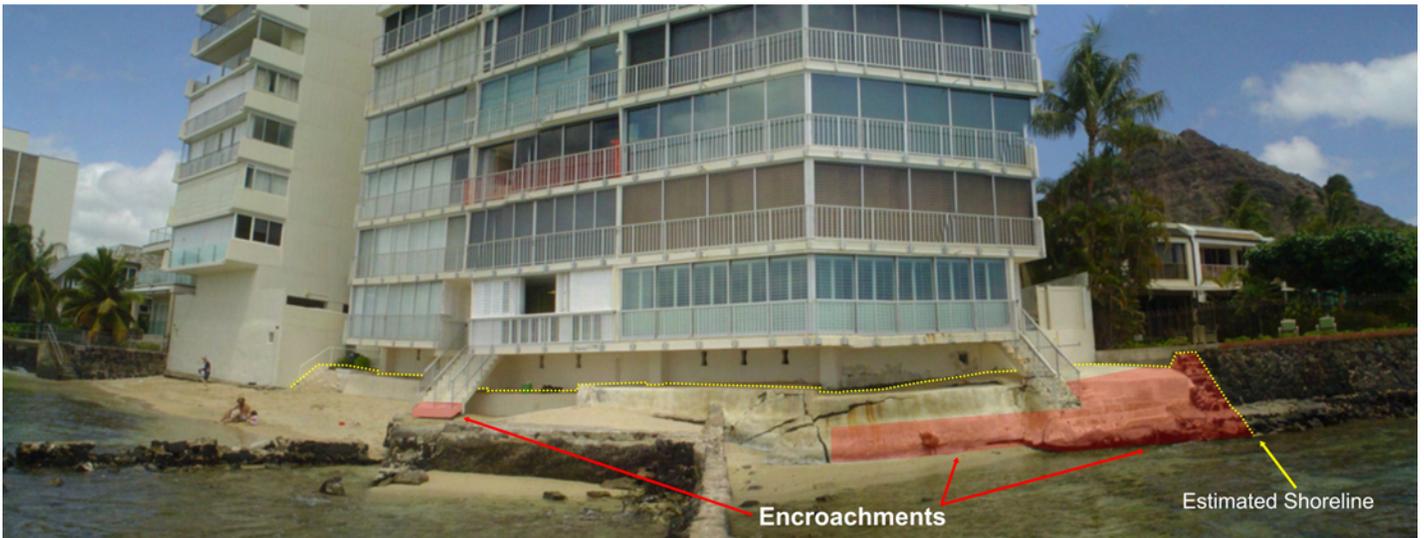
**Figure 10. Encroachments and**

A shoreline certification will take place during the construction phase when the prohibiting encroachments have been removed.
